Never give up, Maramarua K1 Pit Geotech performance – a mine operators perspective

Maramarua Coal Mine

Dean Coplestone, Mine Planner

August 2023

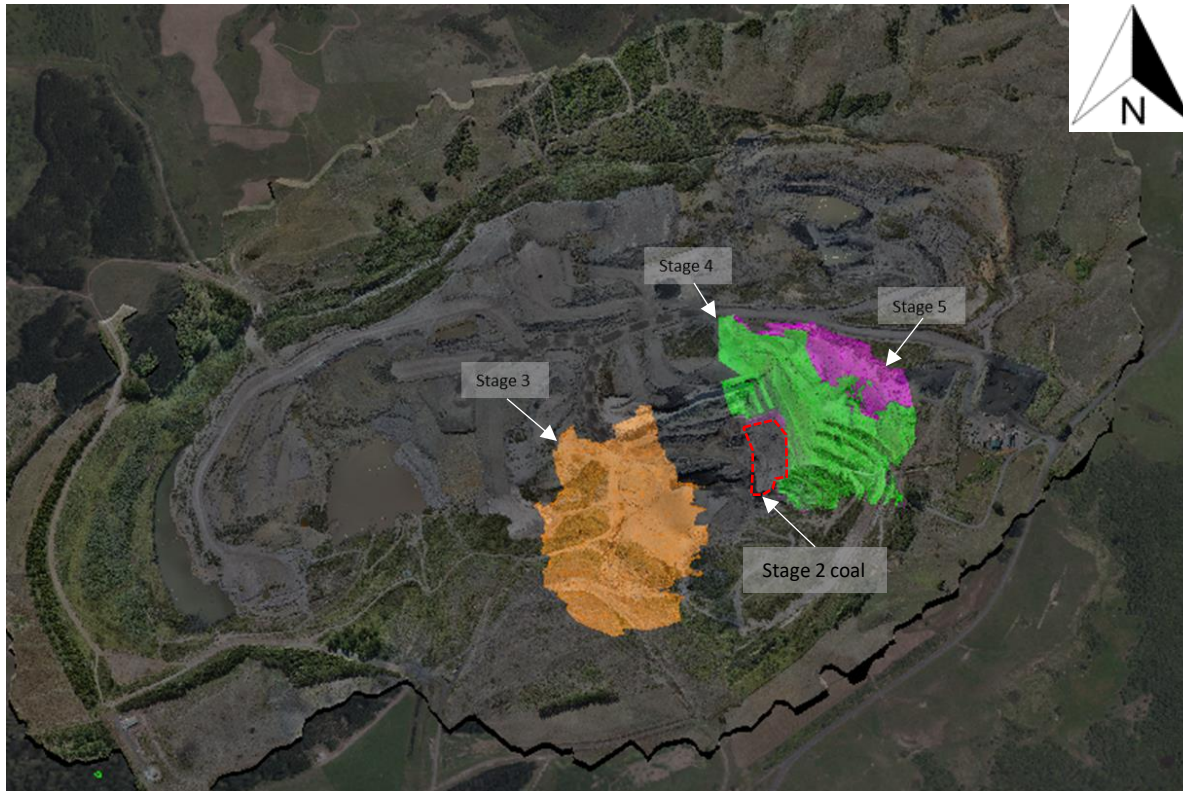
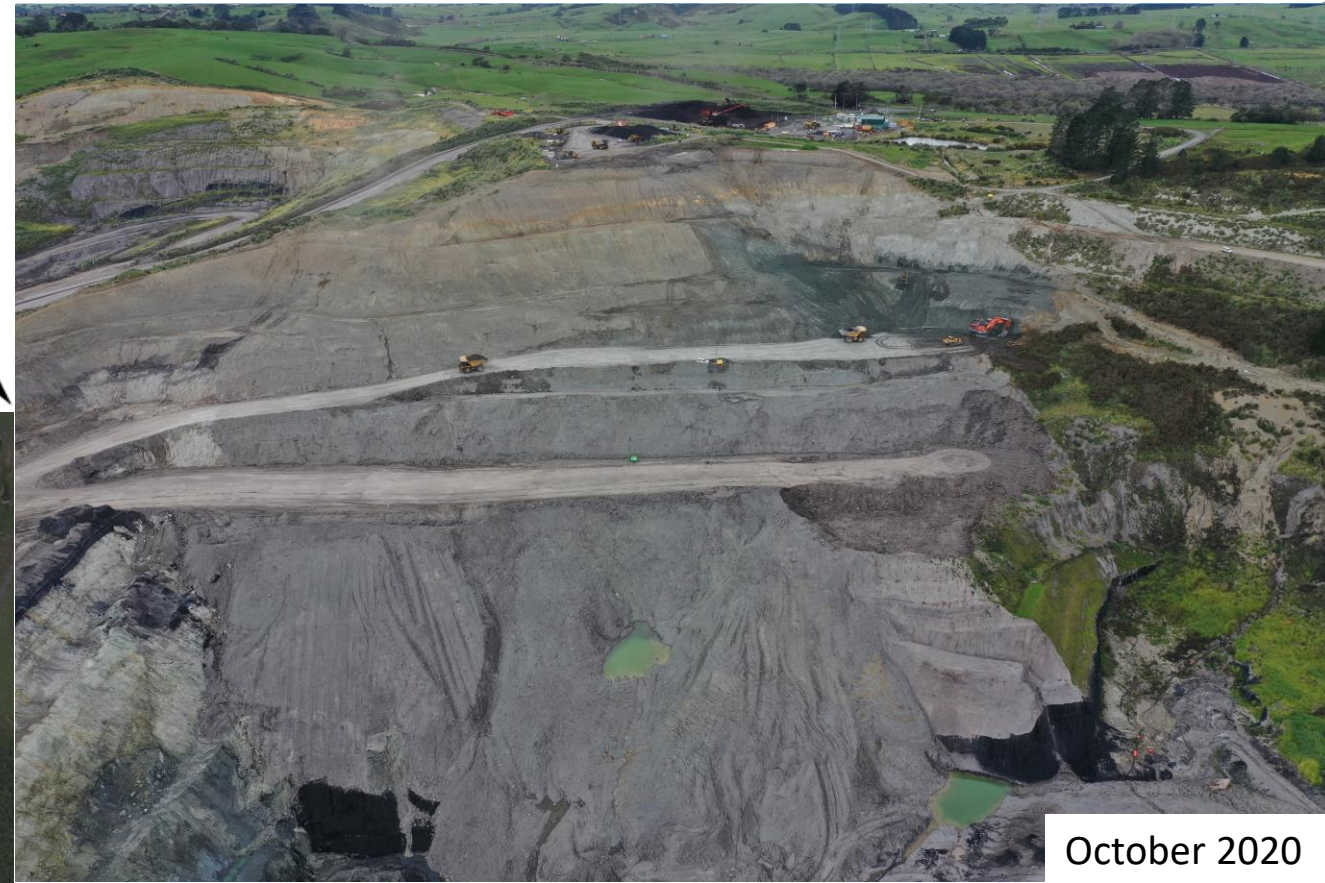
First signs of movement

- Initial movement was picked up by the total station monitoring system in early February 2020.
- K1 pit stages resequenced to unload instability
- Failure debris was dozed down to stabilize the slope and allowed the unloading of stage 4.

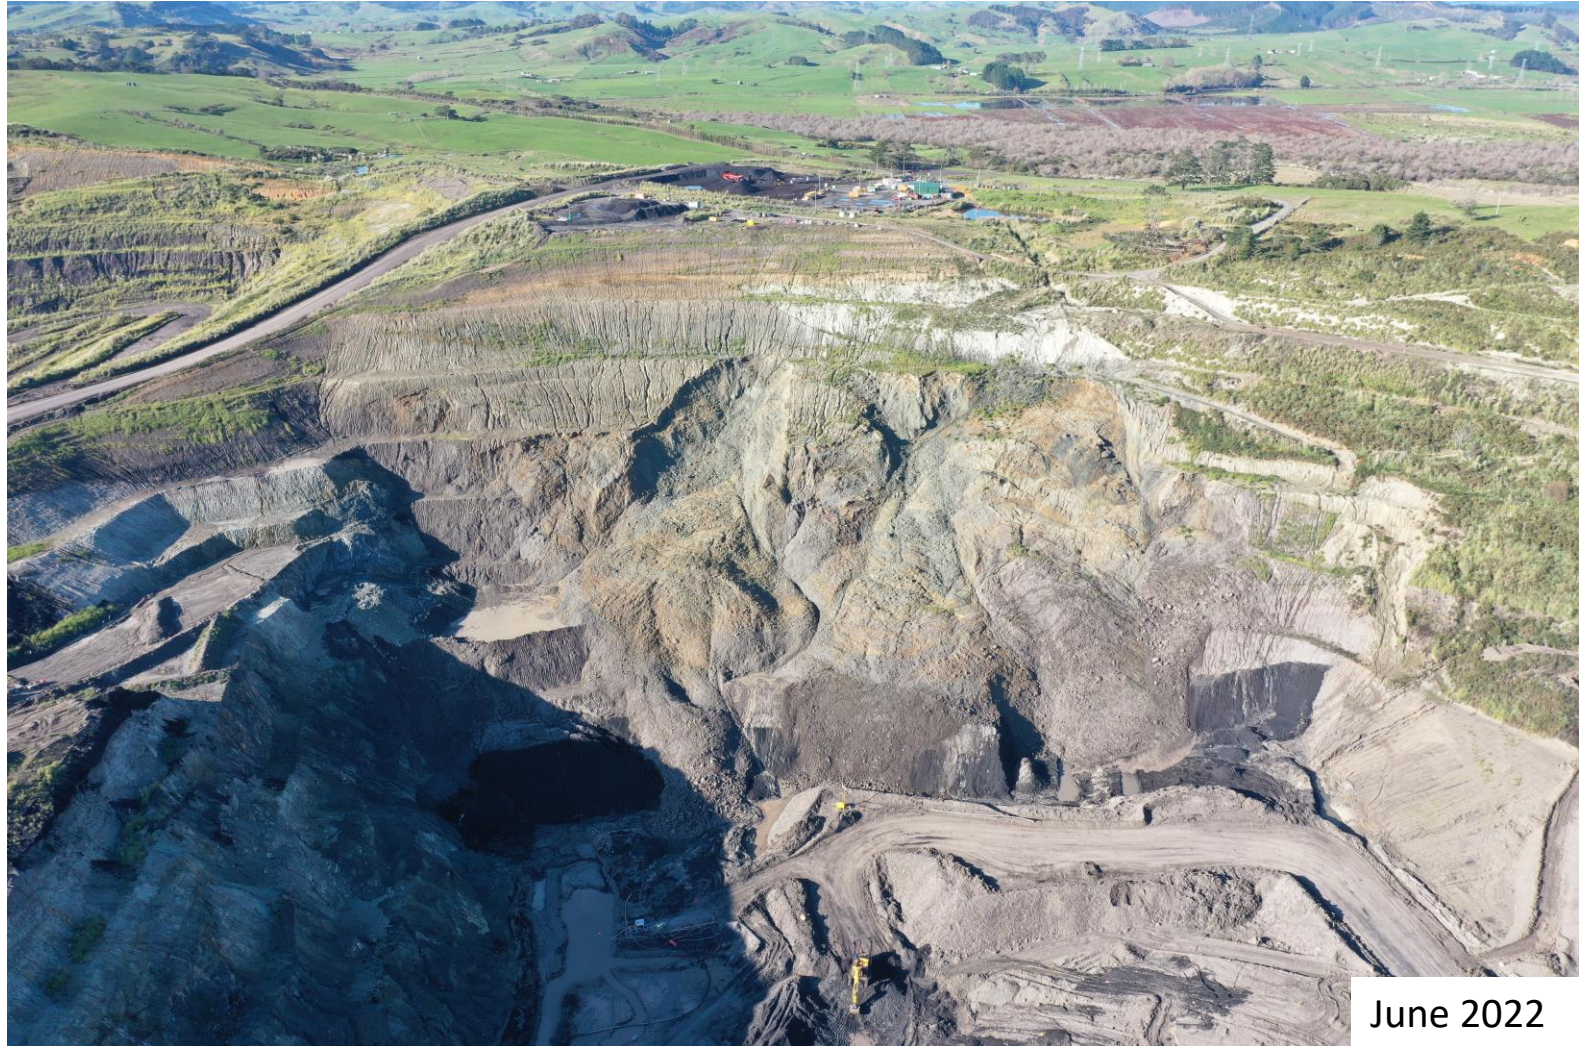
Instability along final highwall

- Minor movement on faults in the cut face.
- December 2021 slumping had occurred in the southern section along the hanging wall of the Foote fault.
- By June 2022 the failure had progressed further to the north. Covering the stage 5 b coal.

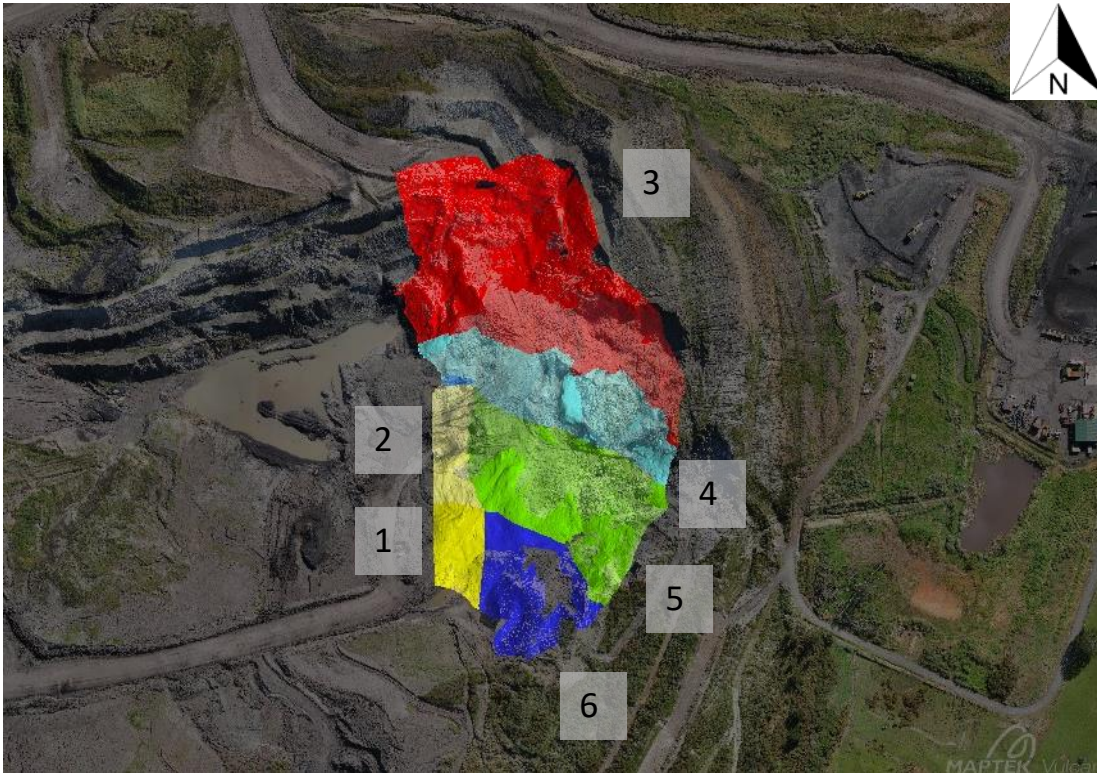
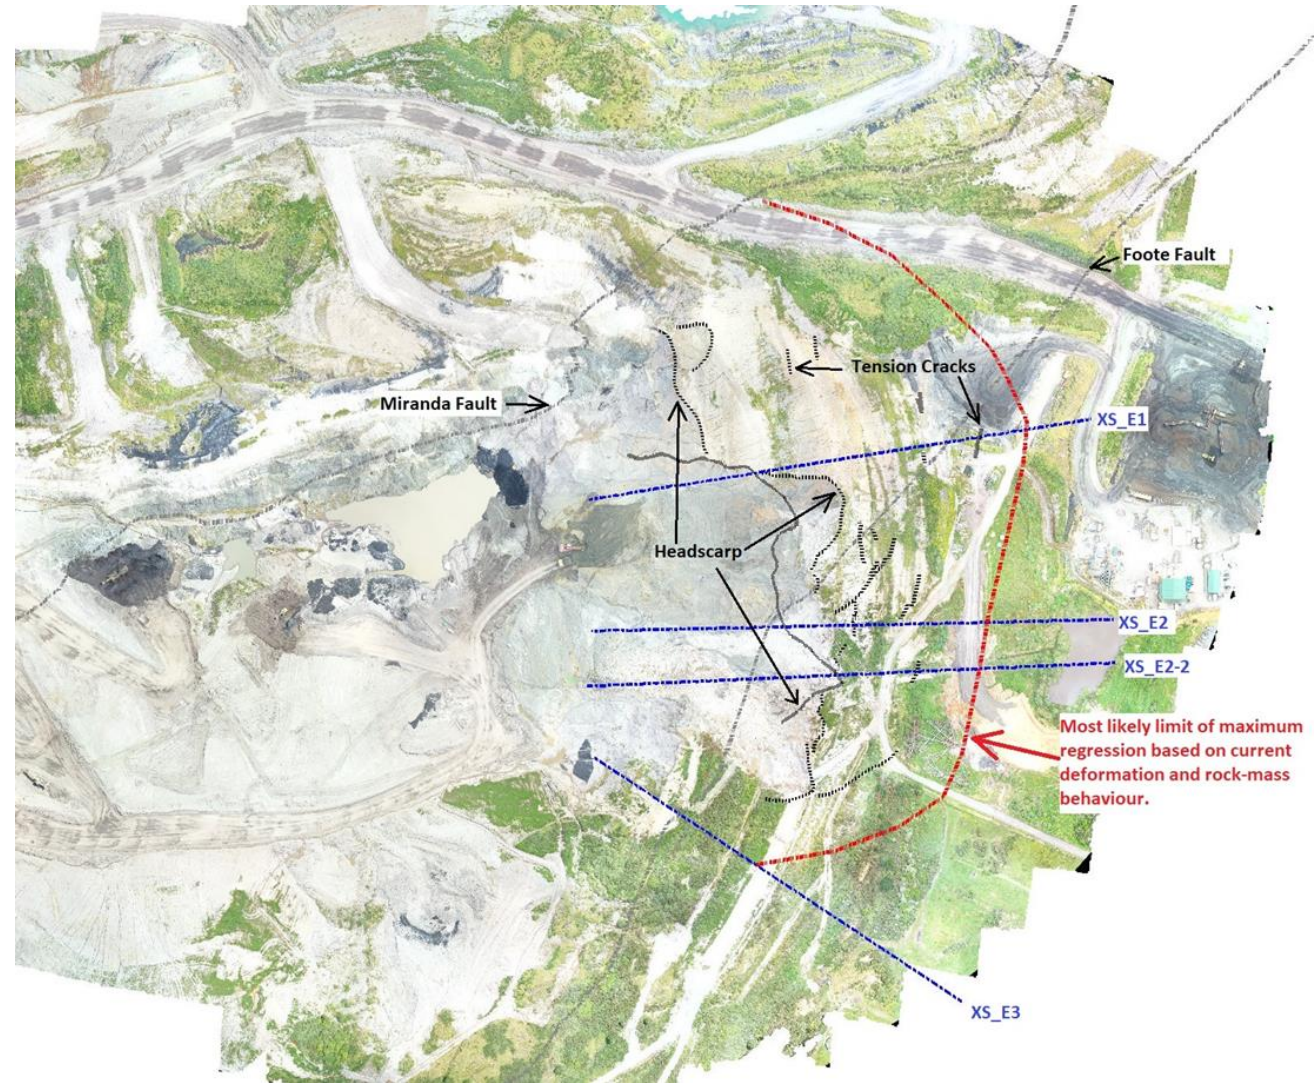
Geotechnical analysis following instability

- K1 East Wall has been undergoing progressive failure and 'loosening' of the rock mass.
- Design was split into smaller stages, backfilling as we retreat from the north

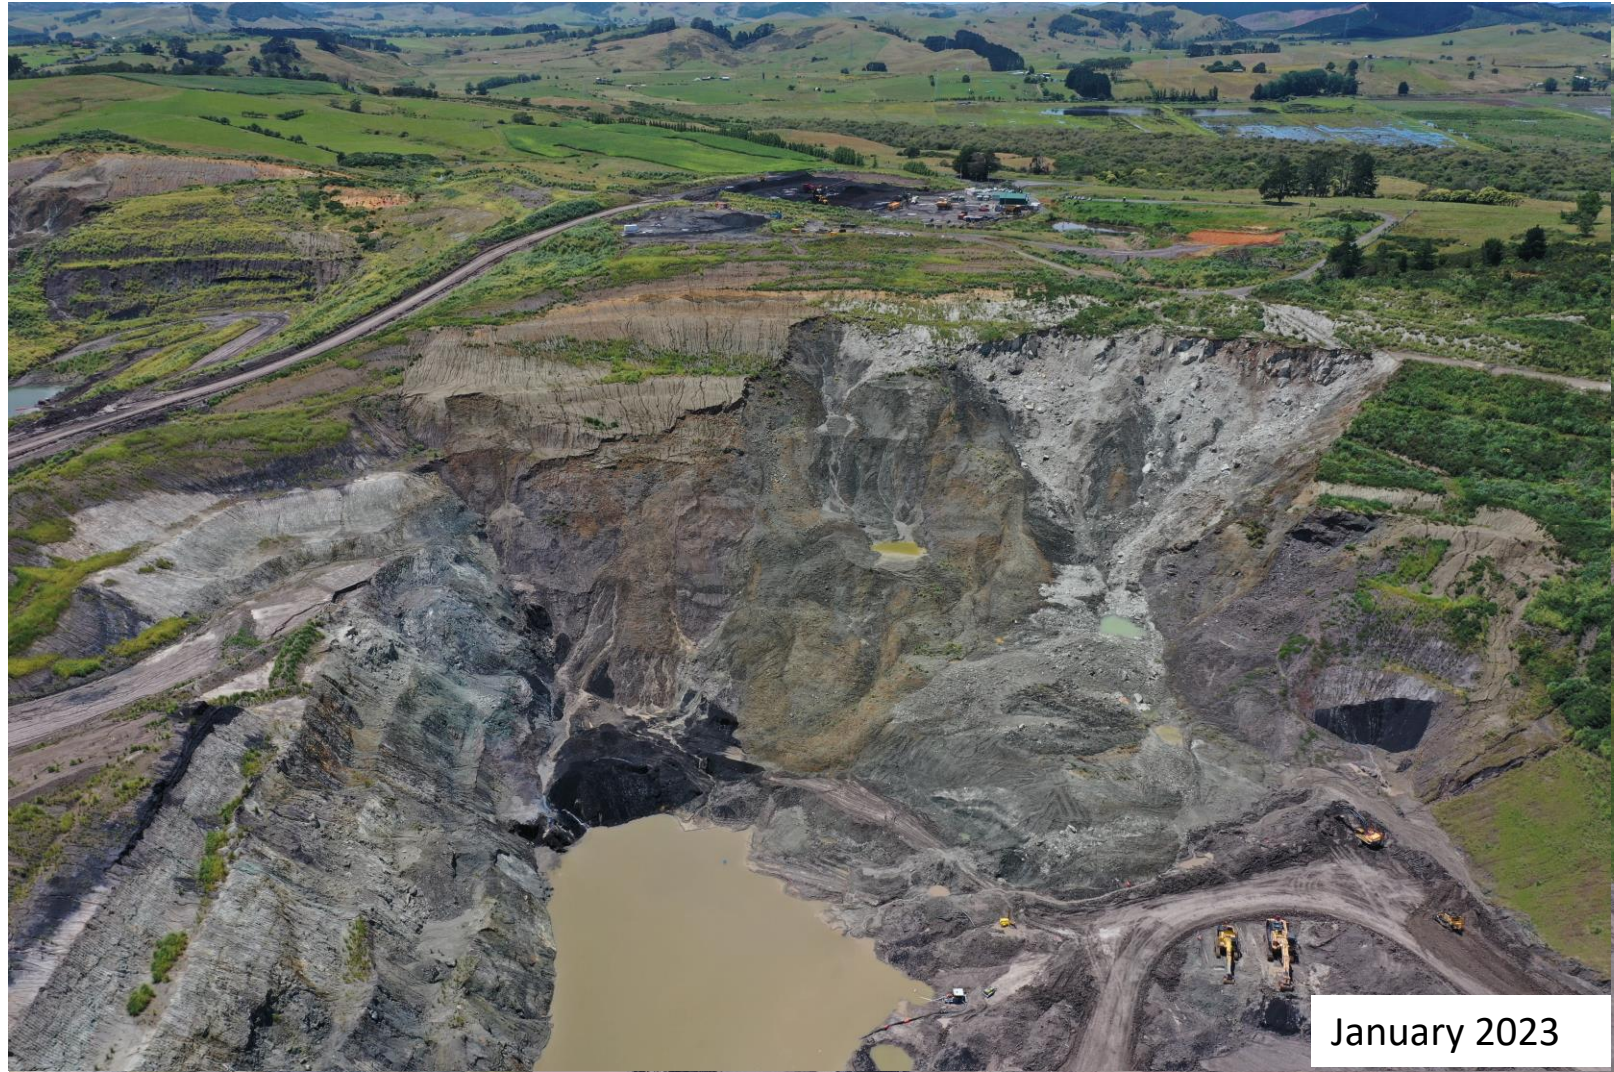
Recovering coal under failed mass

- Further progression of the failure to the north and regression in the south.
- Repeated remobilisation due to saturation from rain events, ground water interaction, and removing material from the toe of the slope.

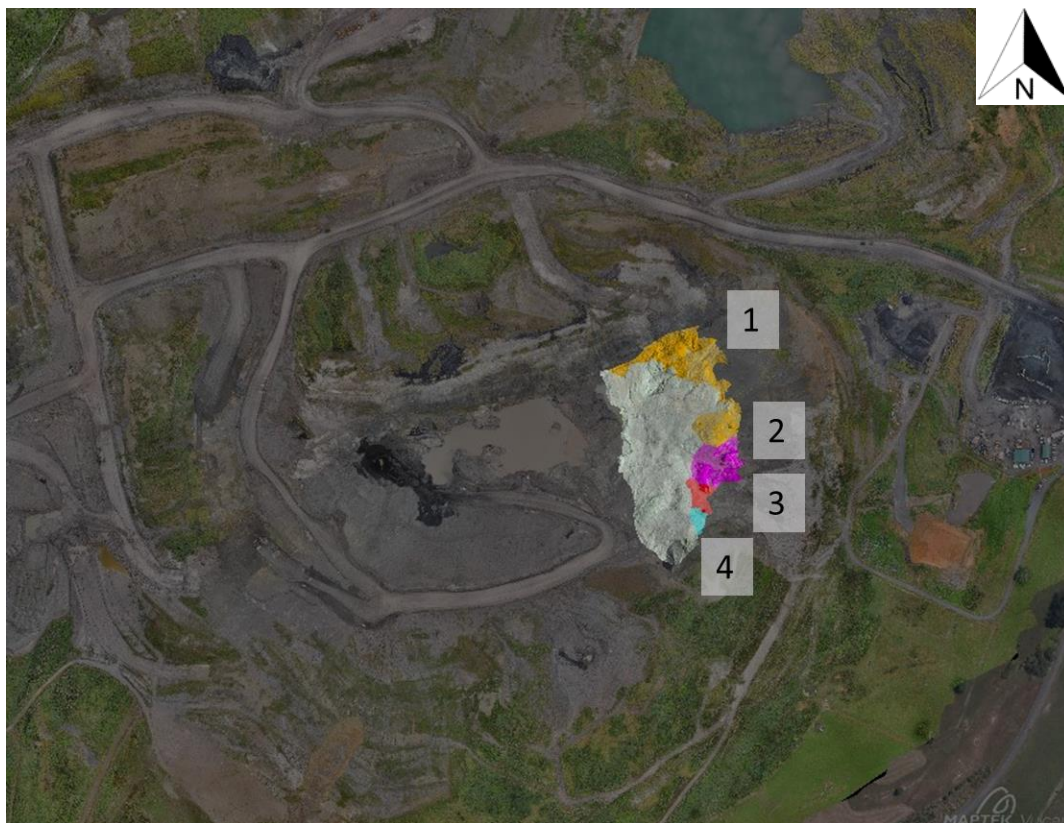
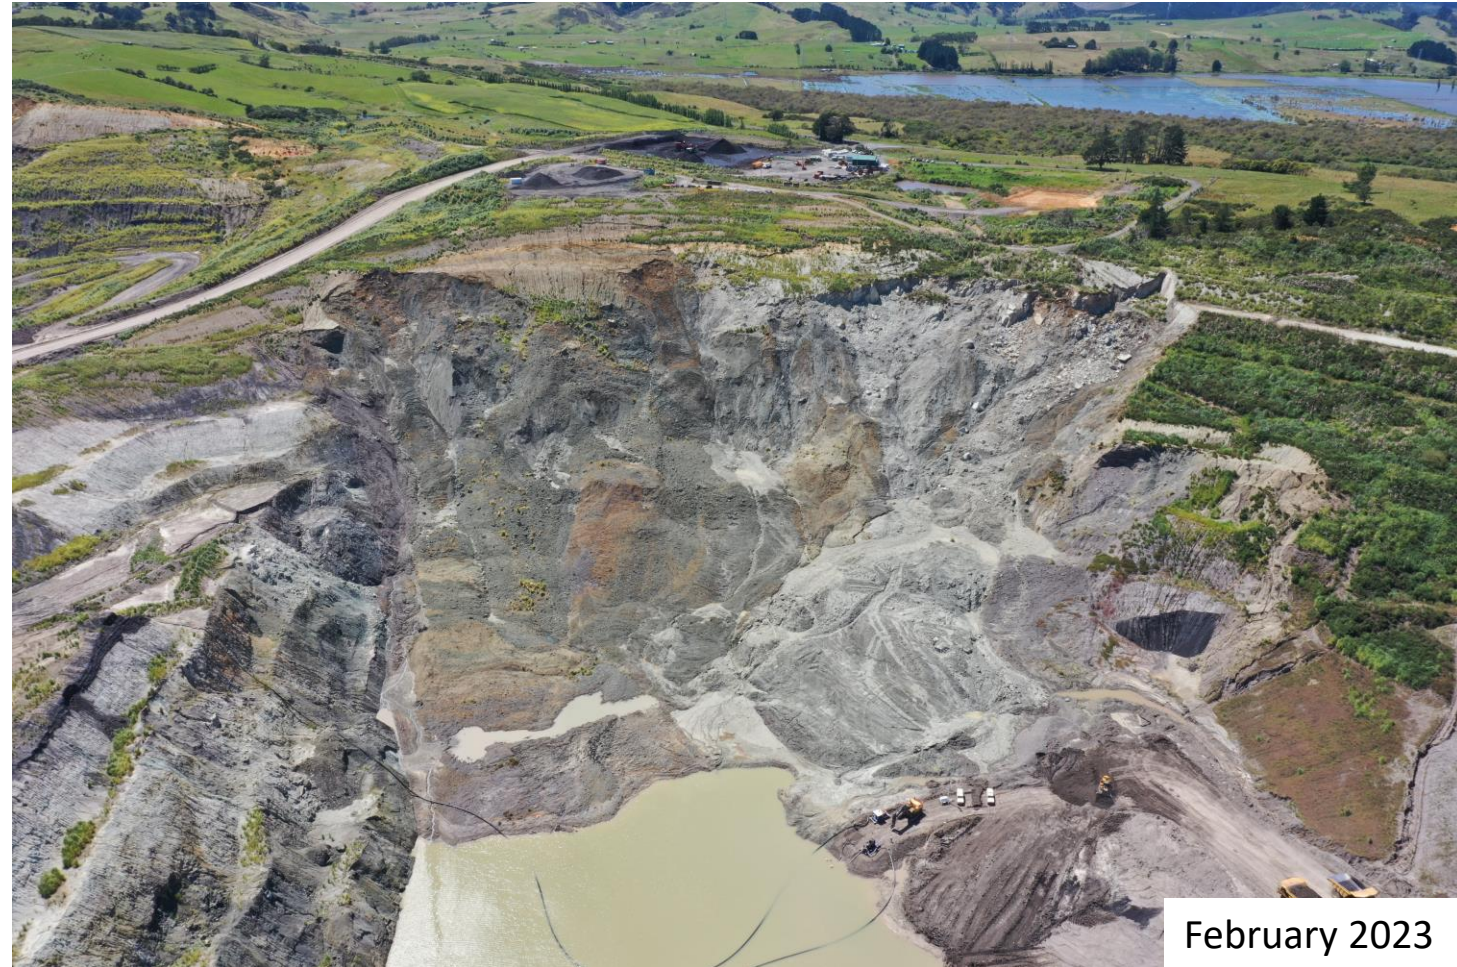
Cyclone Gabrielle

- 85mm of rain over 48hours
- Large scale Remobilisation and regression

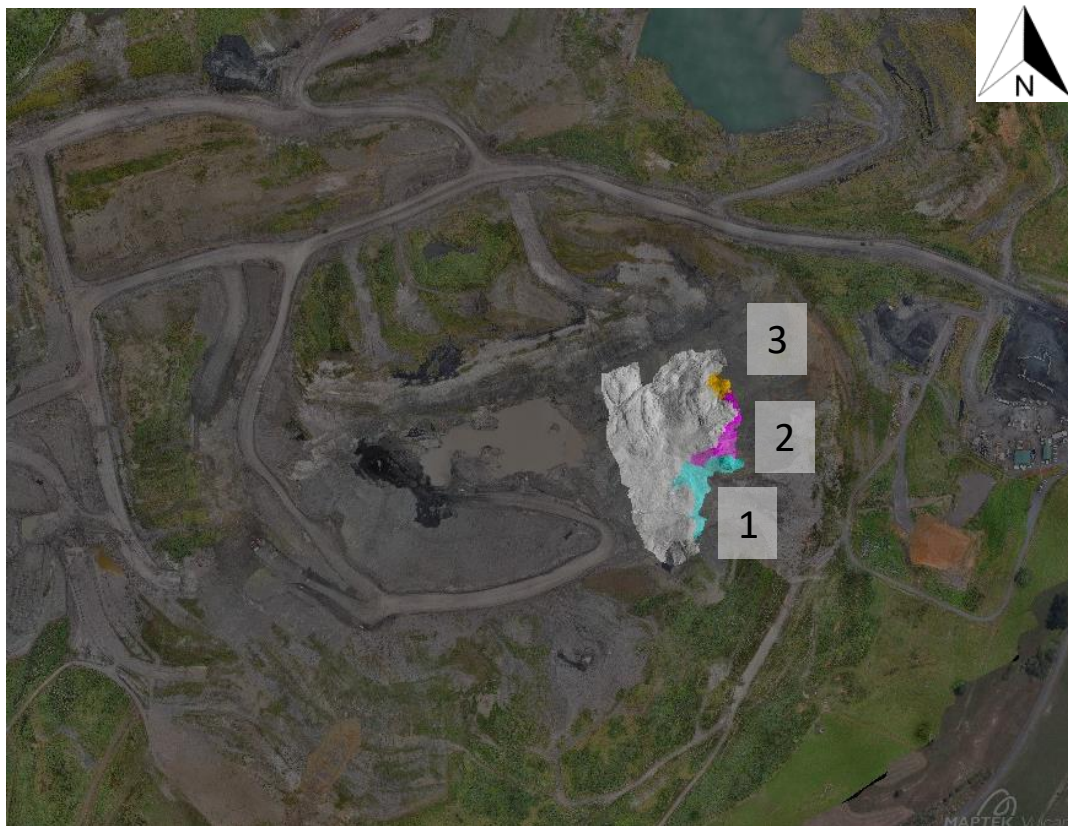
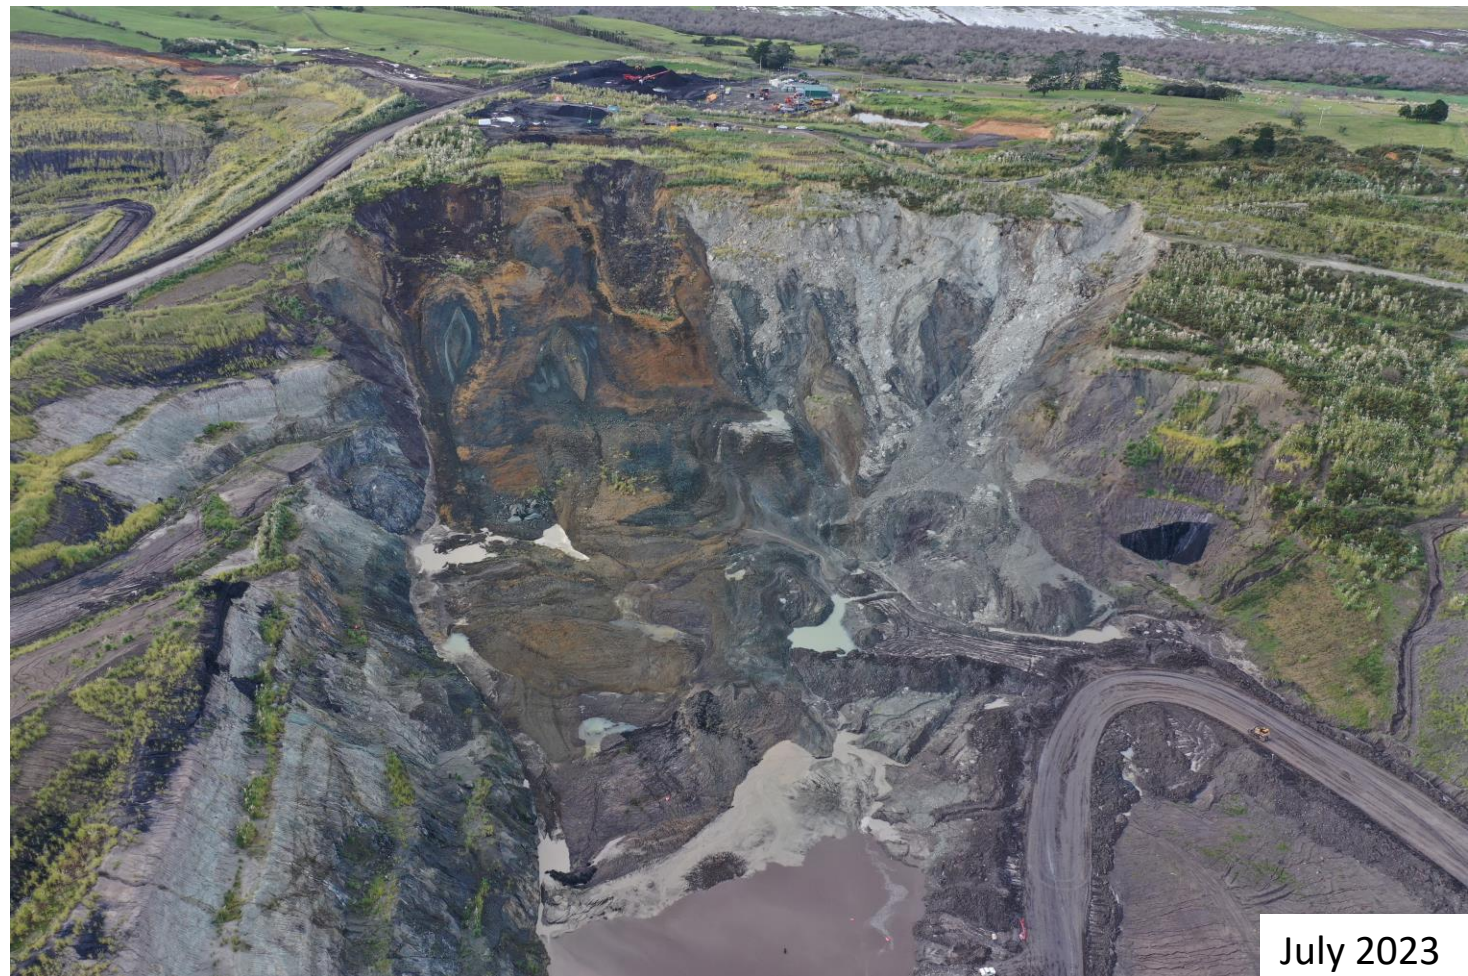
Re-sequenced stage 5 plan

- Headscarp regression was concentrated along the northern limits.
- Resequenced plan mid 2023.

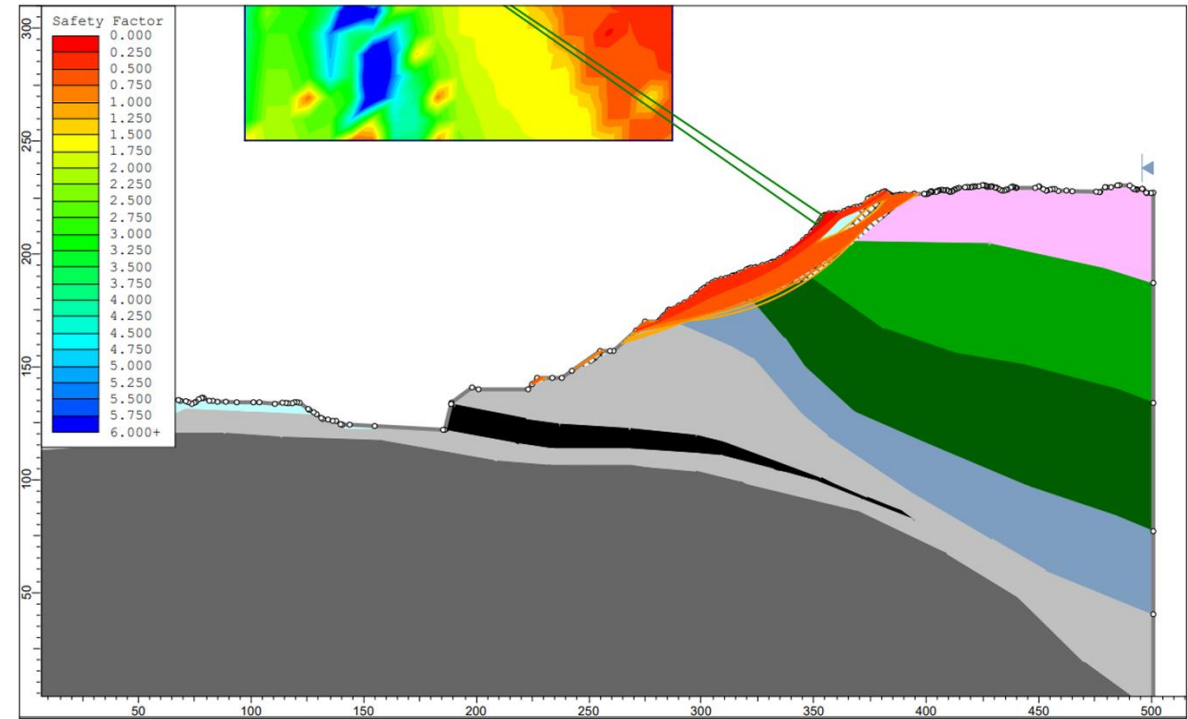
Geotechnical review

- Similar regression limits to original geotechnical assessment
- Geological units starting to roll over influenced by the Foote fault
- Series of small-scale failures
- Circular Failure in Mangakotuku Formation is likely

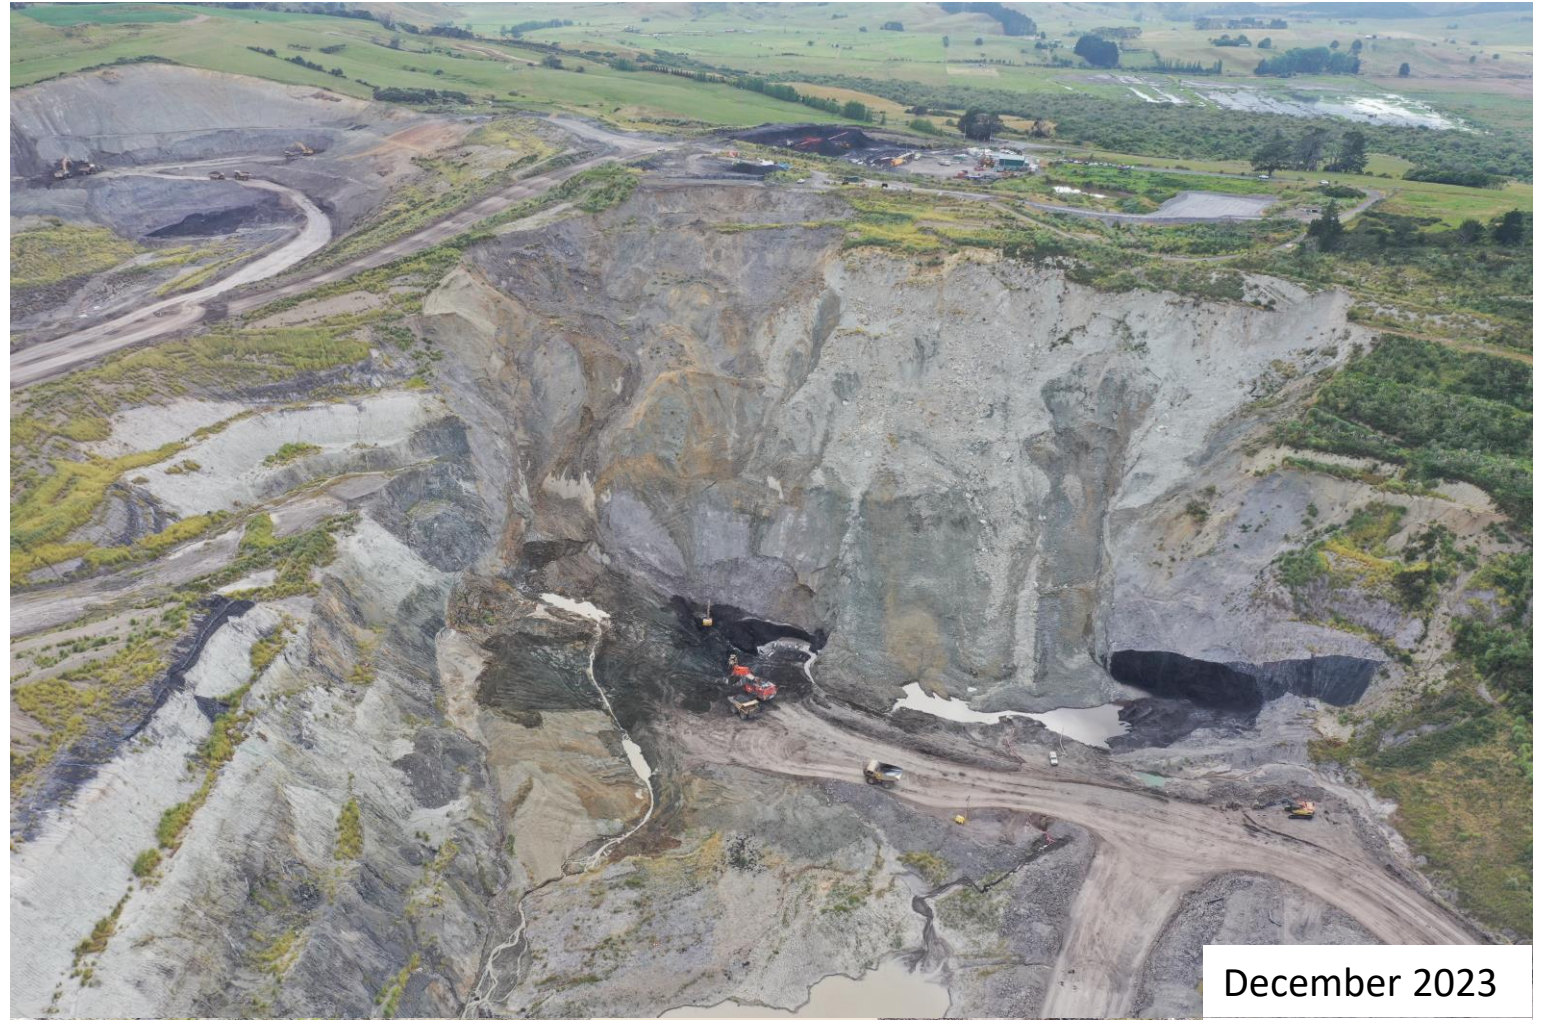
Last chance Summer 2023

- A 3–4 month stretch of favorable summer weather to win the remaining coal.
- Remobilisation of failed material as we excavate out at the toe and as the material saturates.

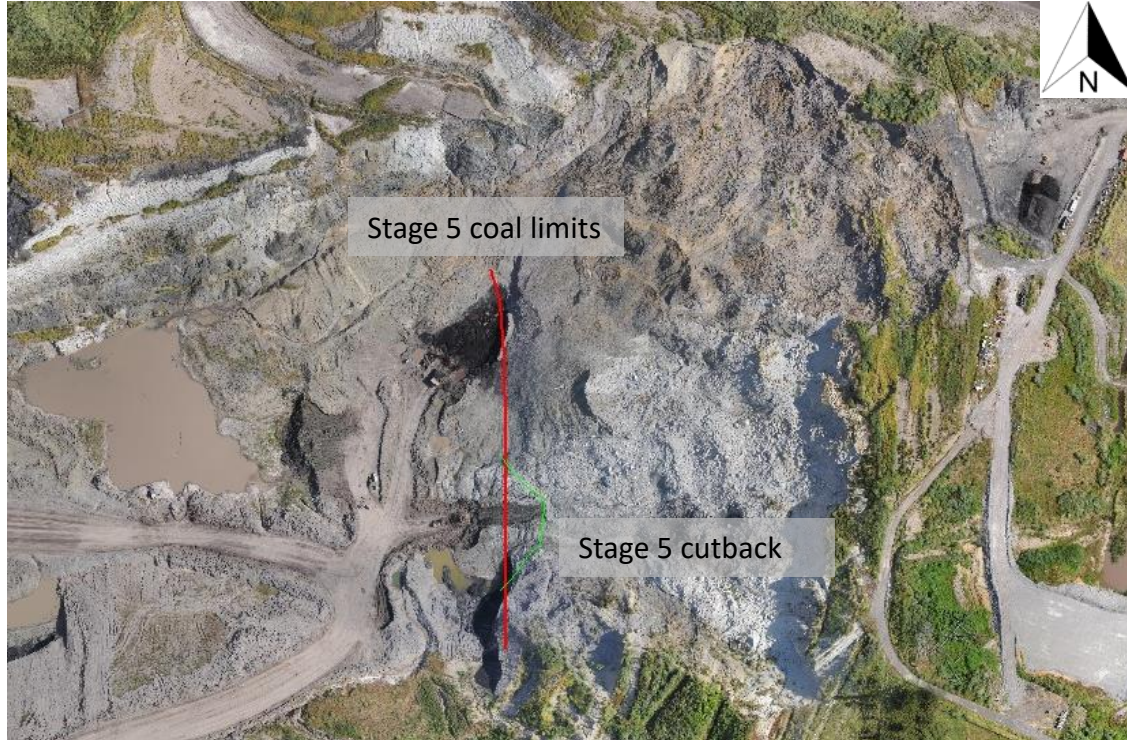
December 2023

- With the performance of the wall over the last few months a cutback was proposed.
- The geotechnical assessment concluded that:
 - A Circular Failure In the Marine's Formation is likely at the contact with WCM.
 - Regression limits stayed the same as previous analysis
