BATHURST
RESOURCES LIMITED

Stress strain regime changes around the Mt William fault and its implications for highwall stability

Benjamin Godfrey Hyde MSc

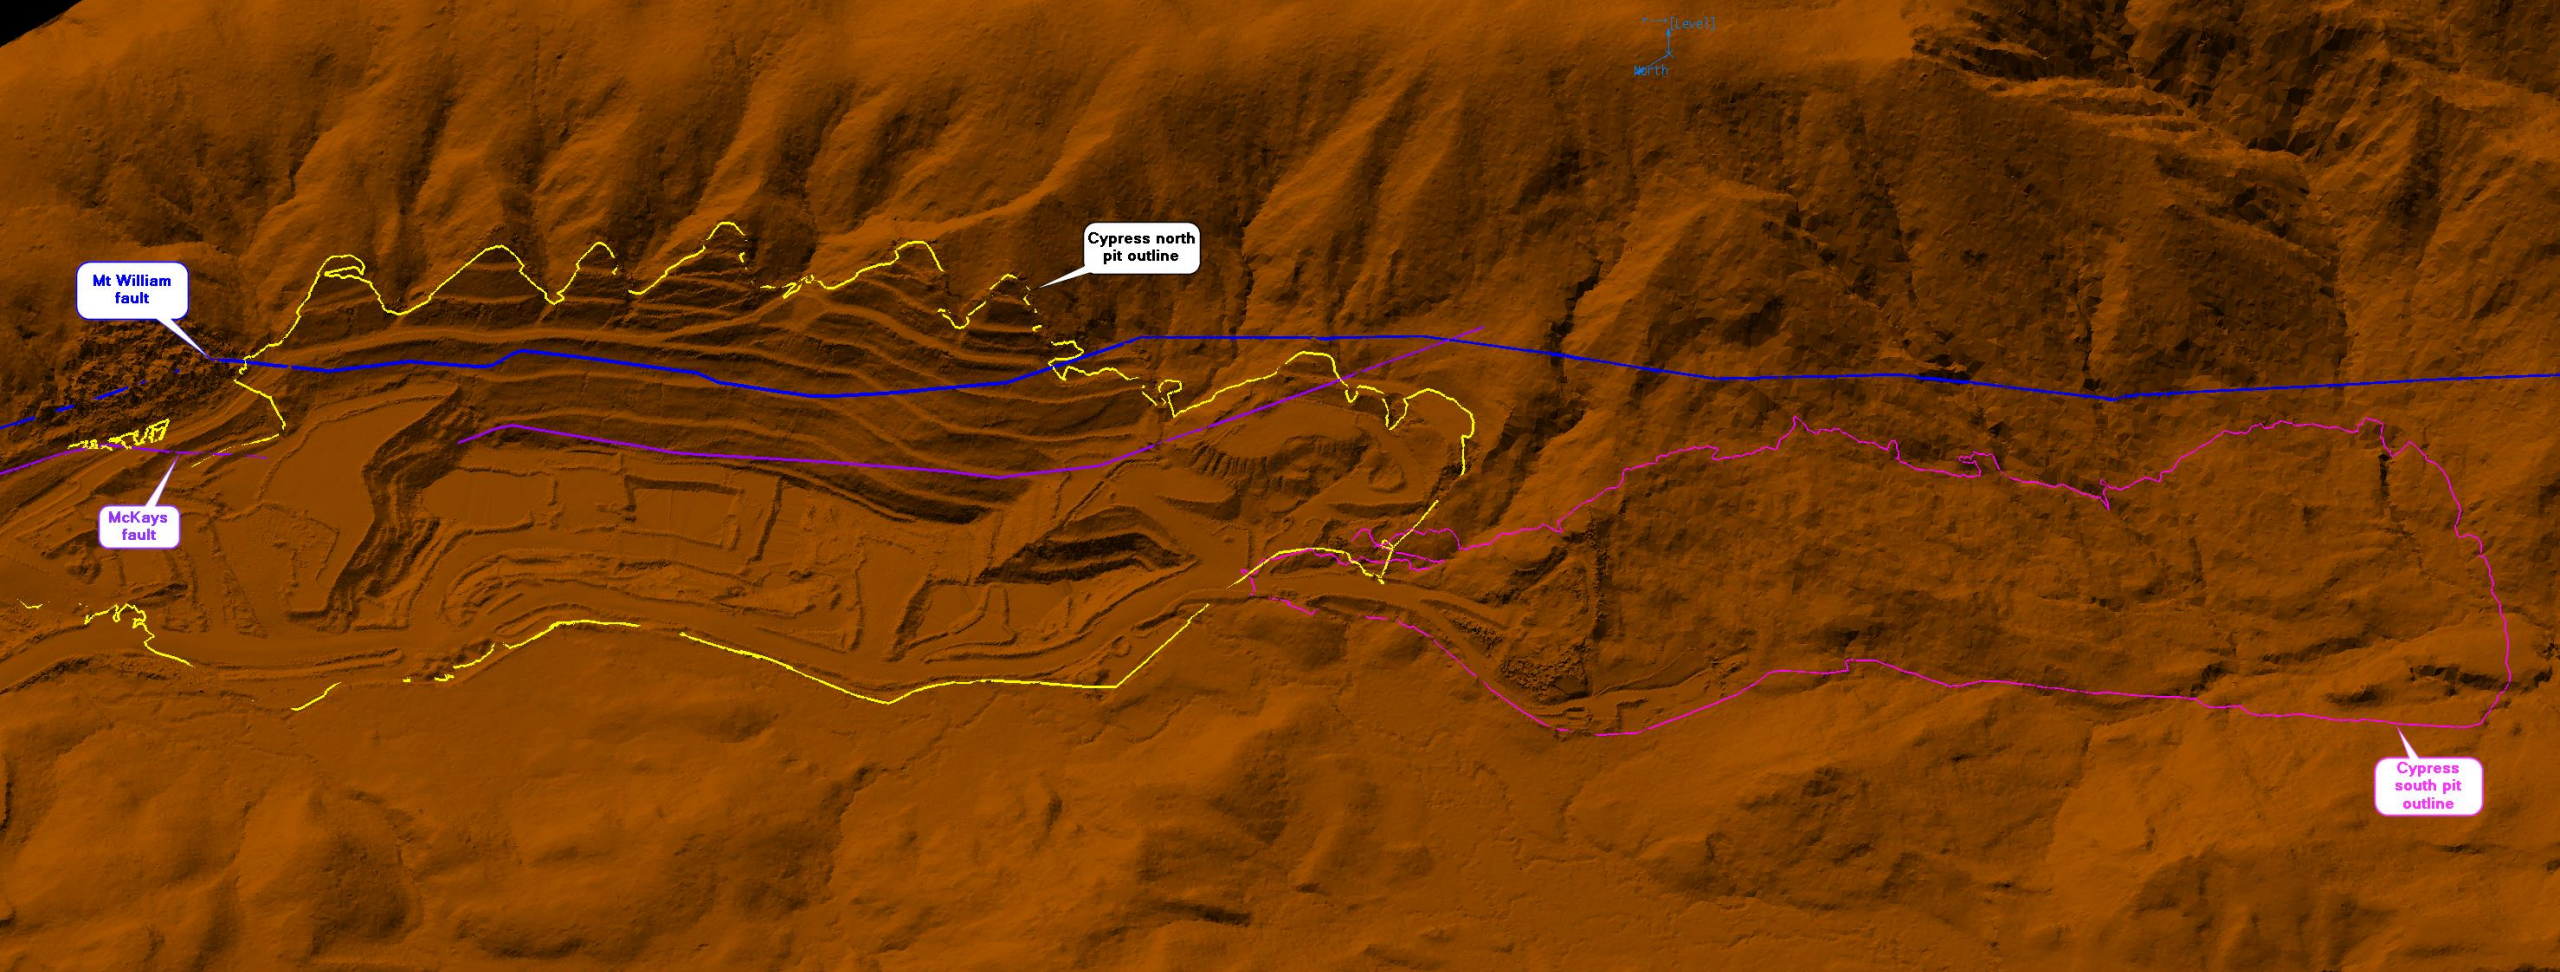
Cypress pit overview

- Cypress north pit shown in Yellow
- Cypress south pit shown in Pink
- Mt William Fault in blue
- McKays fault in purple

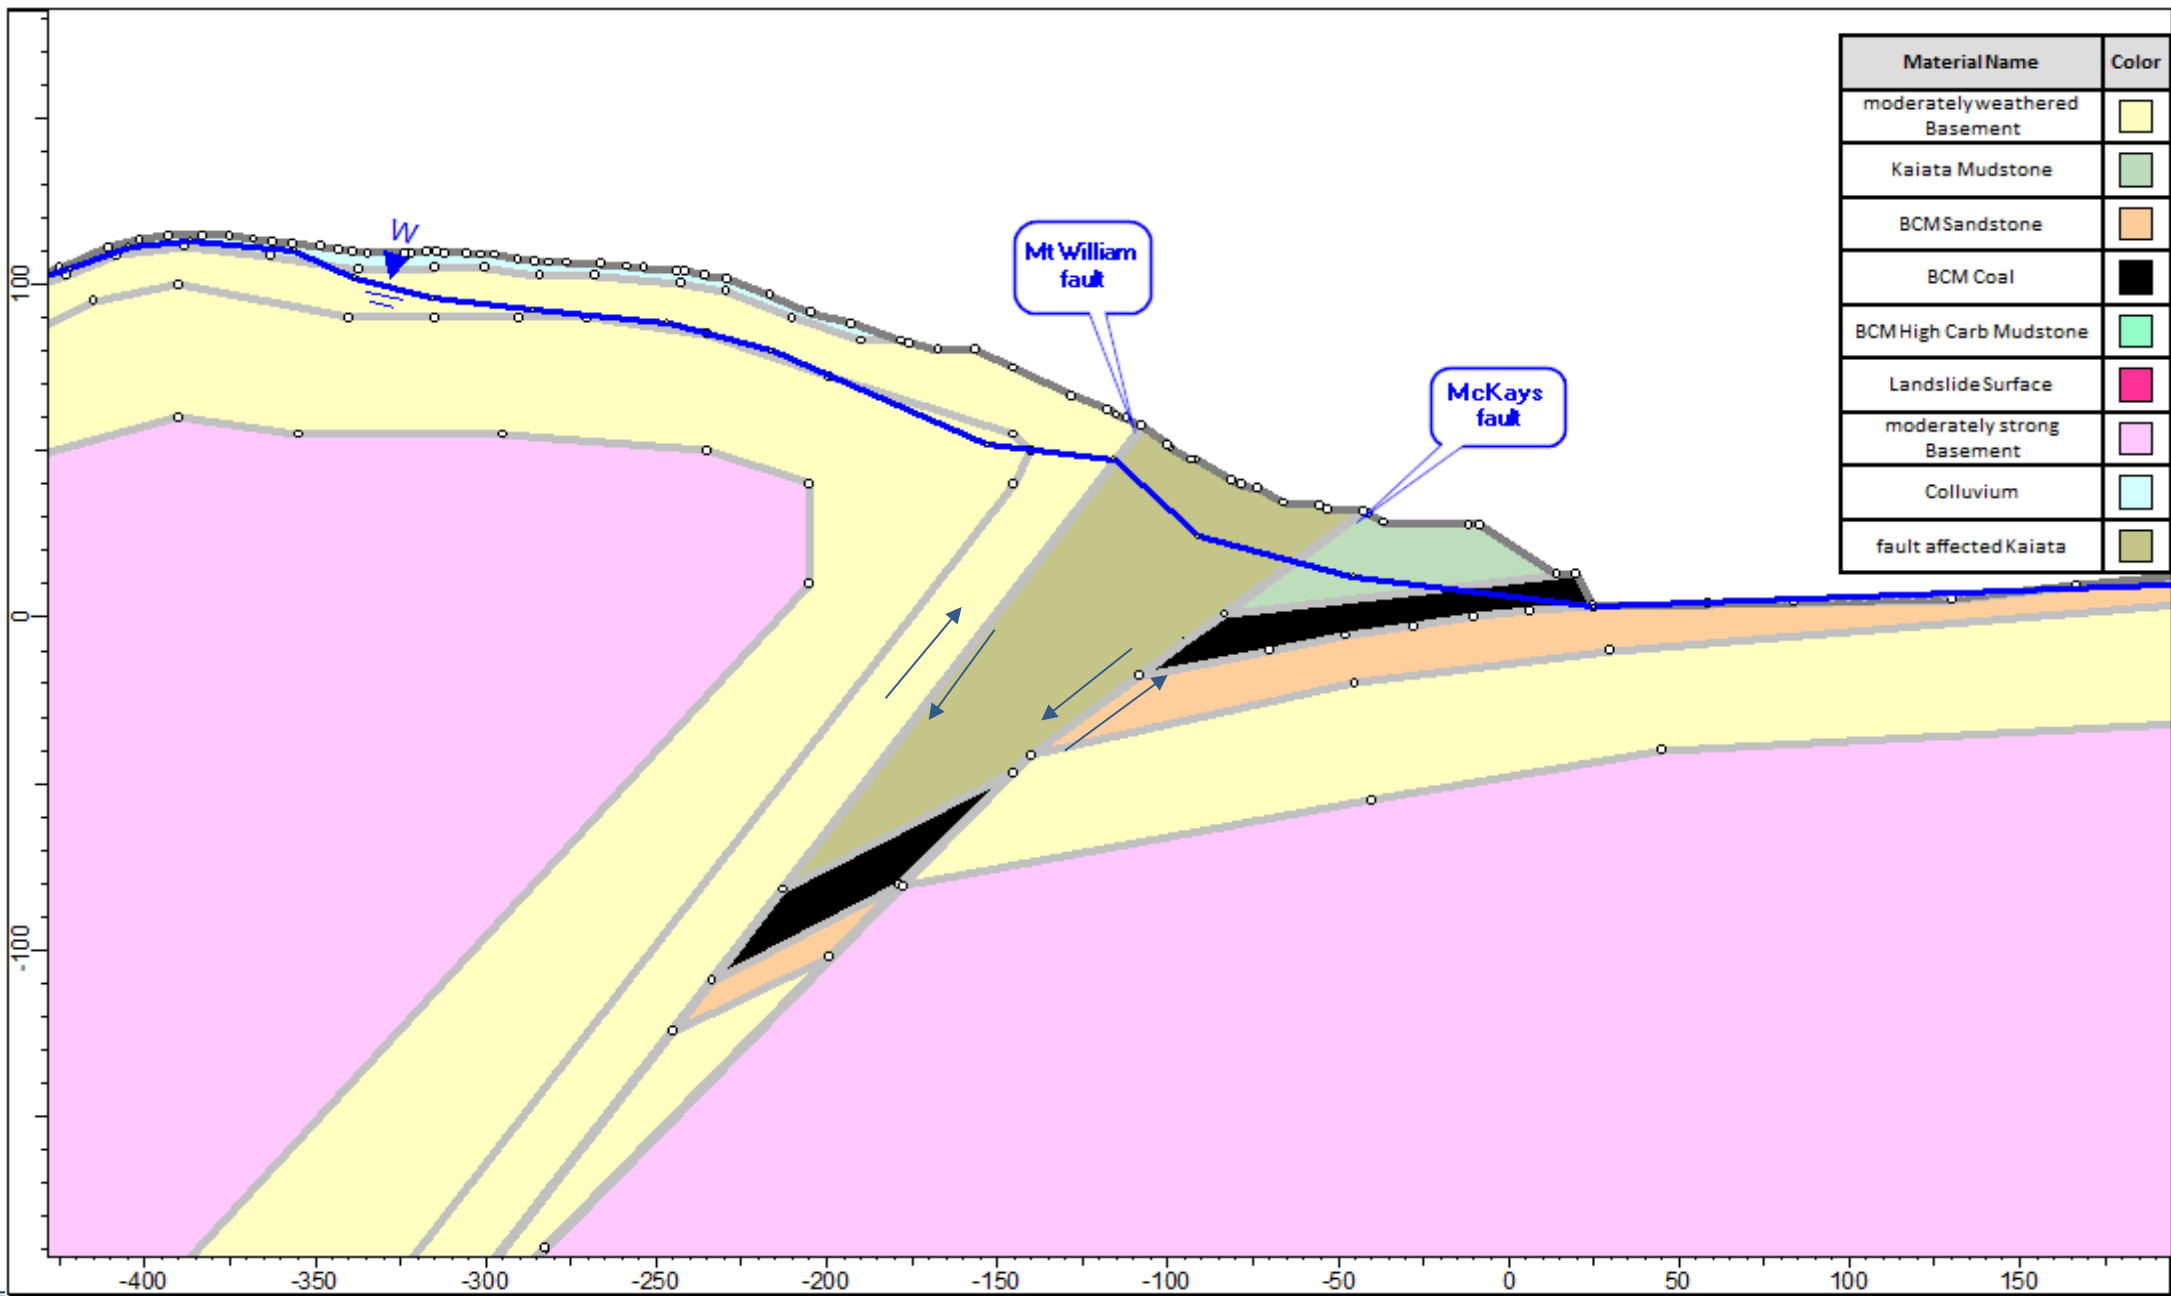
Section view looking south

- In the north pit the highwall cuts through the upthrust basement at the top of the slope through the Mt William fault into the highly sheared Kaiata mudstone and down into the coal measures at the toe of the slope.
- Economic constraints resulted in a significant portion of the wall being cut through the fault affected Kaiata rather than stepping back and removing it.
- This then resulted in a failure of the slope due to this fault affected ground with limited drilling not providing a full picture of the ground prior to excavation.

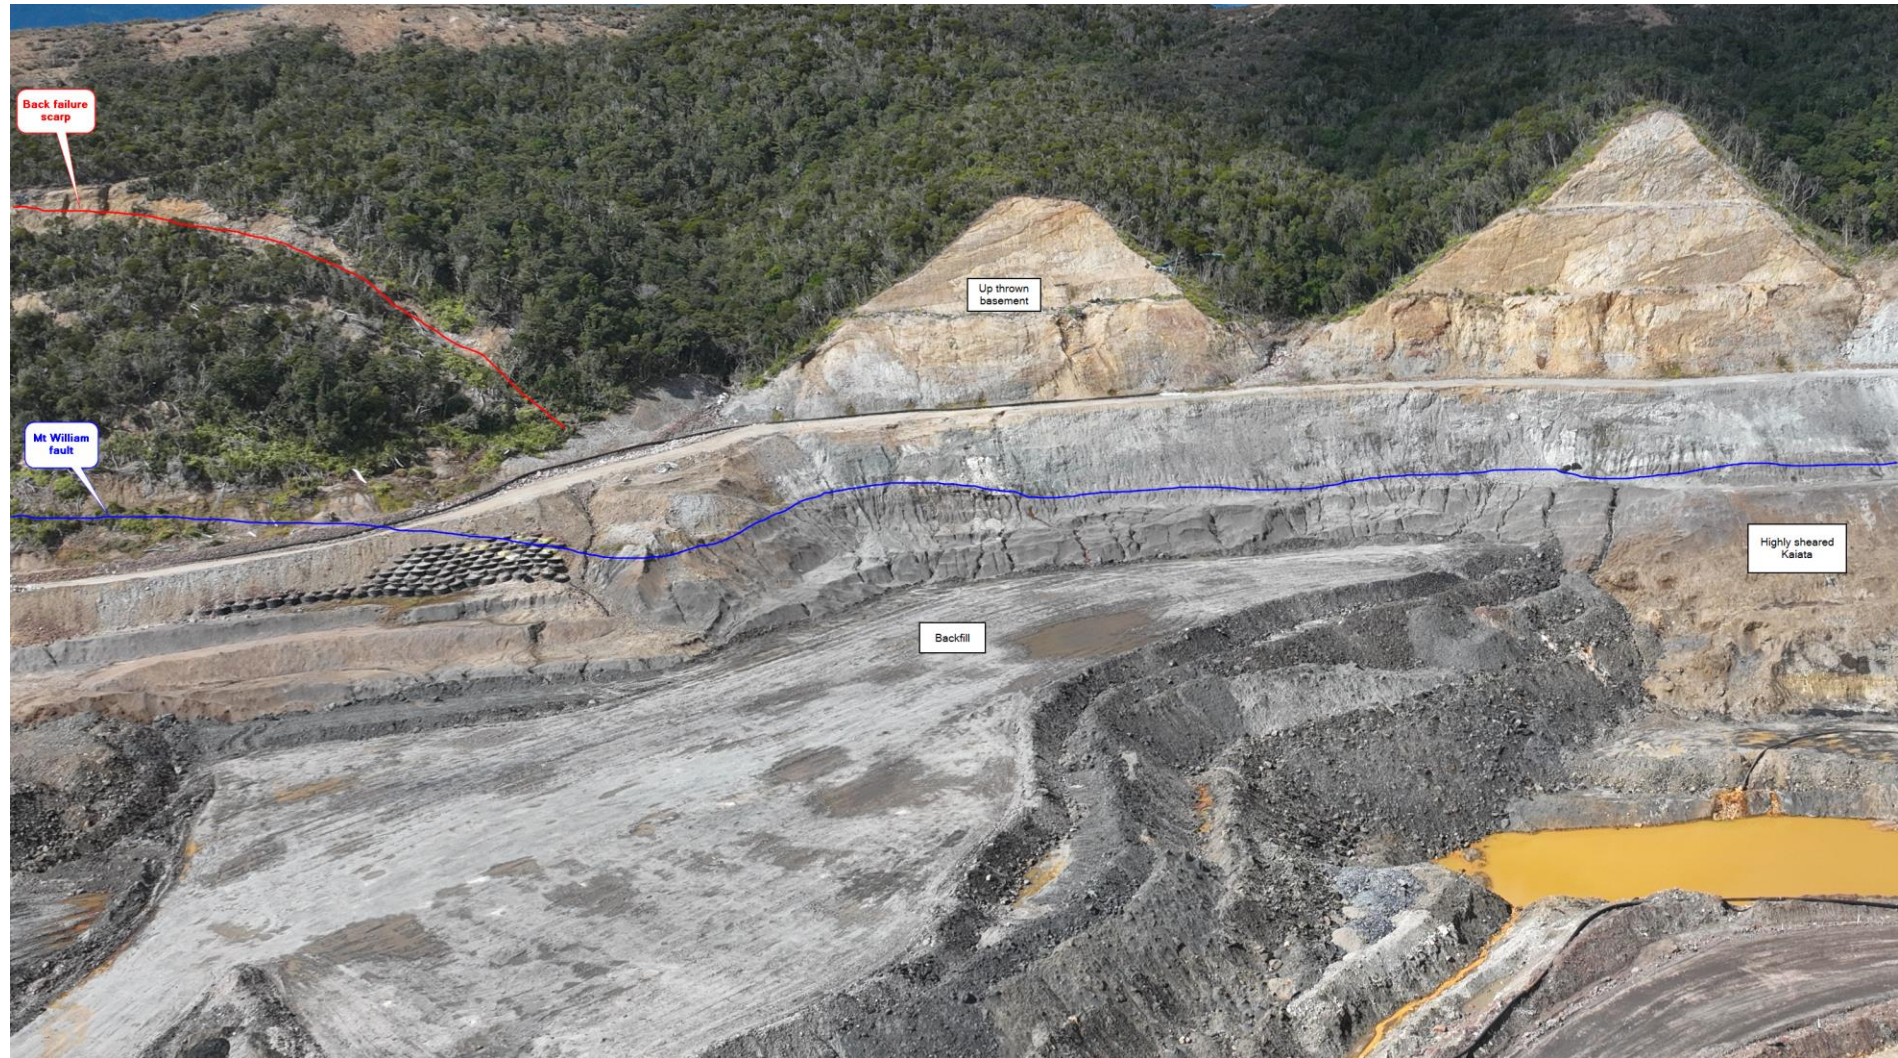
- After the initial problem due to shearing in the Kaiata was designed out of the highwall an additional previously unknown fault caused an additional failure.
- This new failure is the result of additional rock mass damage to the basement behind the Mt William fault in a limited area.

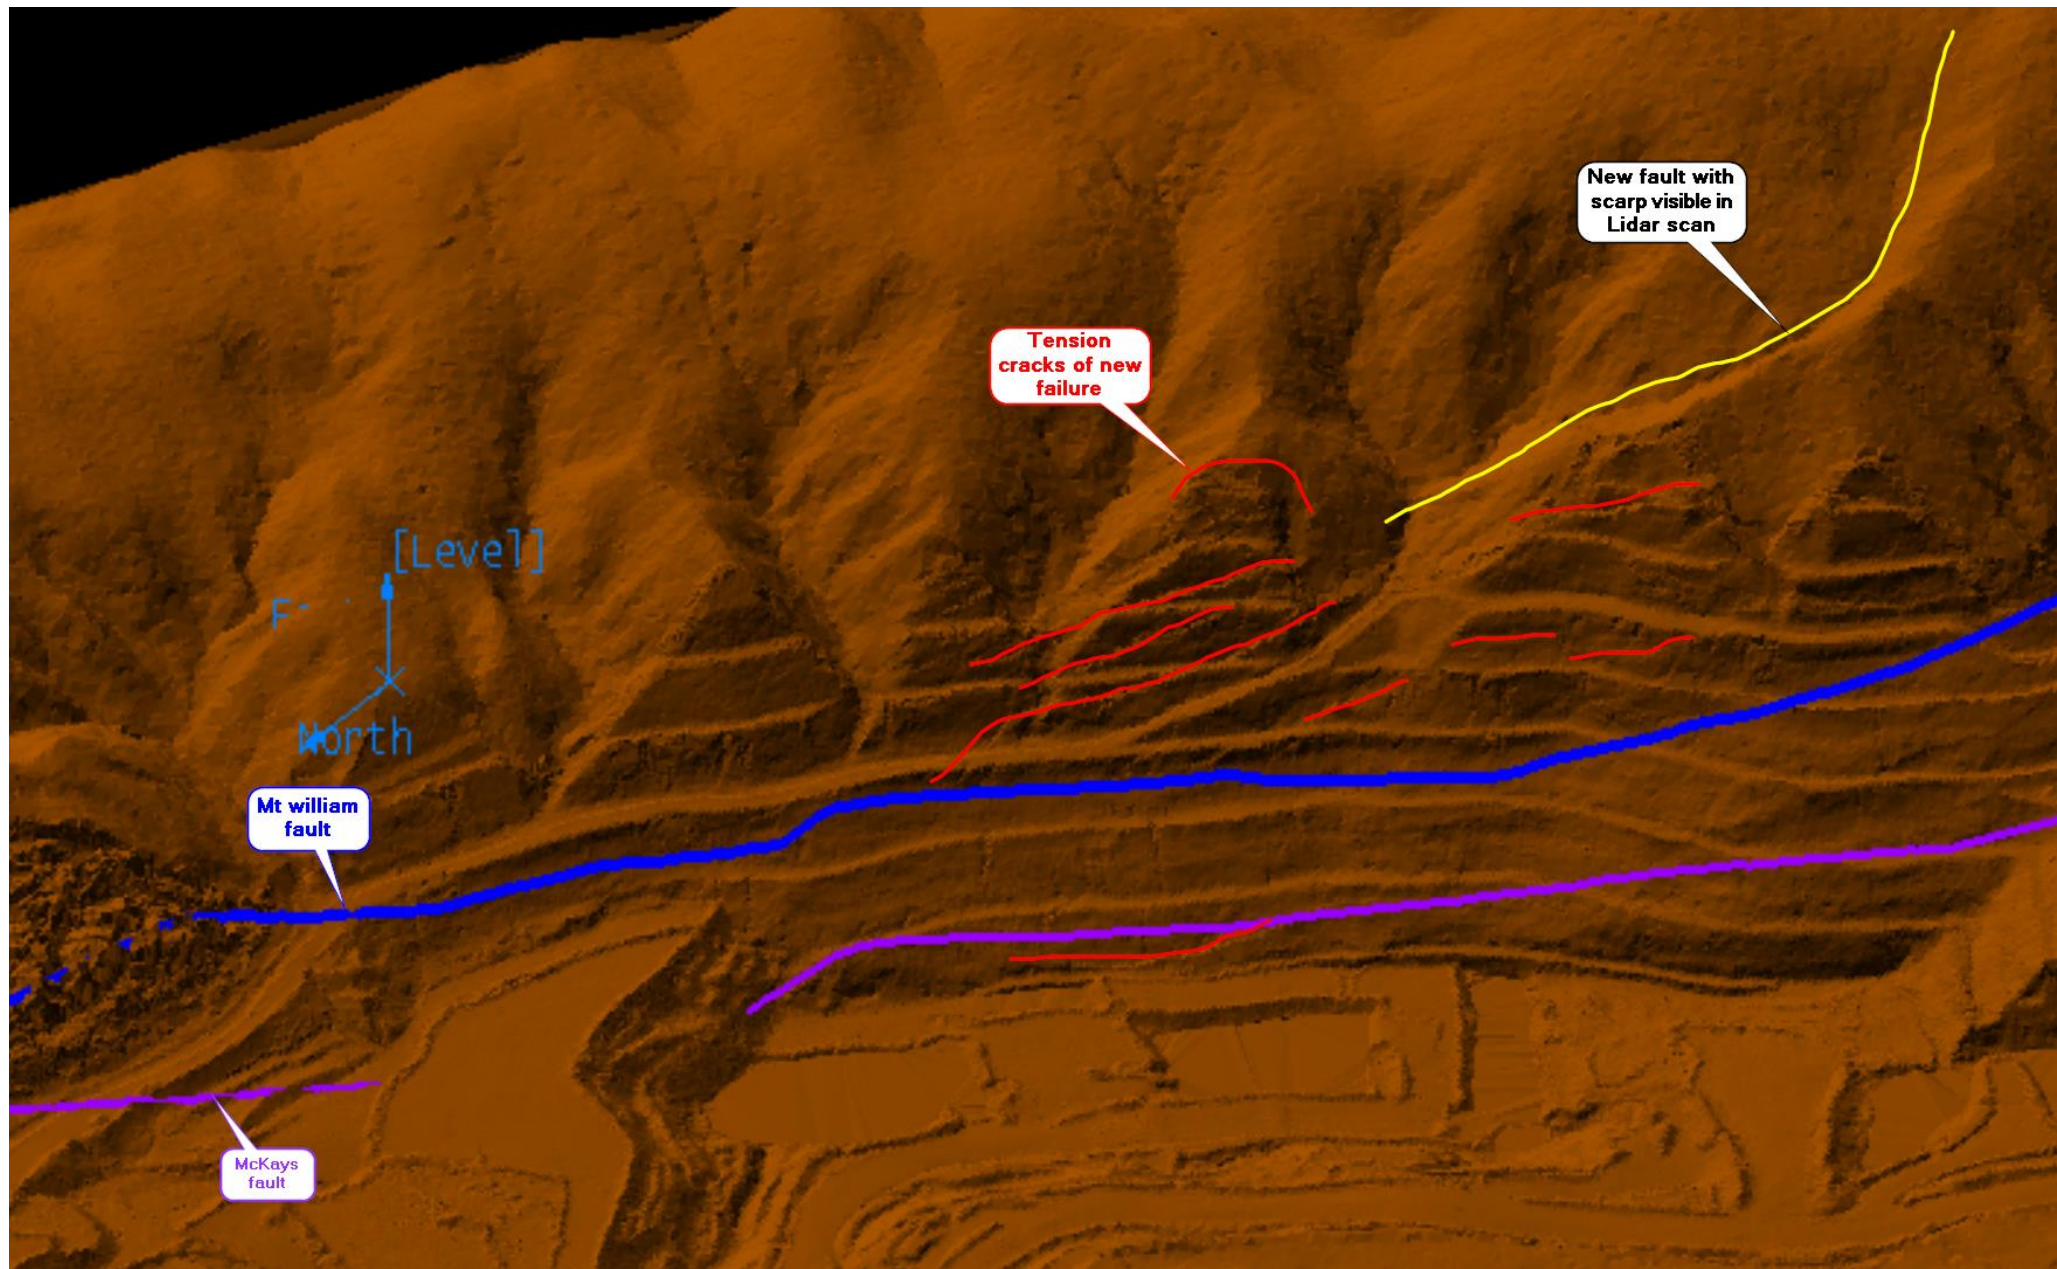
- In the south pit the rock mass damage is to the east of the Mt William fault across a much wider area.
- In the original design this would have caused highly sheared basement to be outcrop through the upper slope and be behind the majority of the slope with little weight/material at the toe of the slope.
- This would have resulted in FoS well below 1 in high water conditions indicating failure.
- This required stepping the pit to the west to avoid disturbing the damaged rock mass thus leaving intact material towards the toe preventing potential highwall stability issues.

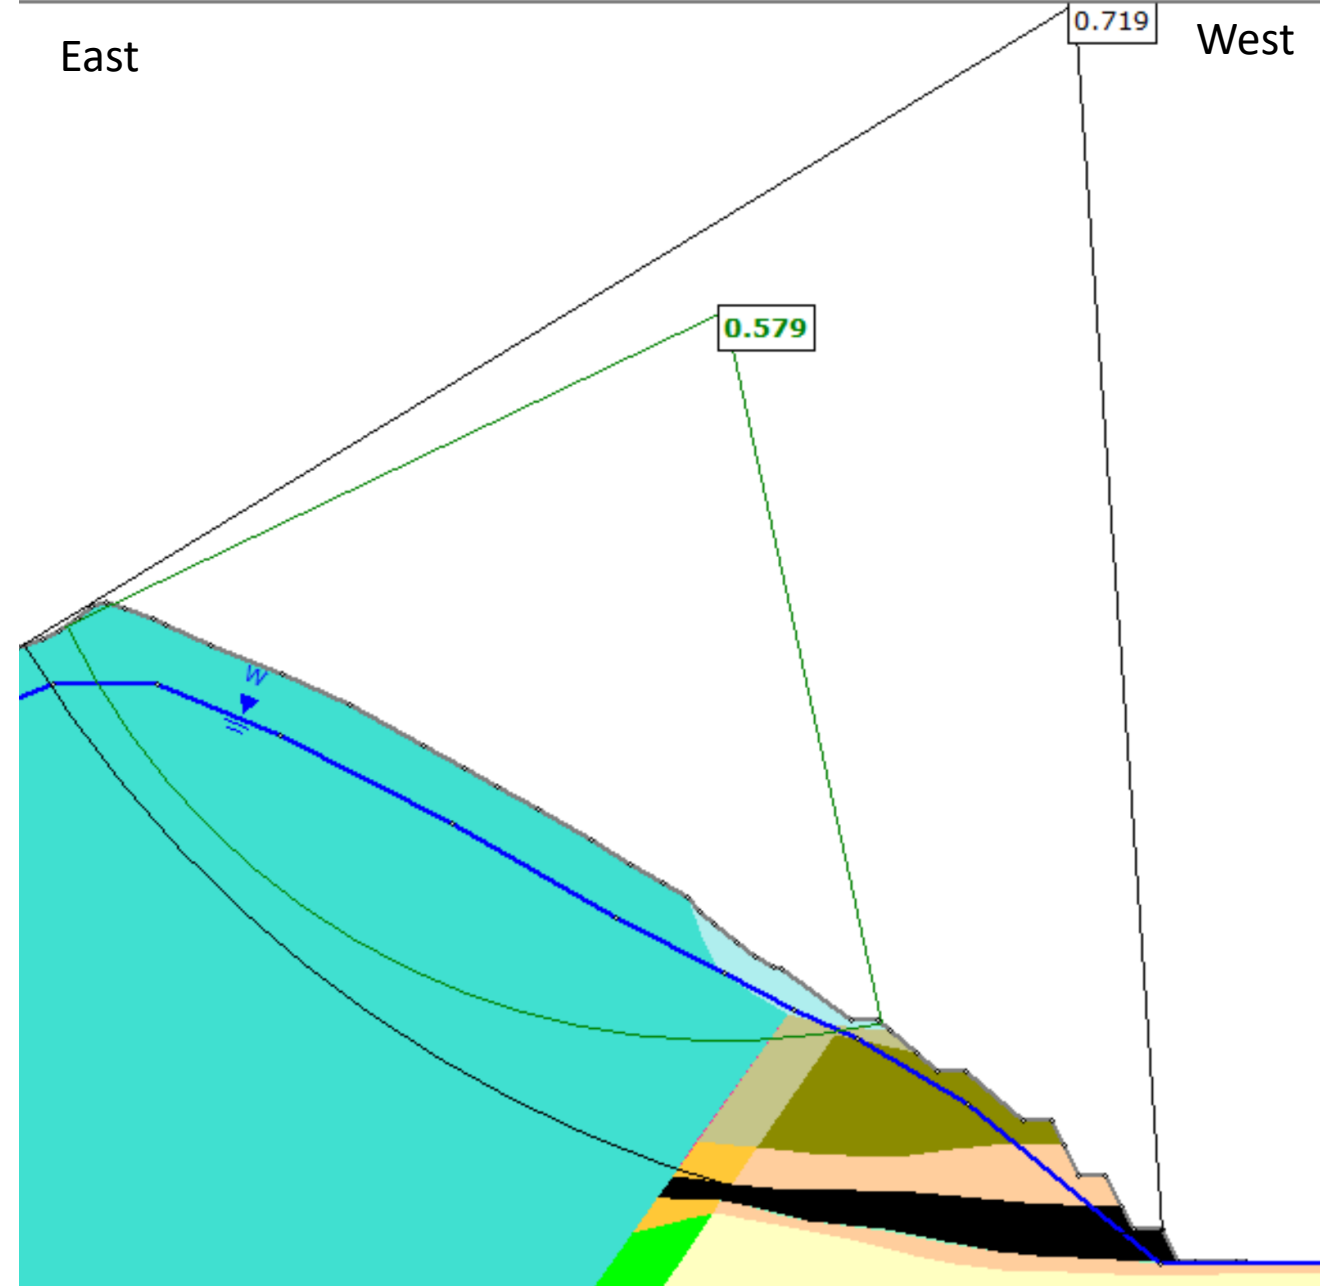
Implications for the originally proposed south pit

- The revised proposal for Cypress south now leaves considerable coal behind to prevent highwall instability.
- Small potential issues still remain due to existing landslips which will be cut into.
- These landslips are the result of the highly sheared and weakened basement historically failing.

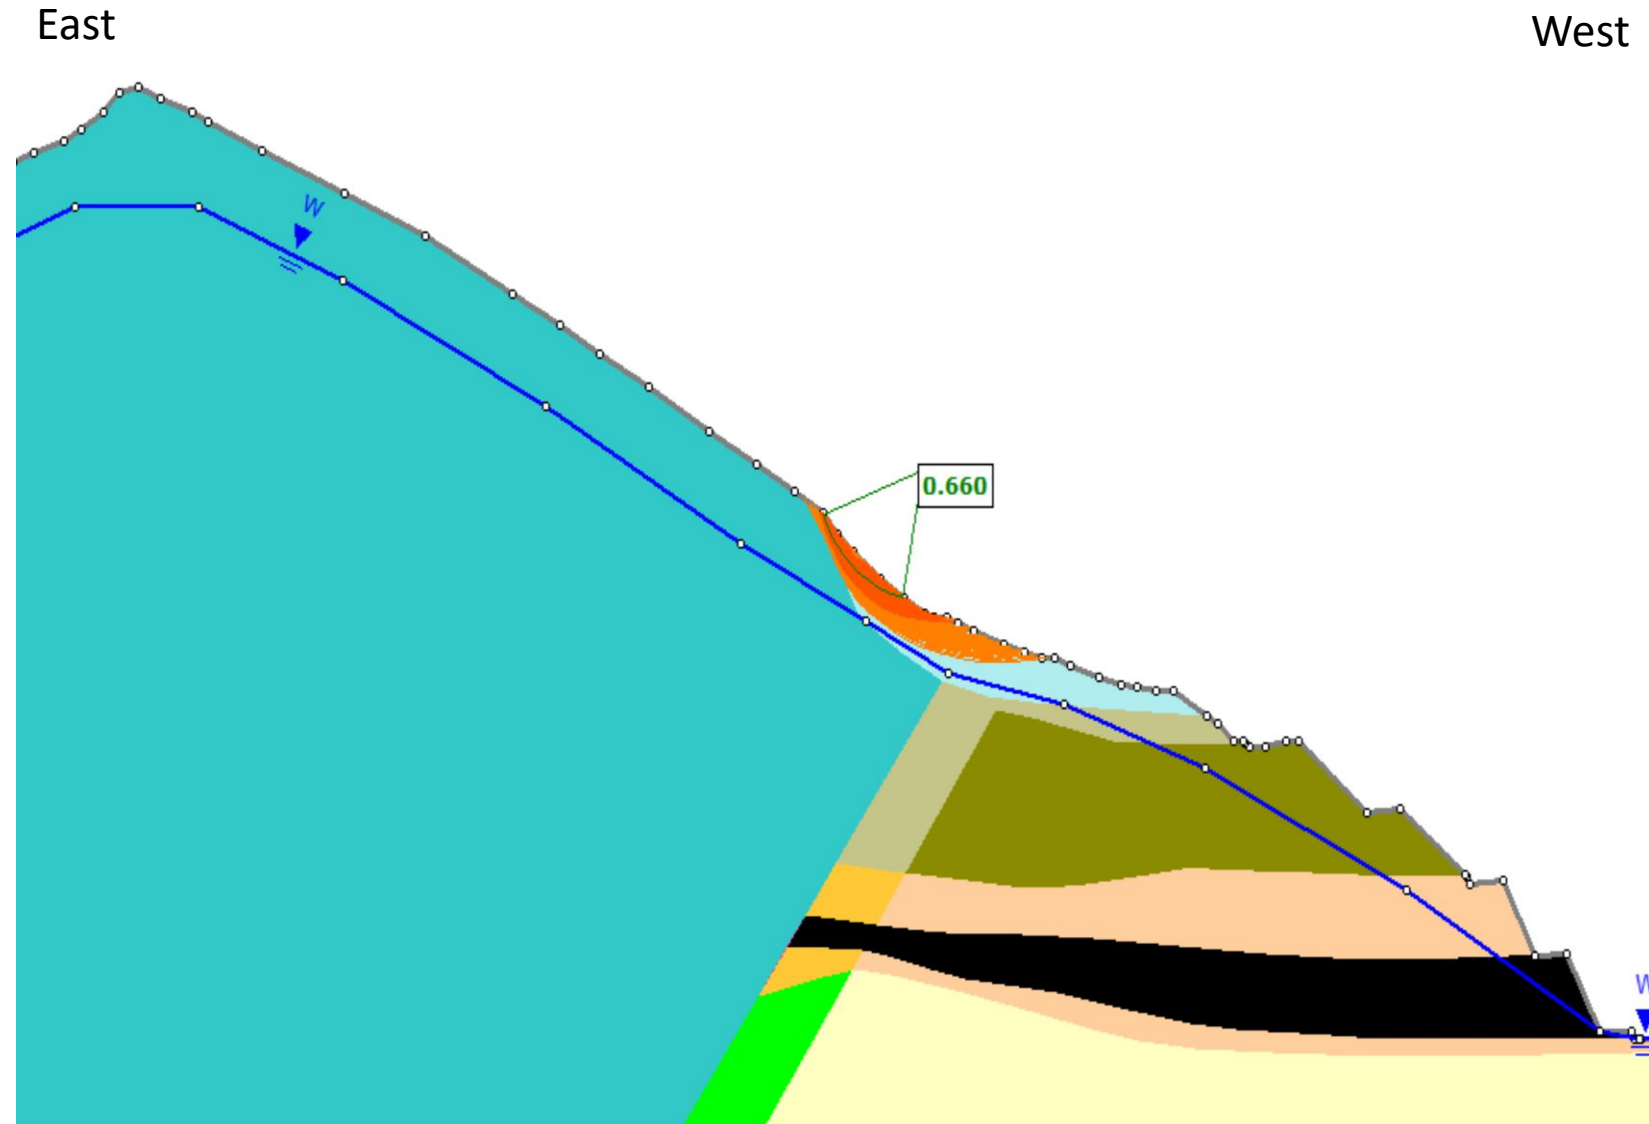
- The historic landslips are far more numerous and pronounced in the south than in the north.
- These slips are likely caused by the highly weakened basement towards the top of the ridgeline allowing larger failures to propagate.

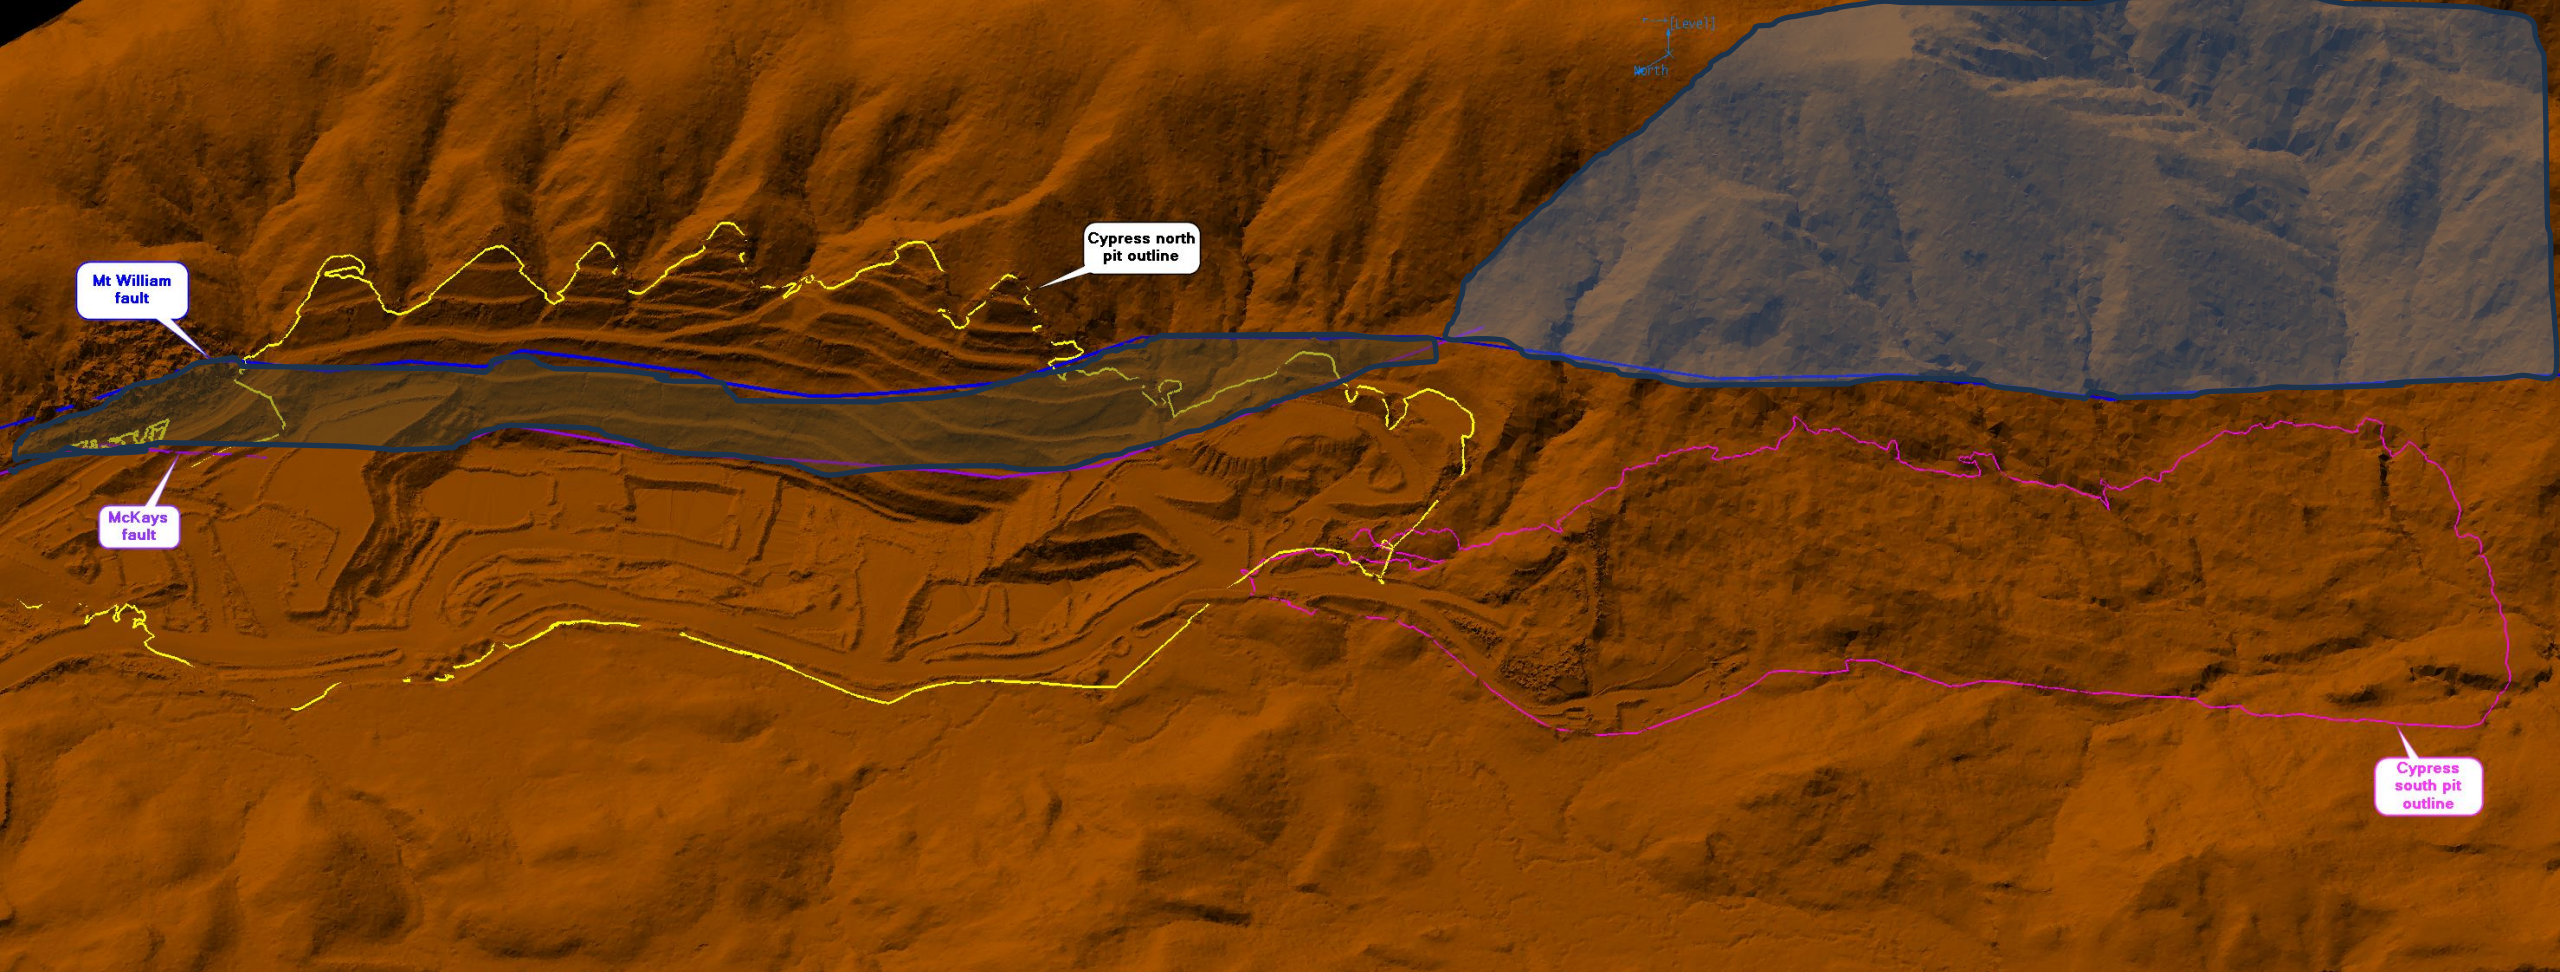
Damaged rock mass around the Mt William fault

- As the Mt William fault kinks up to the east the McKays fault rejoins it.
- This change in the faults corresponds to a change where the principal damage to the rock mass around the Mt William fault occurs.
- In the north pit the shearing and mechanical fracturing has principally been to the west of the Mt William fault (bound by the McKays fault).
- In the southern pit the drilling has shown the damage has been pushed to the east of the Mt William fault into the upthrust basement.

- This difference in rock mass damage has been caused by the change in the stress regime around the Mt William fault.
- This is likely due to the compressional stress not being able to be easily accommodated on the reactivated normal fault systems.
- This has caused stress to propagate out from the fault with minor changes along the fault potentially acting as pivot points.

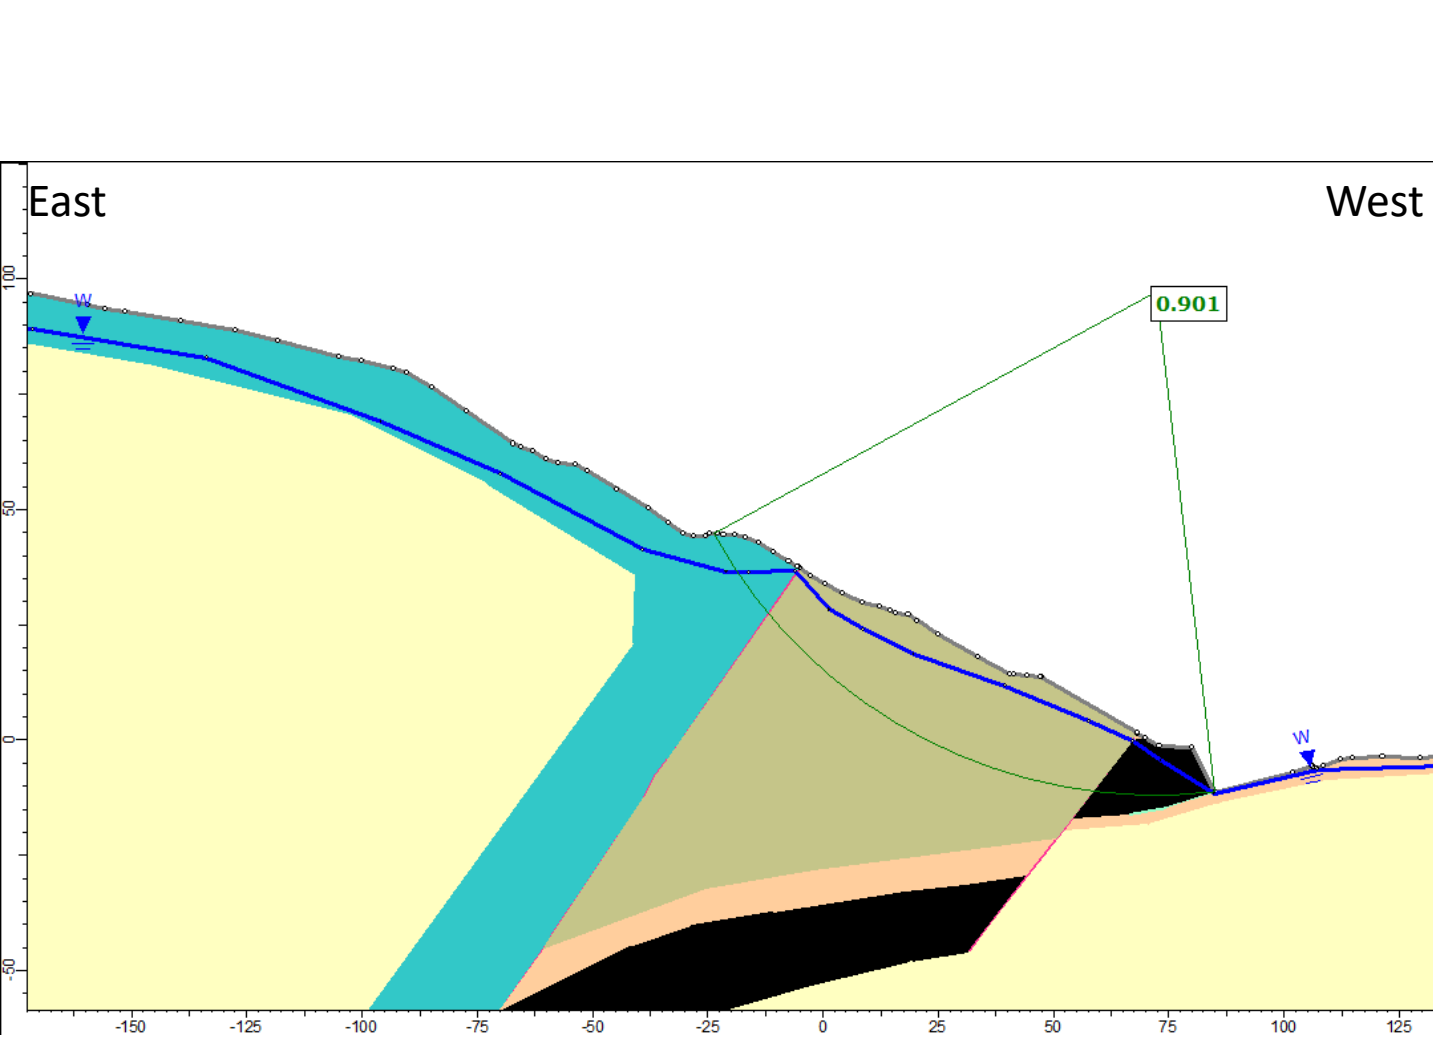
- Cypress North initial failure with shallow failure modelled

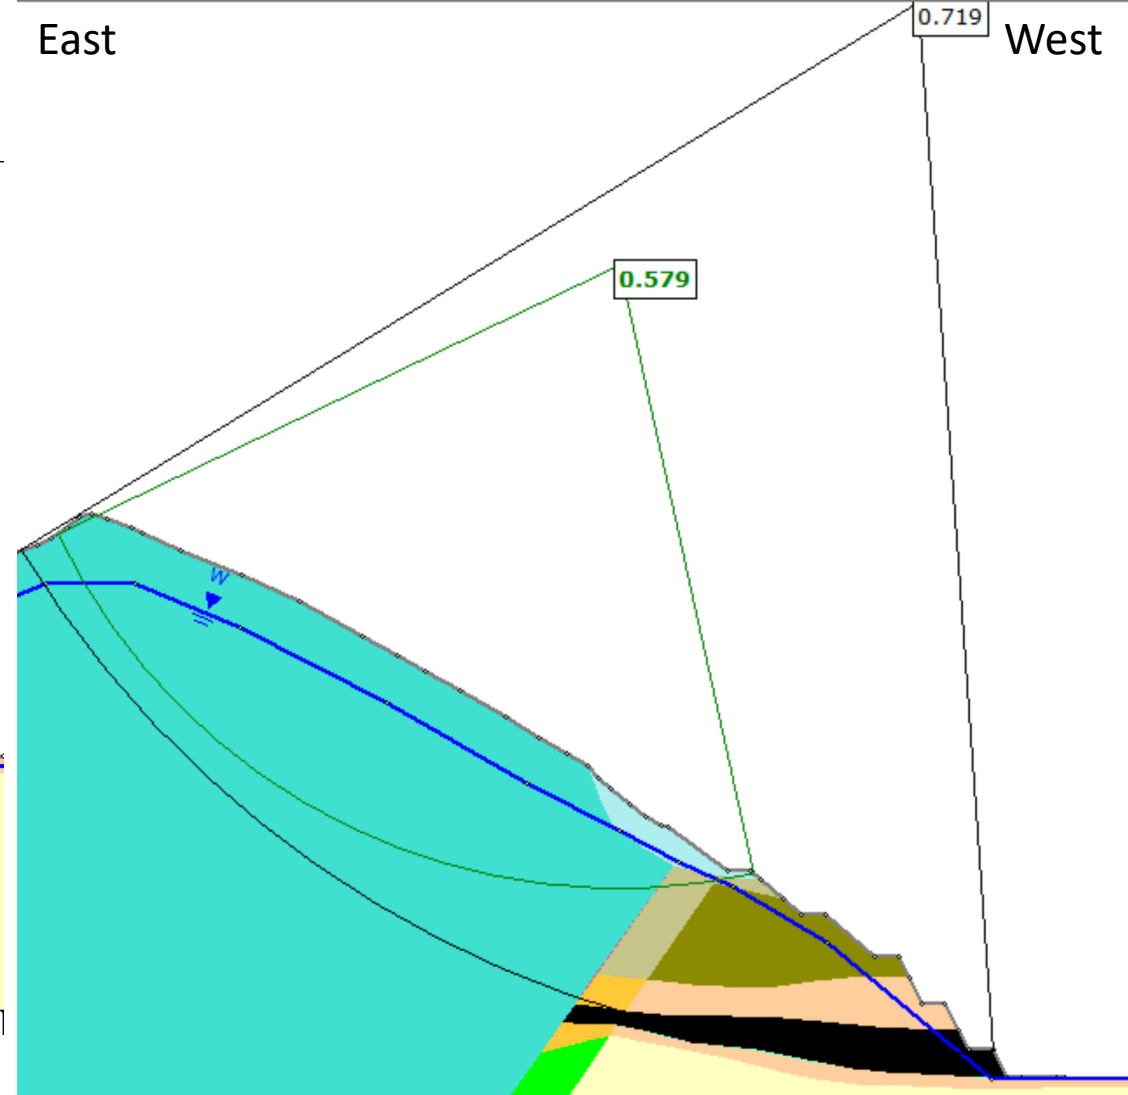
- Cypress South original proposal with Deep seated potential failure
