Managing and validating diamond drilling around complex historic workings

Samantha Muir AusIMM New Zealand Branch Annual Conference 2023

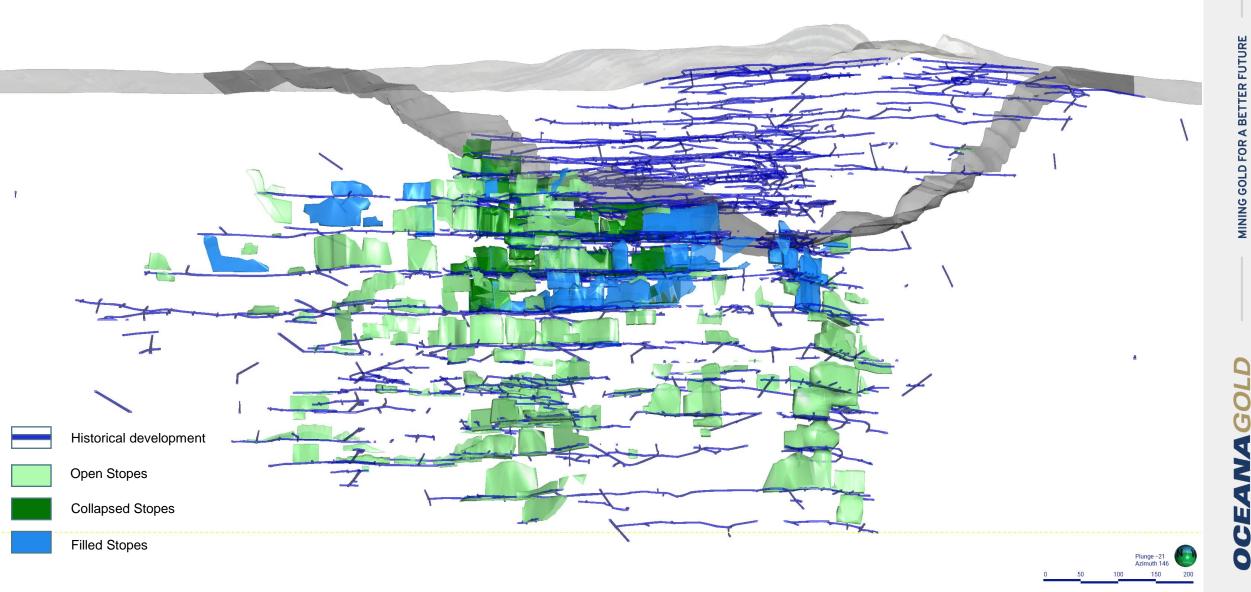
Cross section showing extent of historical workings mined between 1887 – 1955...

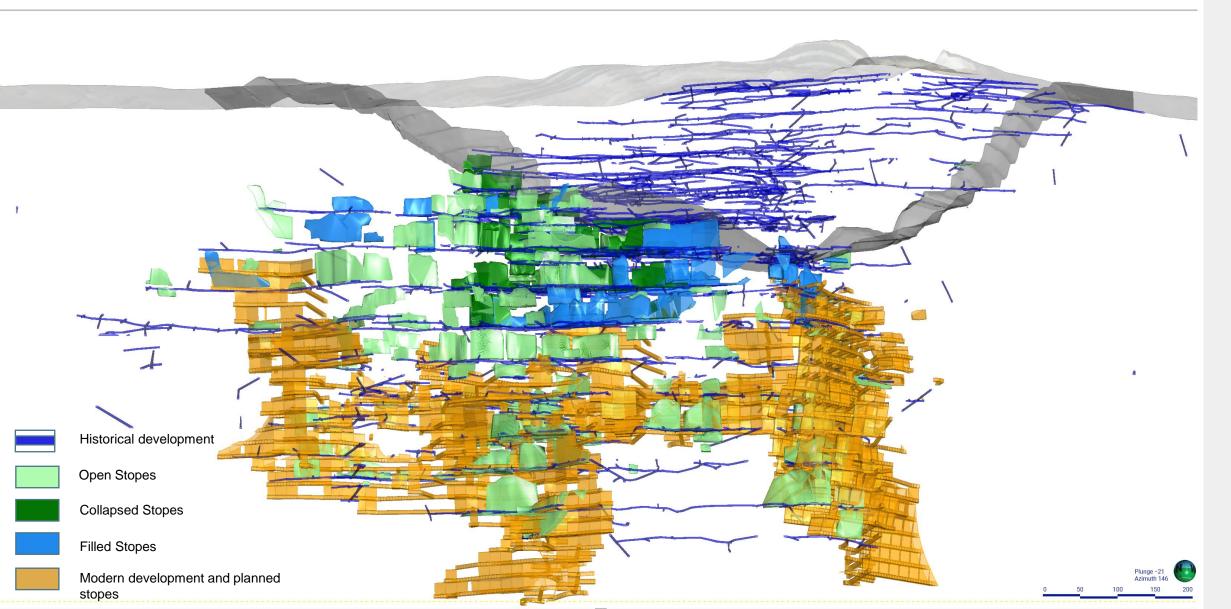
Cross section showing extent of workings mined between 1887 – 1955...with modern mine workings

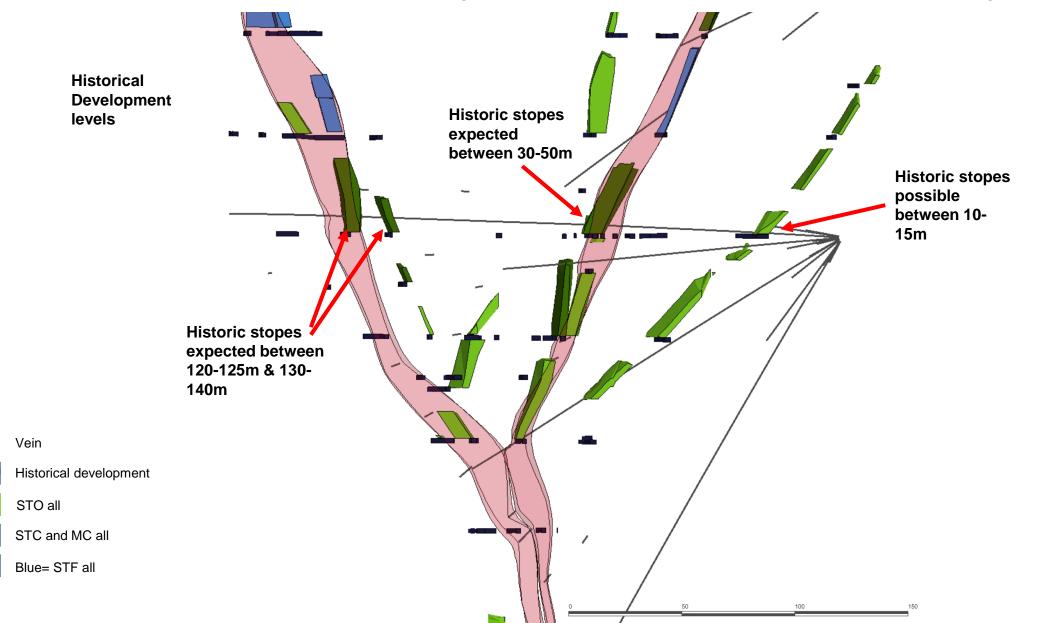
Drillers know when to expect voids and are given detailed section views with the drillhole design sheet

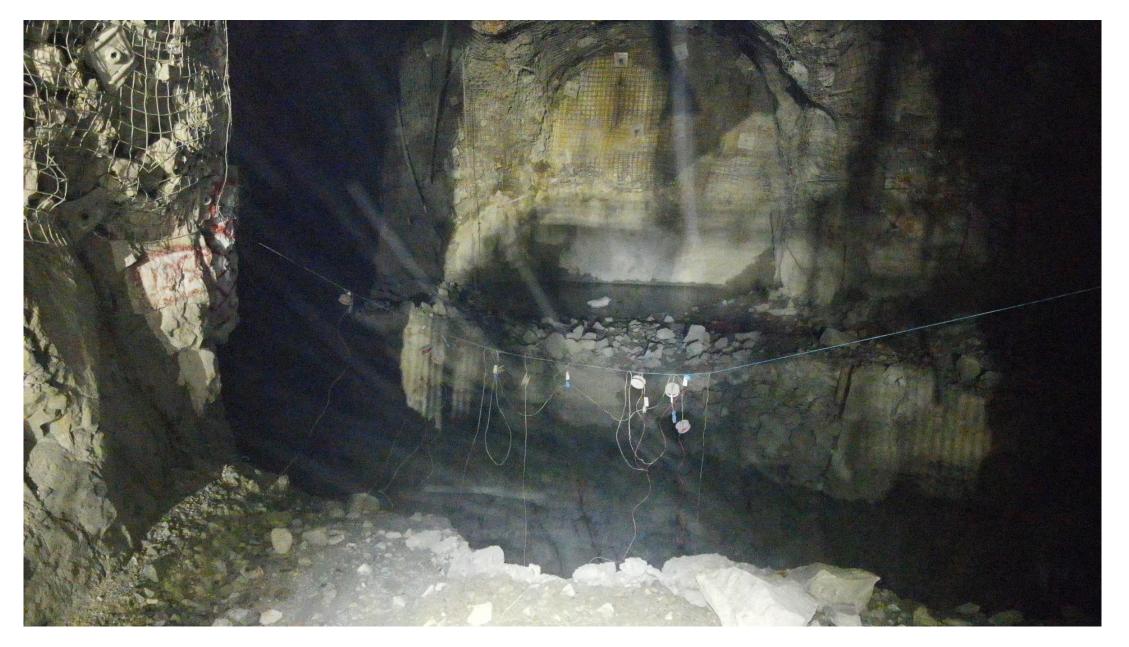
Inside an historic open stope

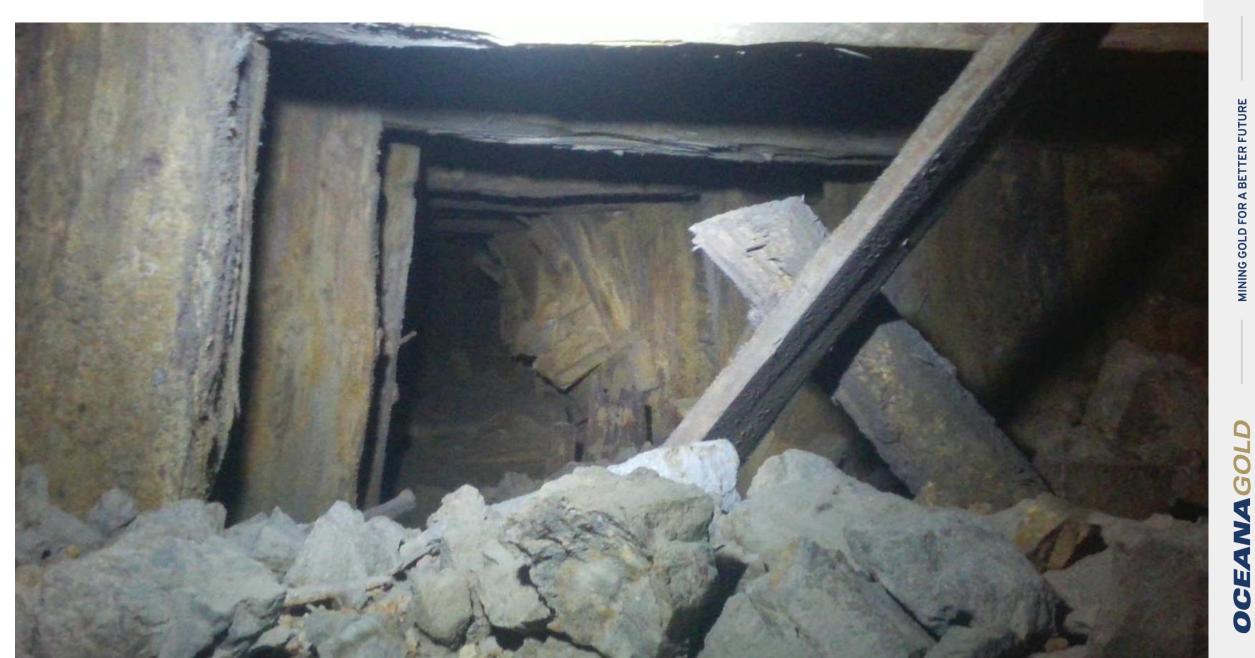
Intercepted drives

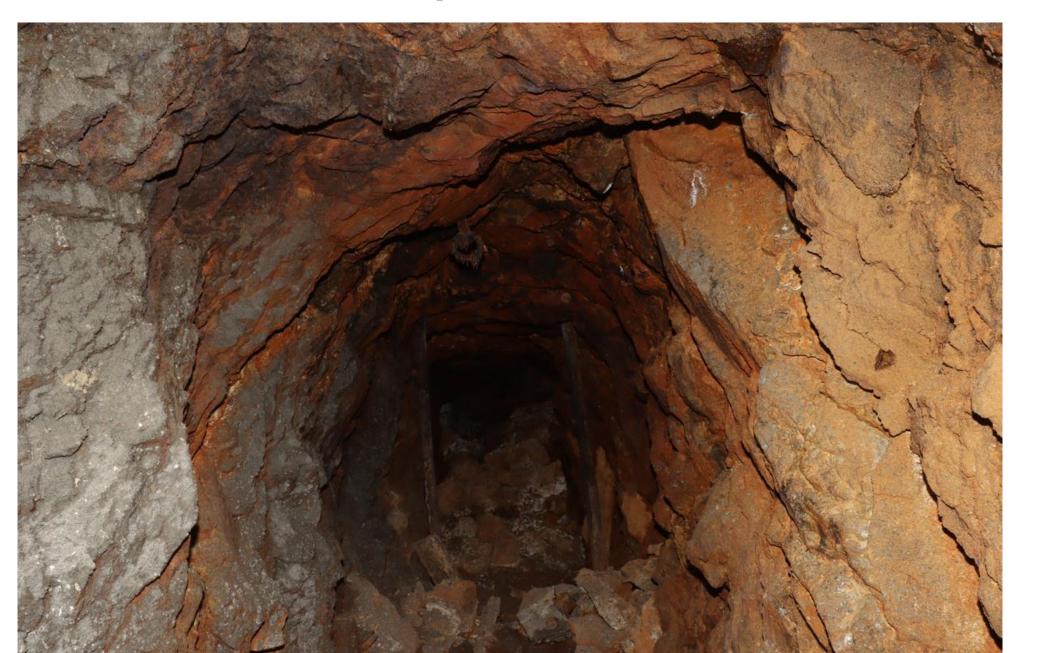
Intercepted drives

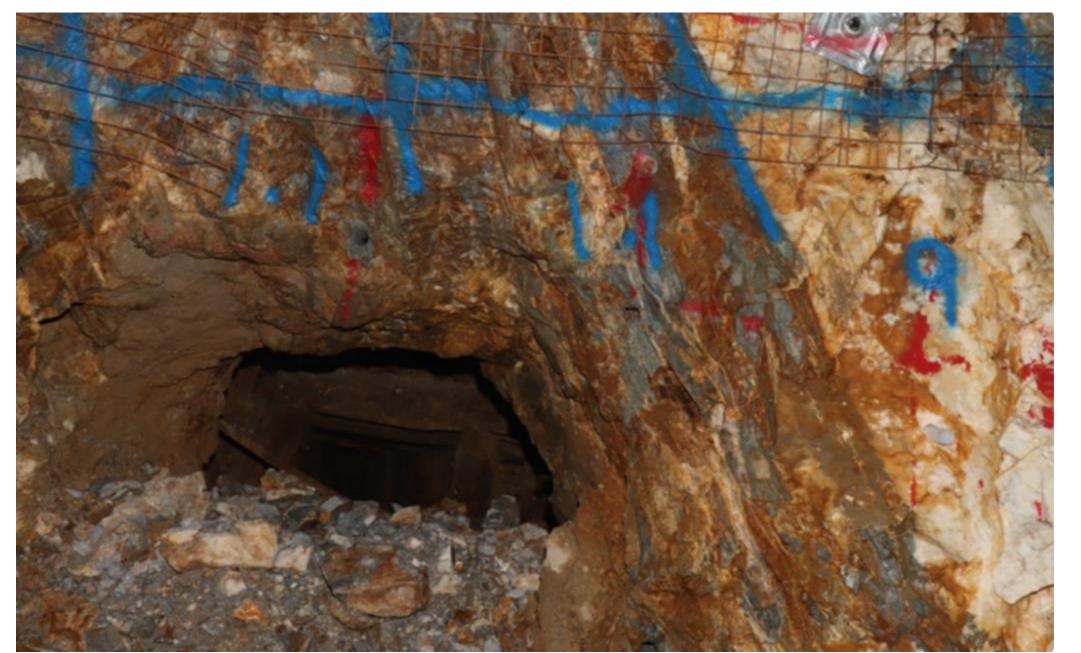
Intercepted drives

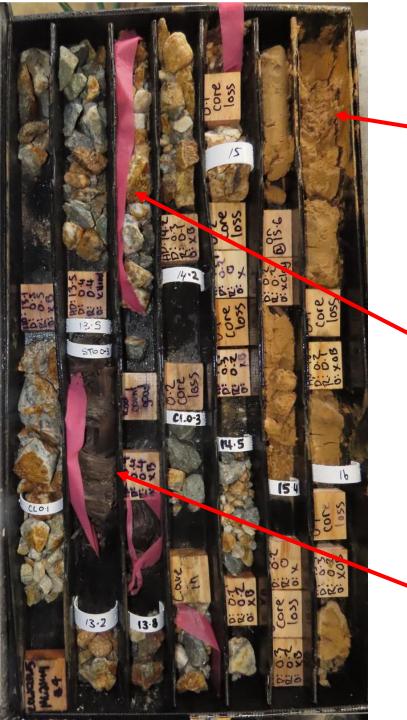
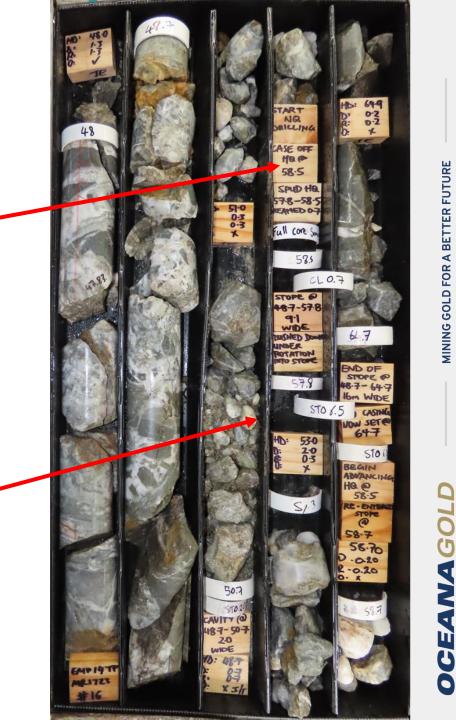
Logging core through workings

Historic stope fill

Detailed blocks from the drillers

The pink tape indicates core considered "cave" or "not in-situ"

Historic open stope 6.5m wide

Old timber beams

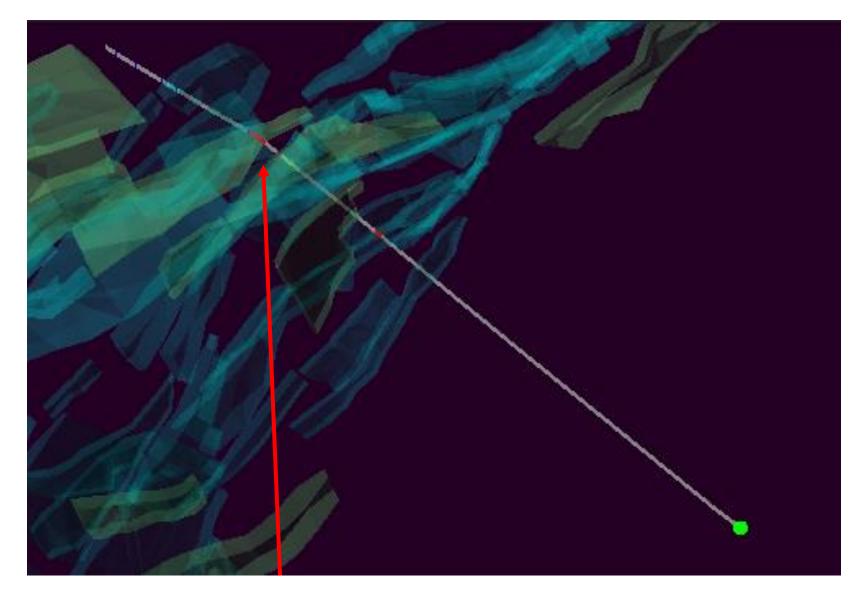
Notice the bend in the drillhole as it intersects the historic stope

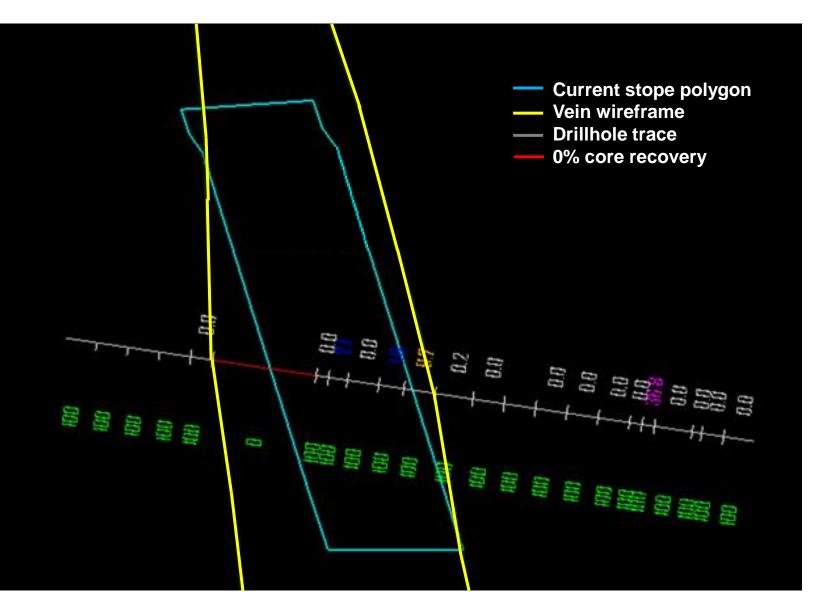
The red section on the drillhole trace indicates zero recovery – the open stope.

The blue polygon is the current stope shape which needs to be rotated and pinched to match.
