VERIFICATION OF INITIAL DEVELOPMENT DESIGN AND NUMERICAL MODEL, POBOYA RIVER REEF, INDONESIA

MINING APPROACH

BOXCUT DESIGN

SITE VISIT AND VERIFICATION

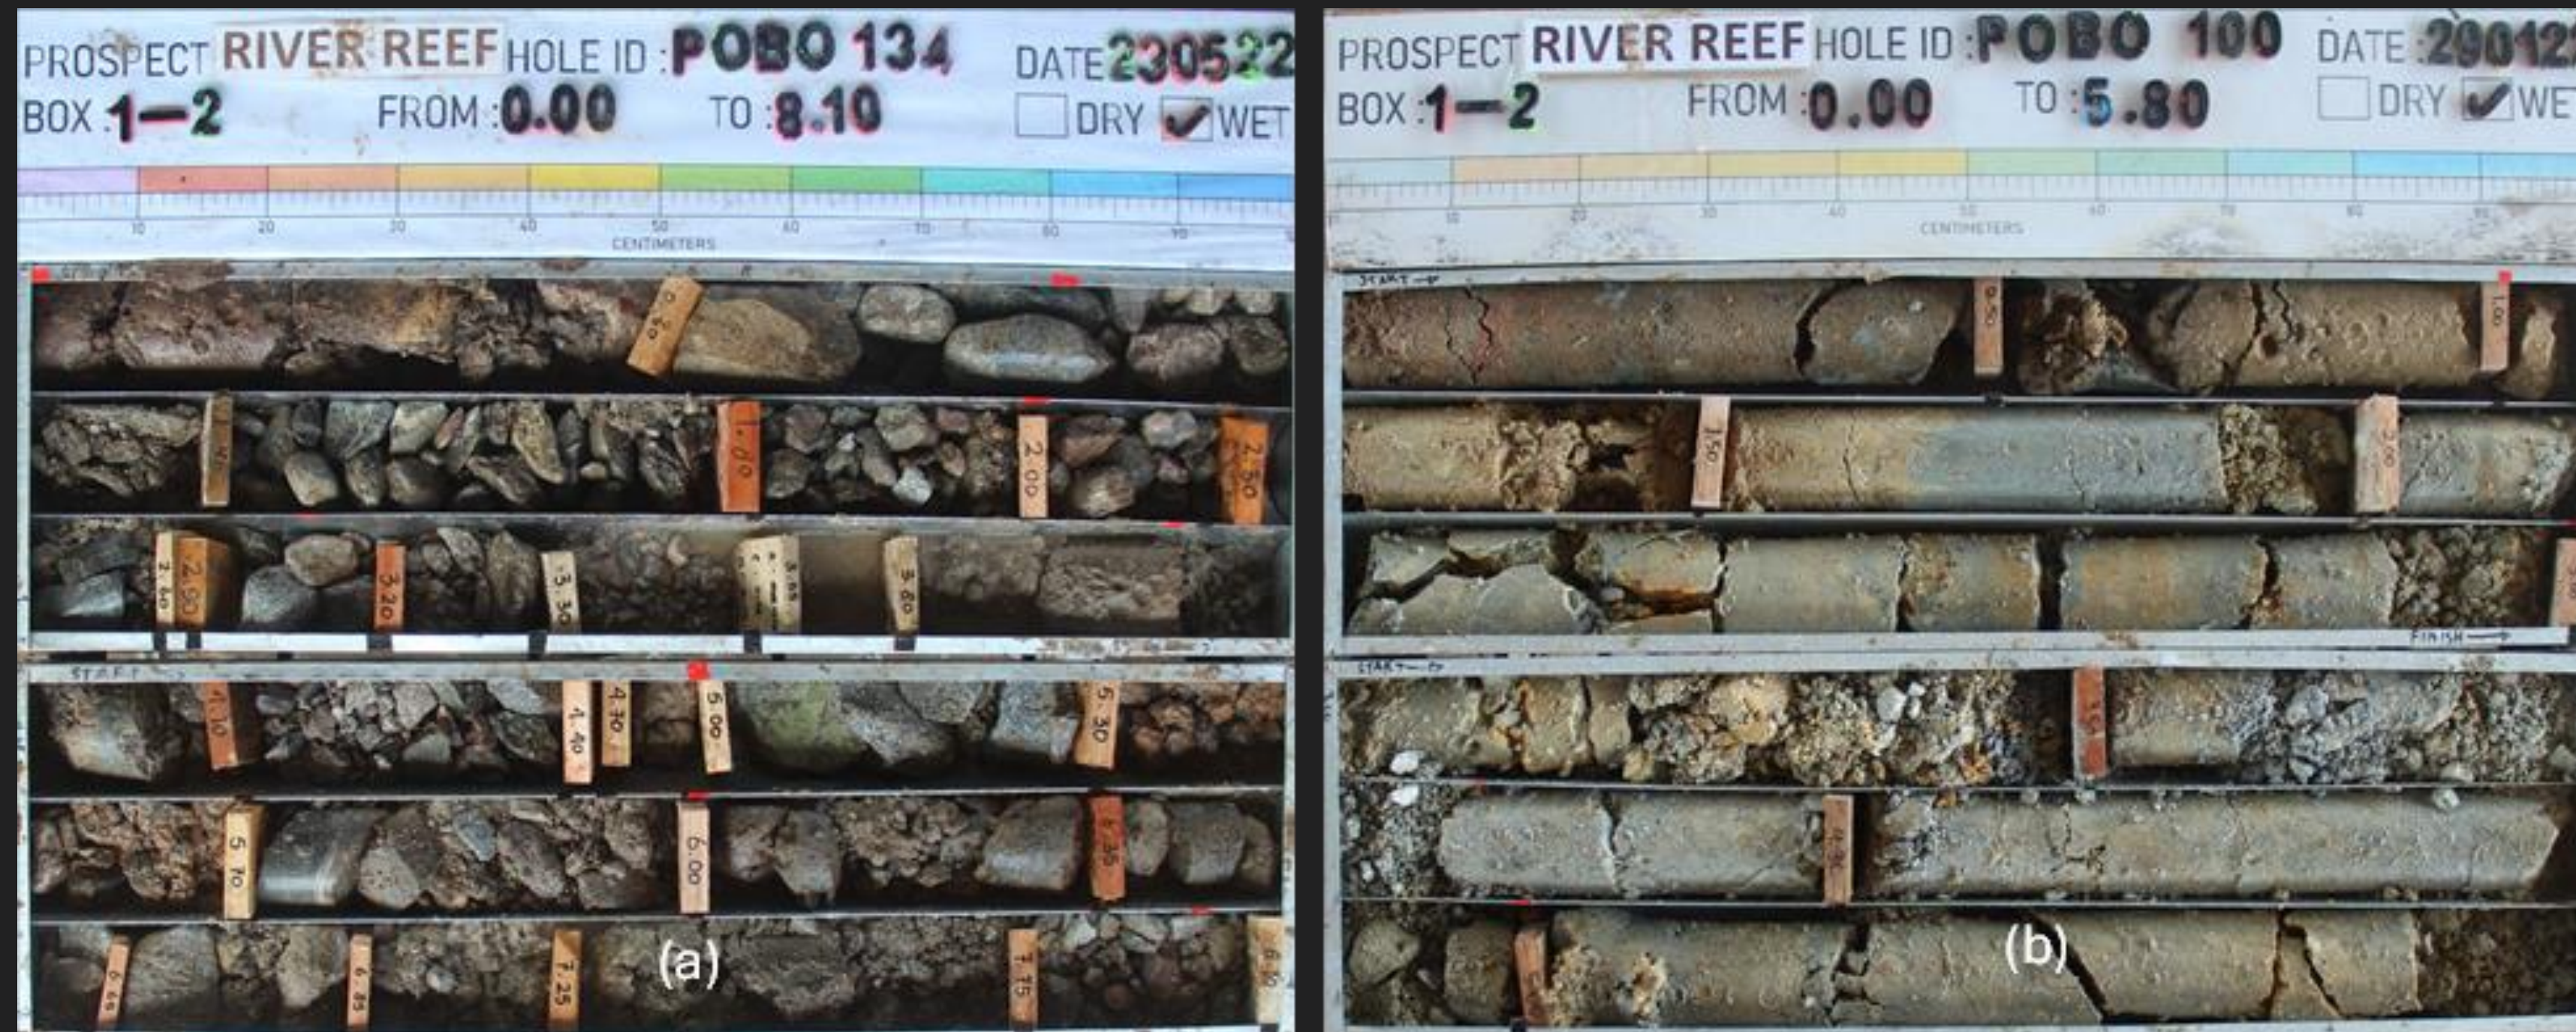
STRONGLY WEATHERED DOMAIN

Core photos from the Strong Weathered Domain (a) alluvial material (b) strongly weathered rock

- comprises alluvial material and heavily weathered rock.
- To 25m below surface.
- unconsolidated gravel, silt and sand sized fragments with rounded shape and poor sorting.
- The rock fragments are a mixture of schist, gneiss, monzonite and vein material.

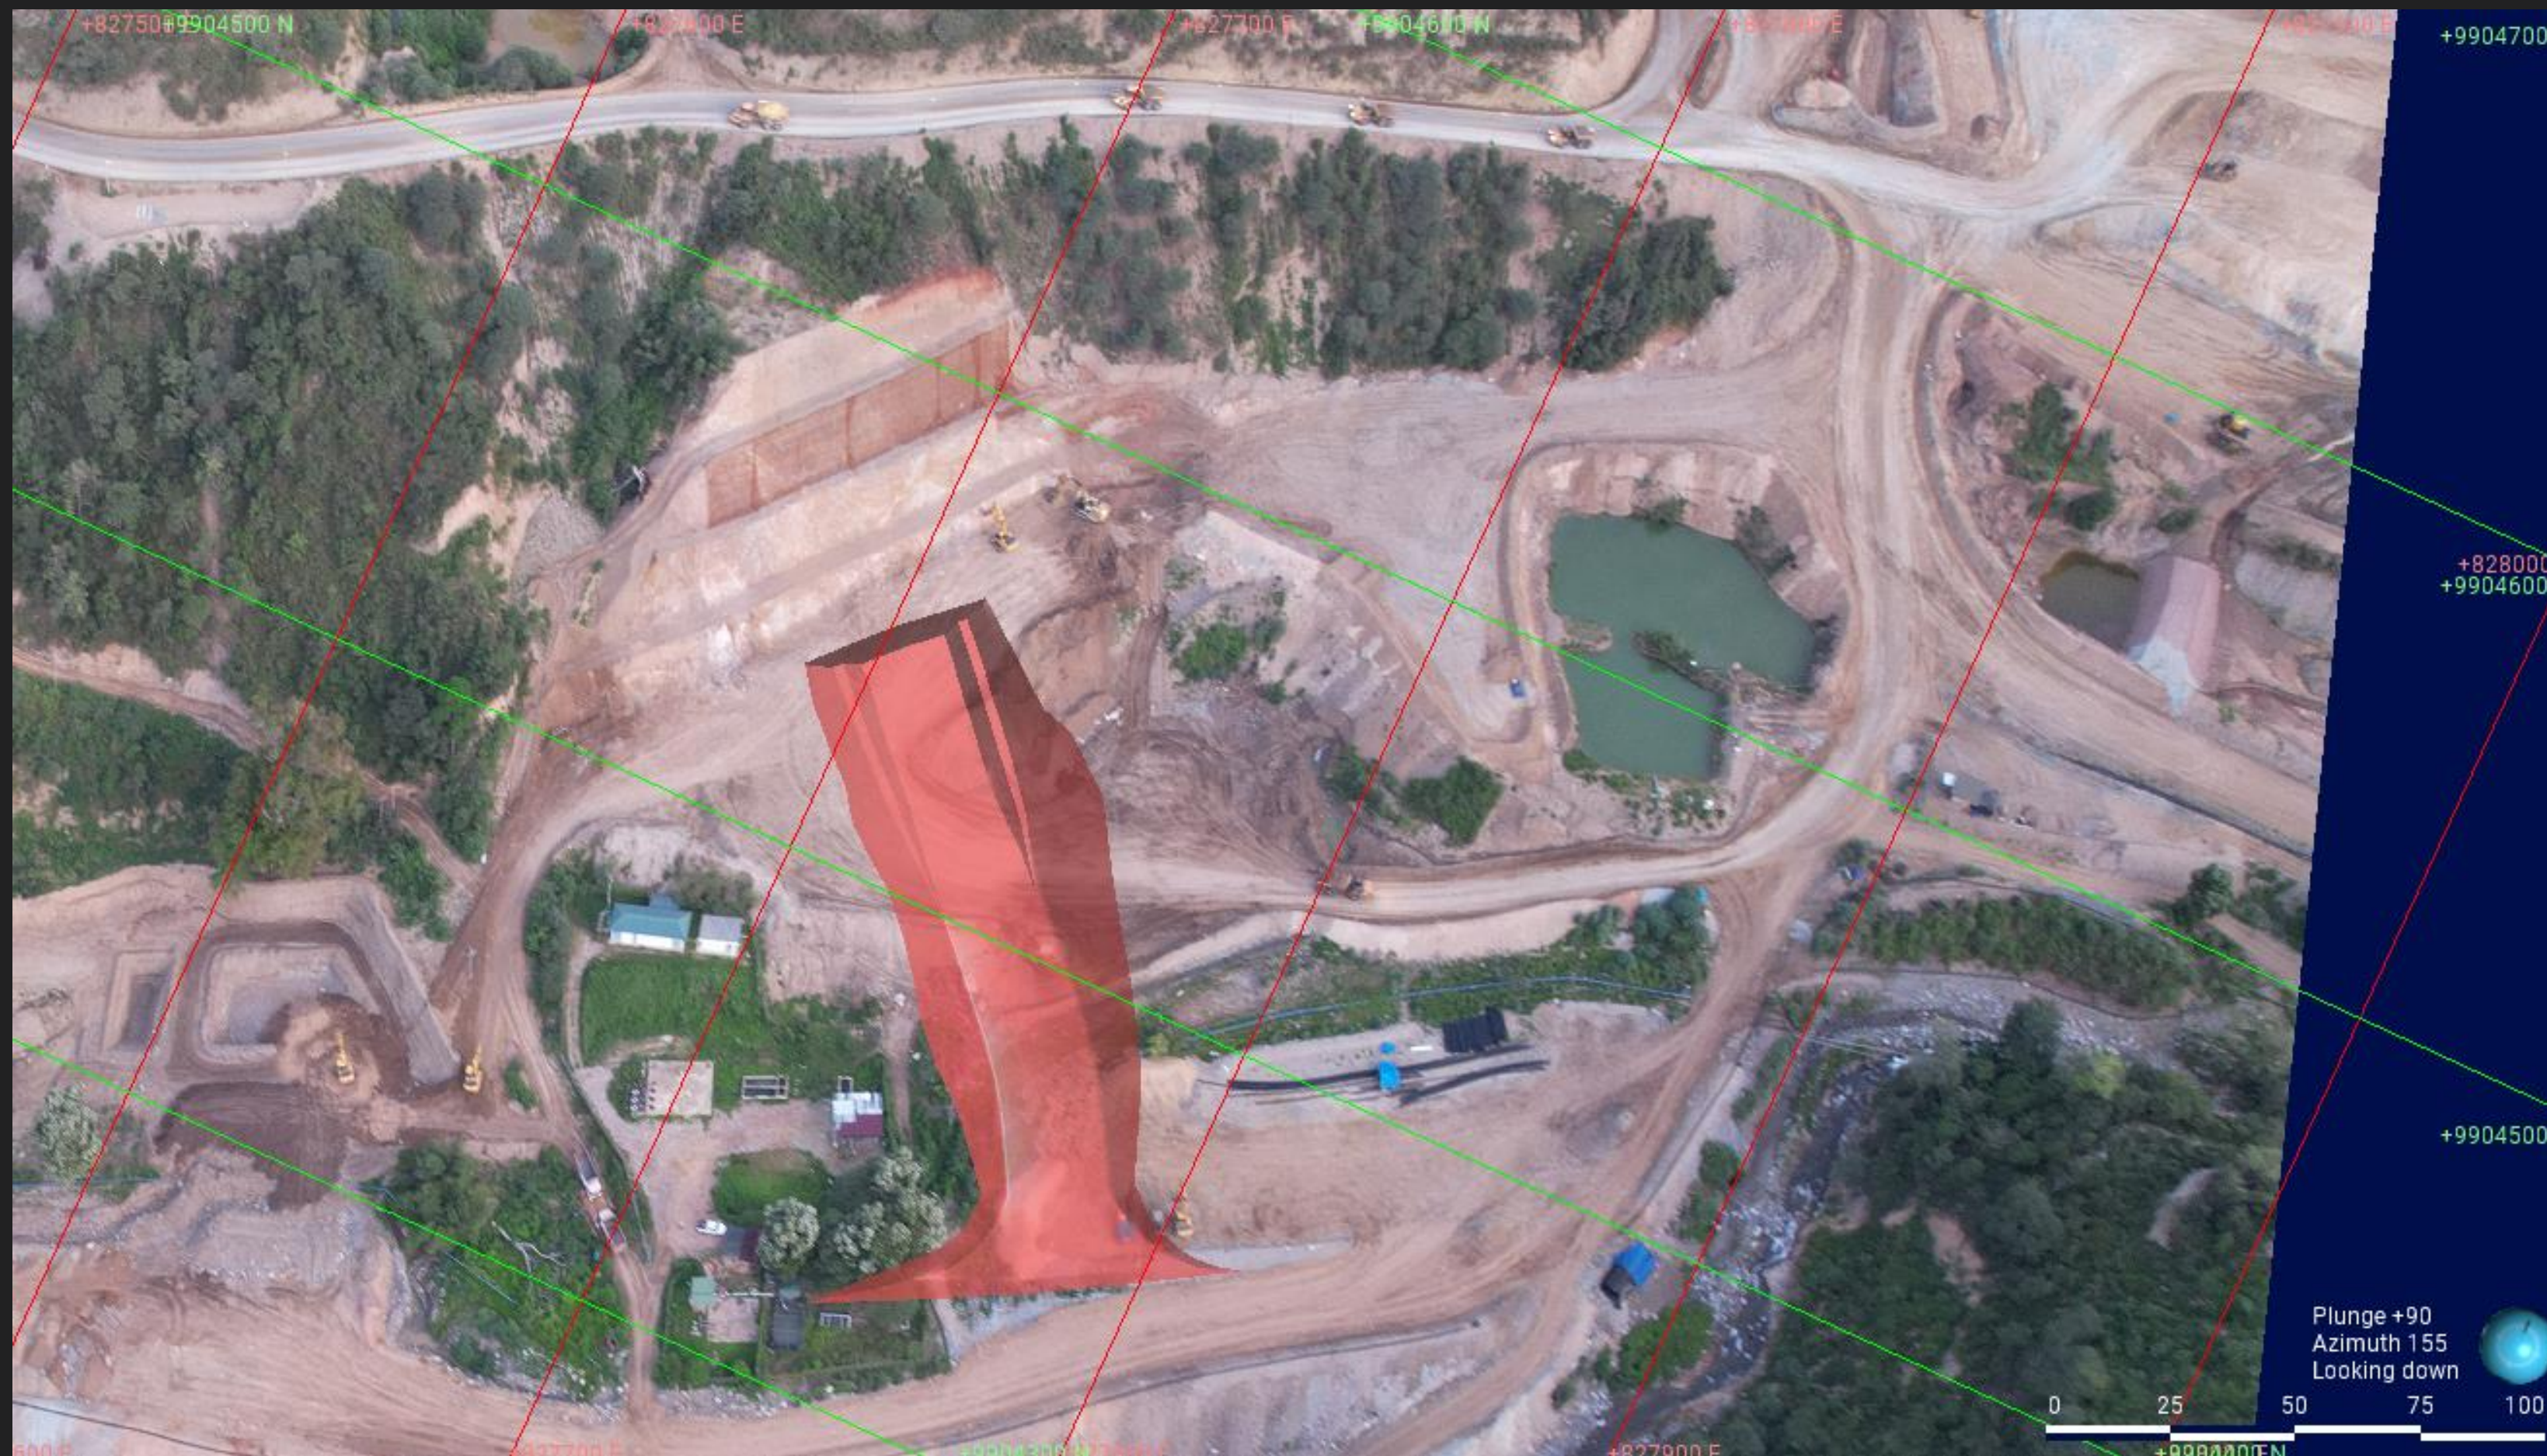
- Boxcut Sides (Highly Weathered Domain); 60° batters, 10m high, 2m benches – overall slope 50°
- Portal Face (Transitional Monzonite); 14.5m height at batter angle of 70°
- Above portal (Weathered & Alluvium); 50° batters, 10m high, 4.5m benches – overall slope 45°
- Side-cast fill from the haul road, minor failures, buttress to support

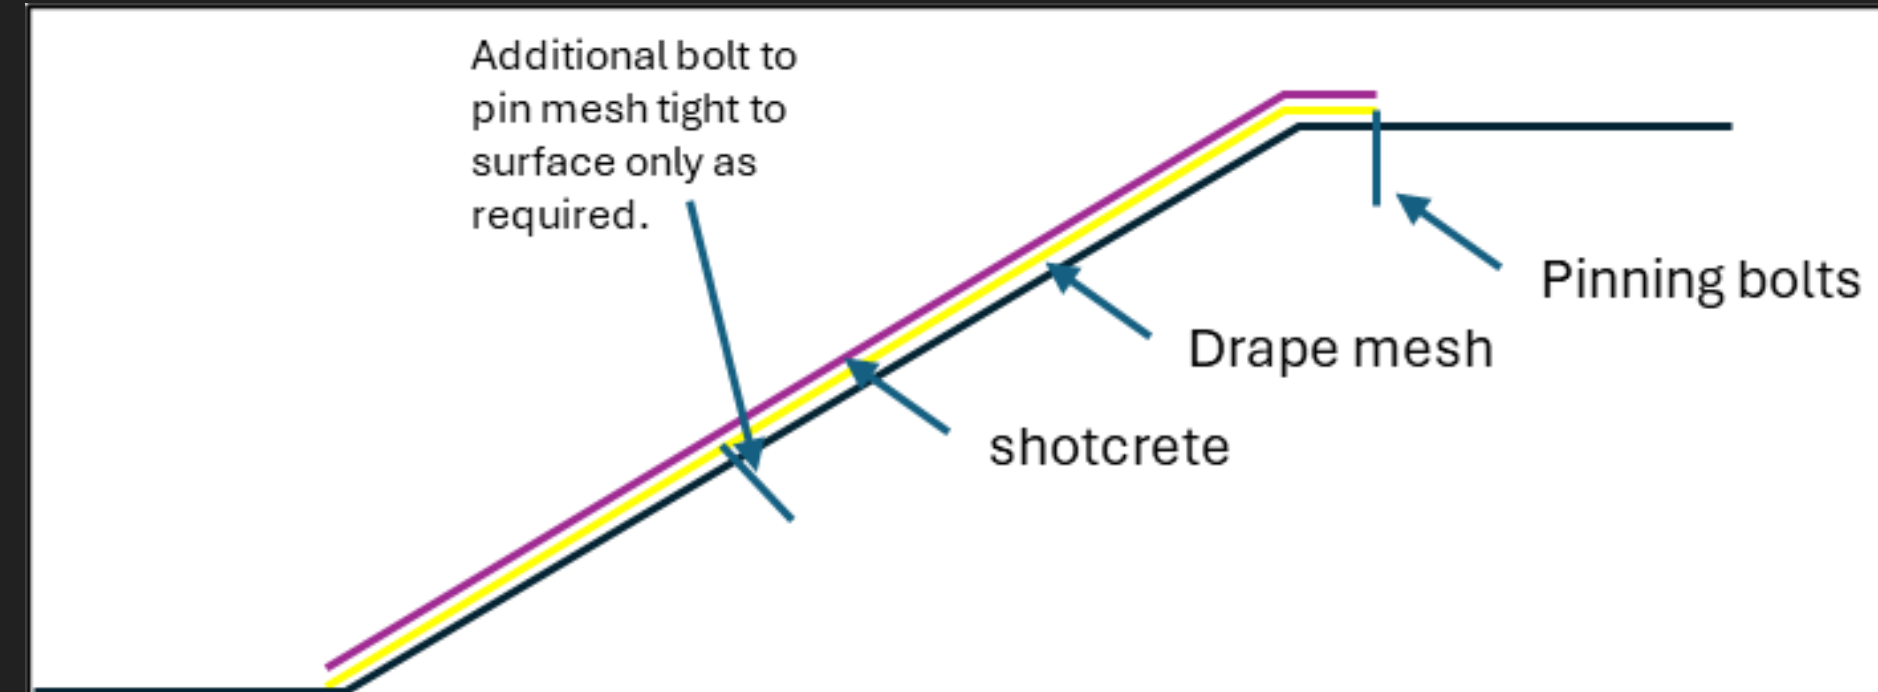
ALLUVIAL MATERIAL

- Slope protection from erosion and for aesthetics
- Chain link mesh drape overlapped and pinned 1m back from crest.
- Crest pinning at 1m spacing with either split sets or rebar driven directly into the ground.
- Additional 0.9m split sets can be used to ensure the mesh conforms tightly to the face to minimize shotcrete consumption.
- 50mm of shotcrete or until the mesh is covered.

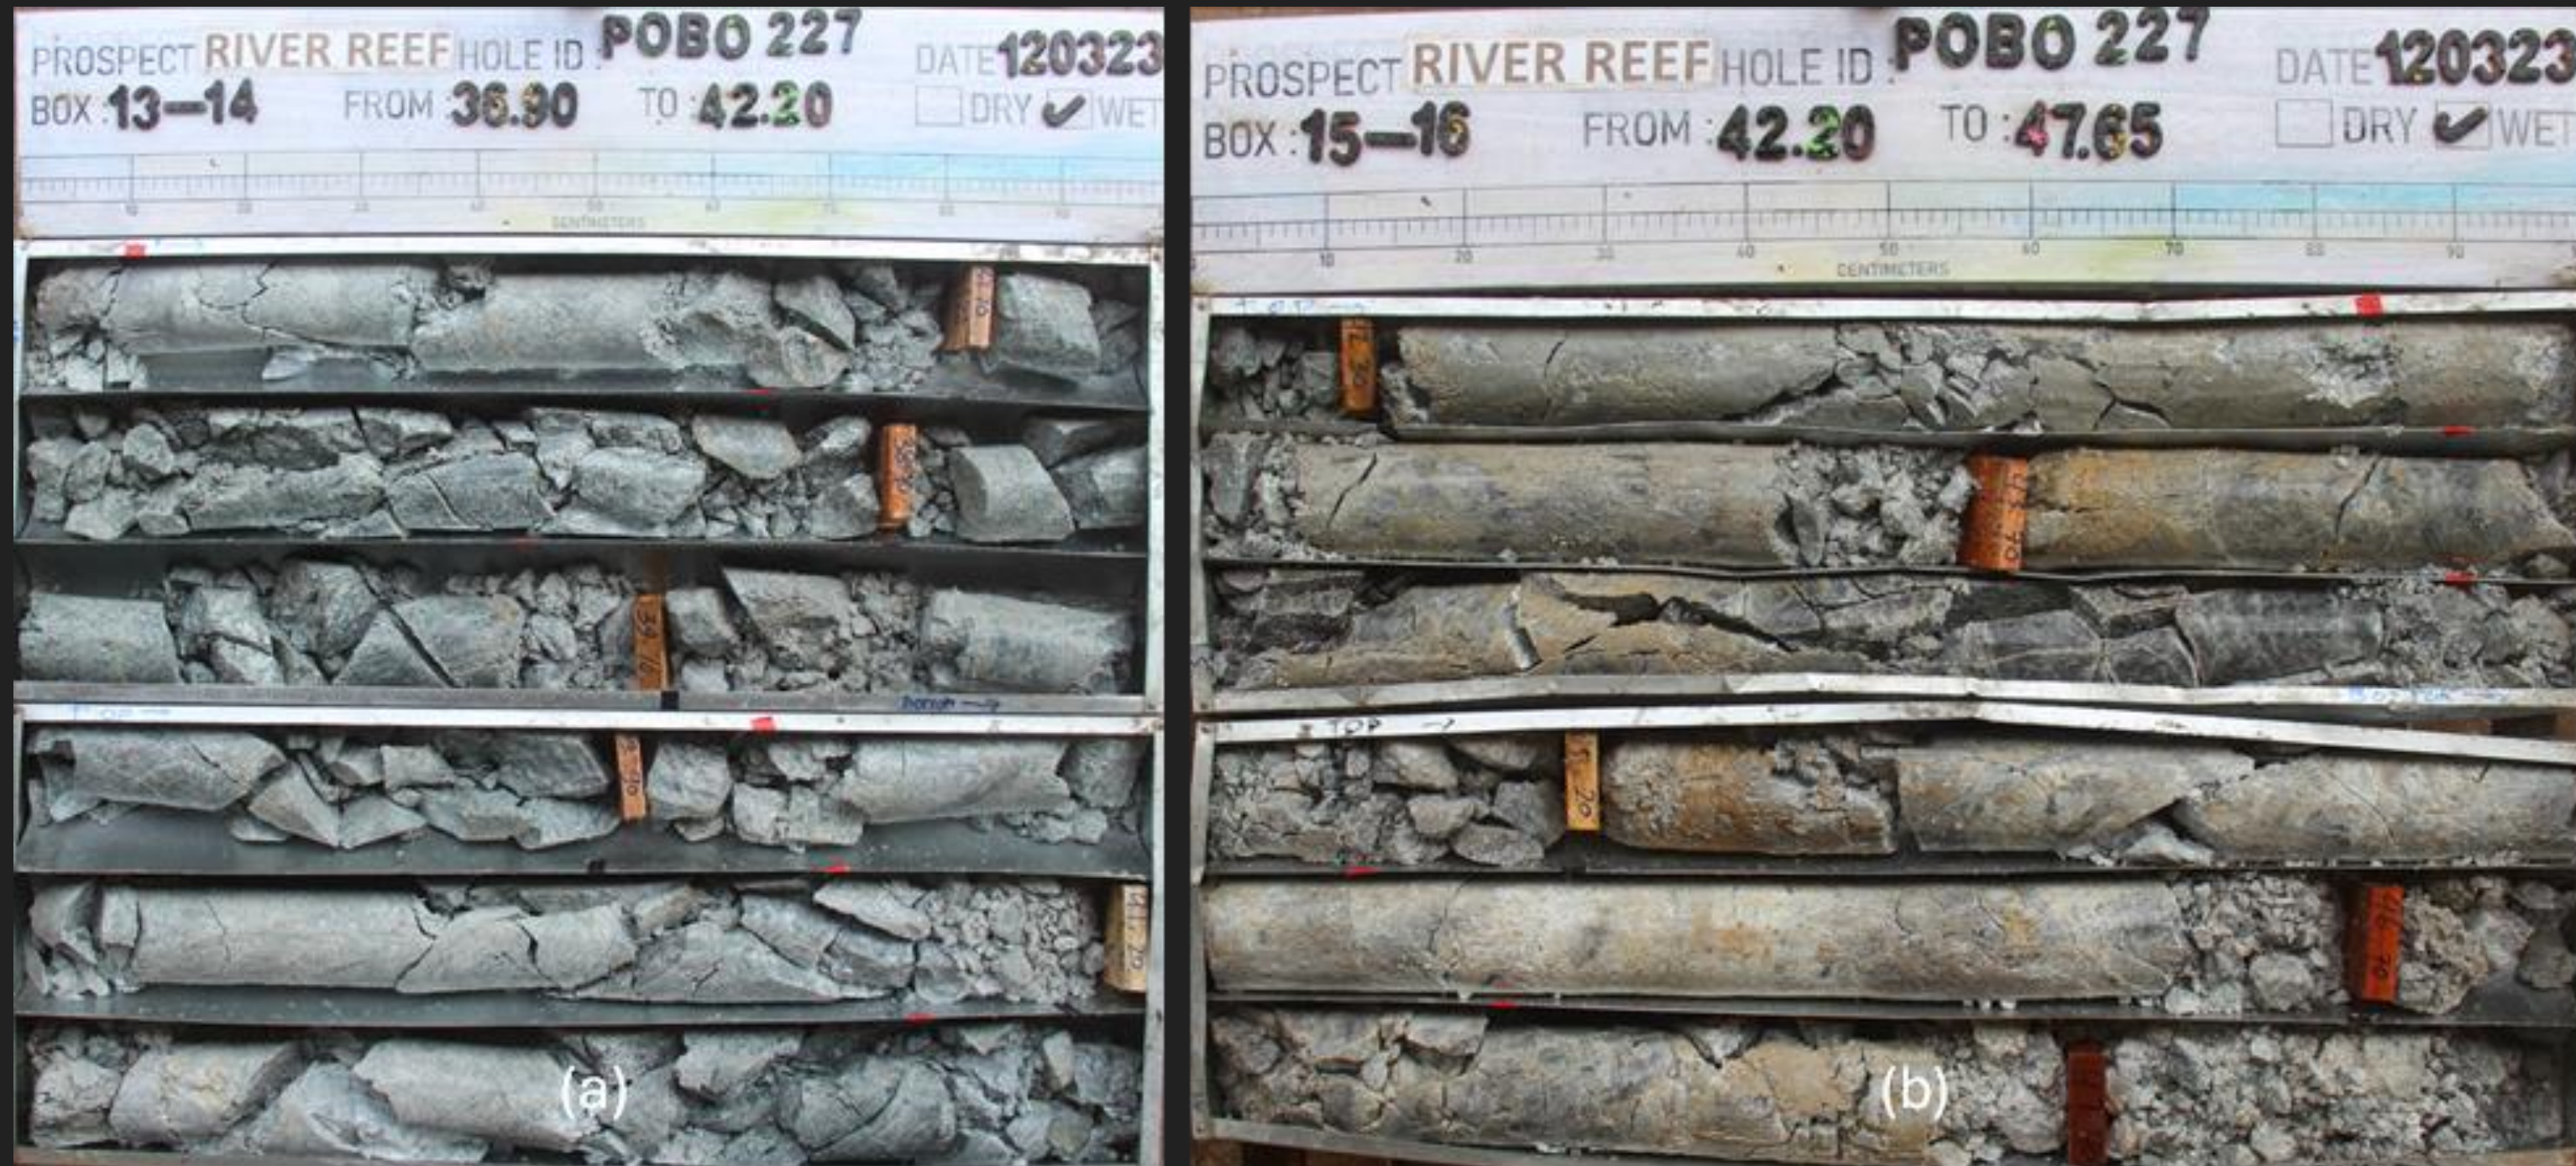
TRANSITIONAL DOMAIN

- General description of the weathered rock mass.
- Different lithology units are present; Portal will be in Monzonite
- Very weak rock
- Foliated
- Weathered

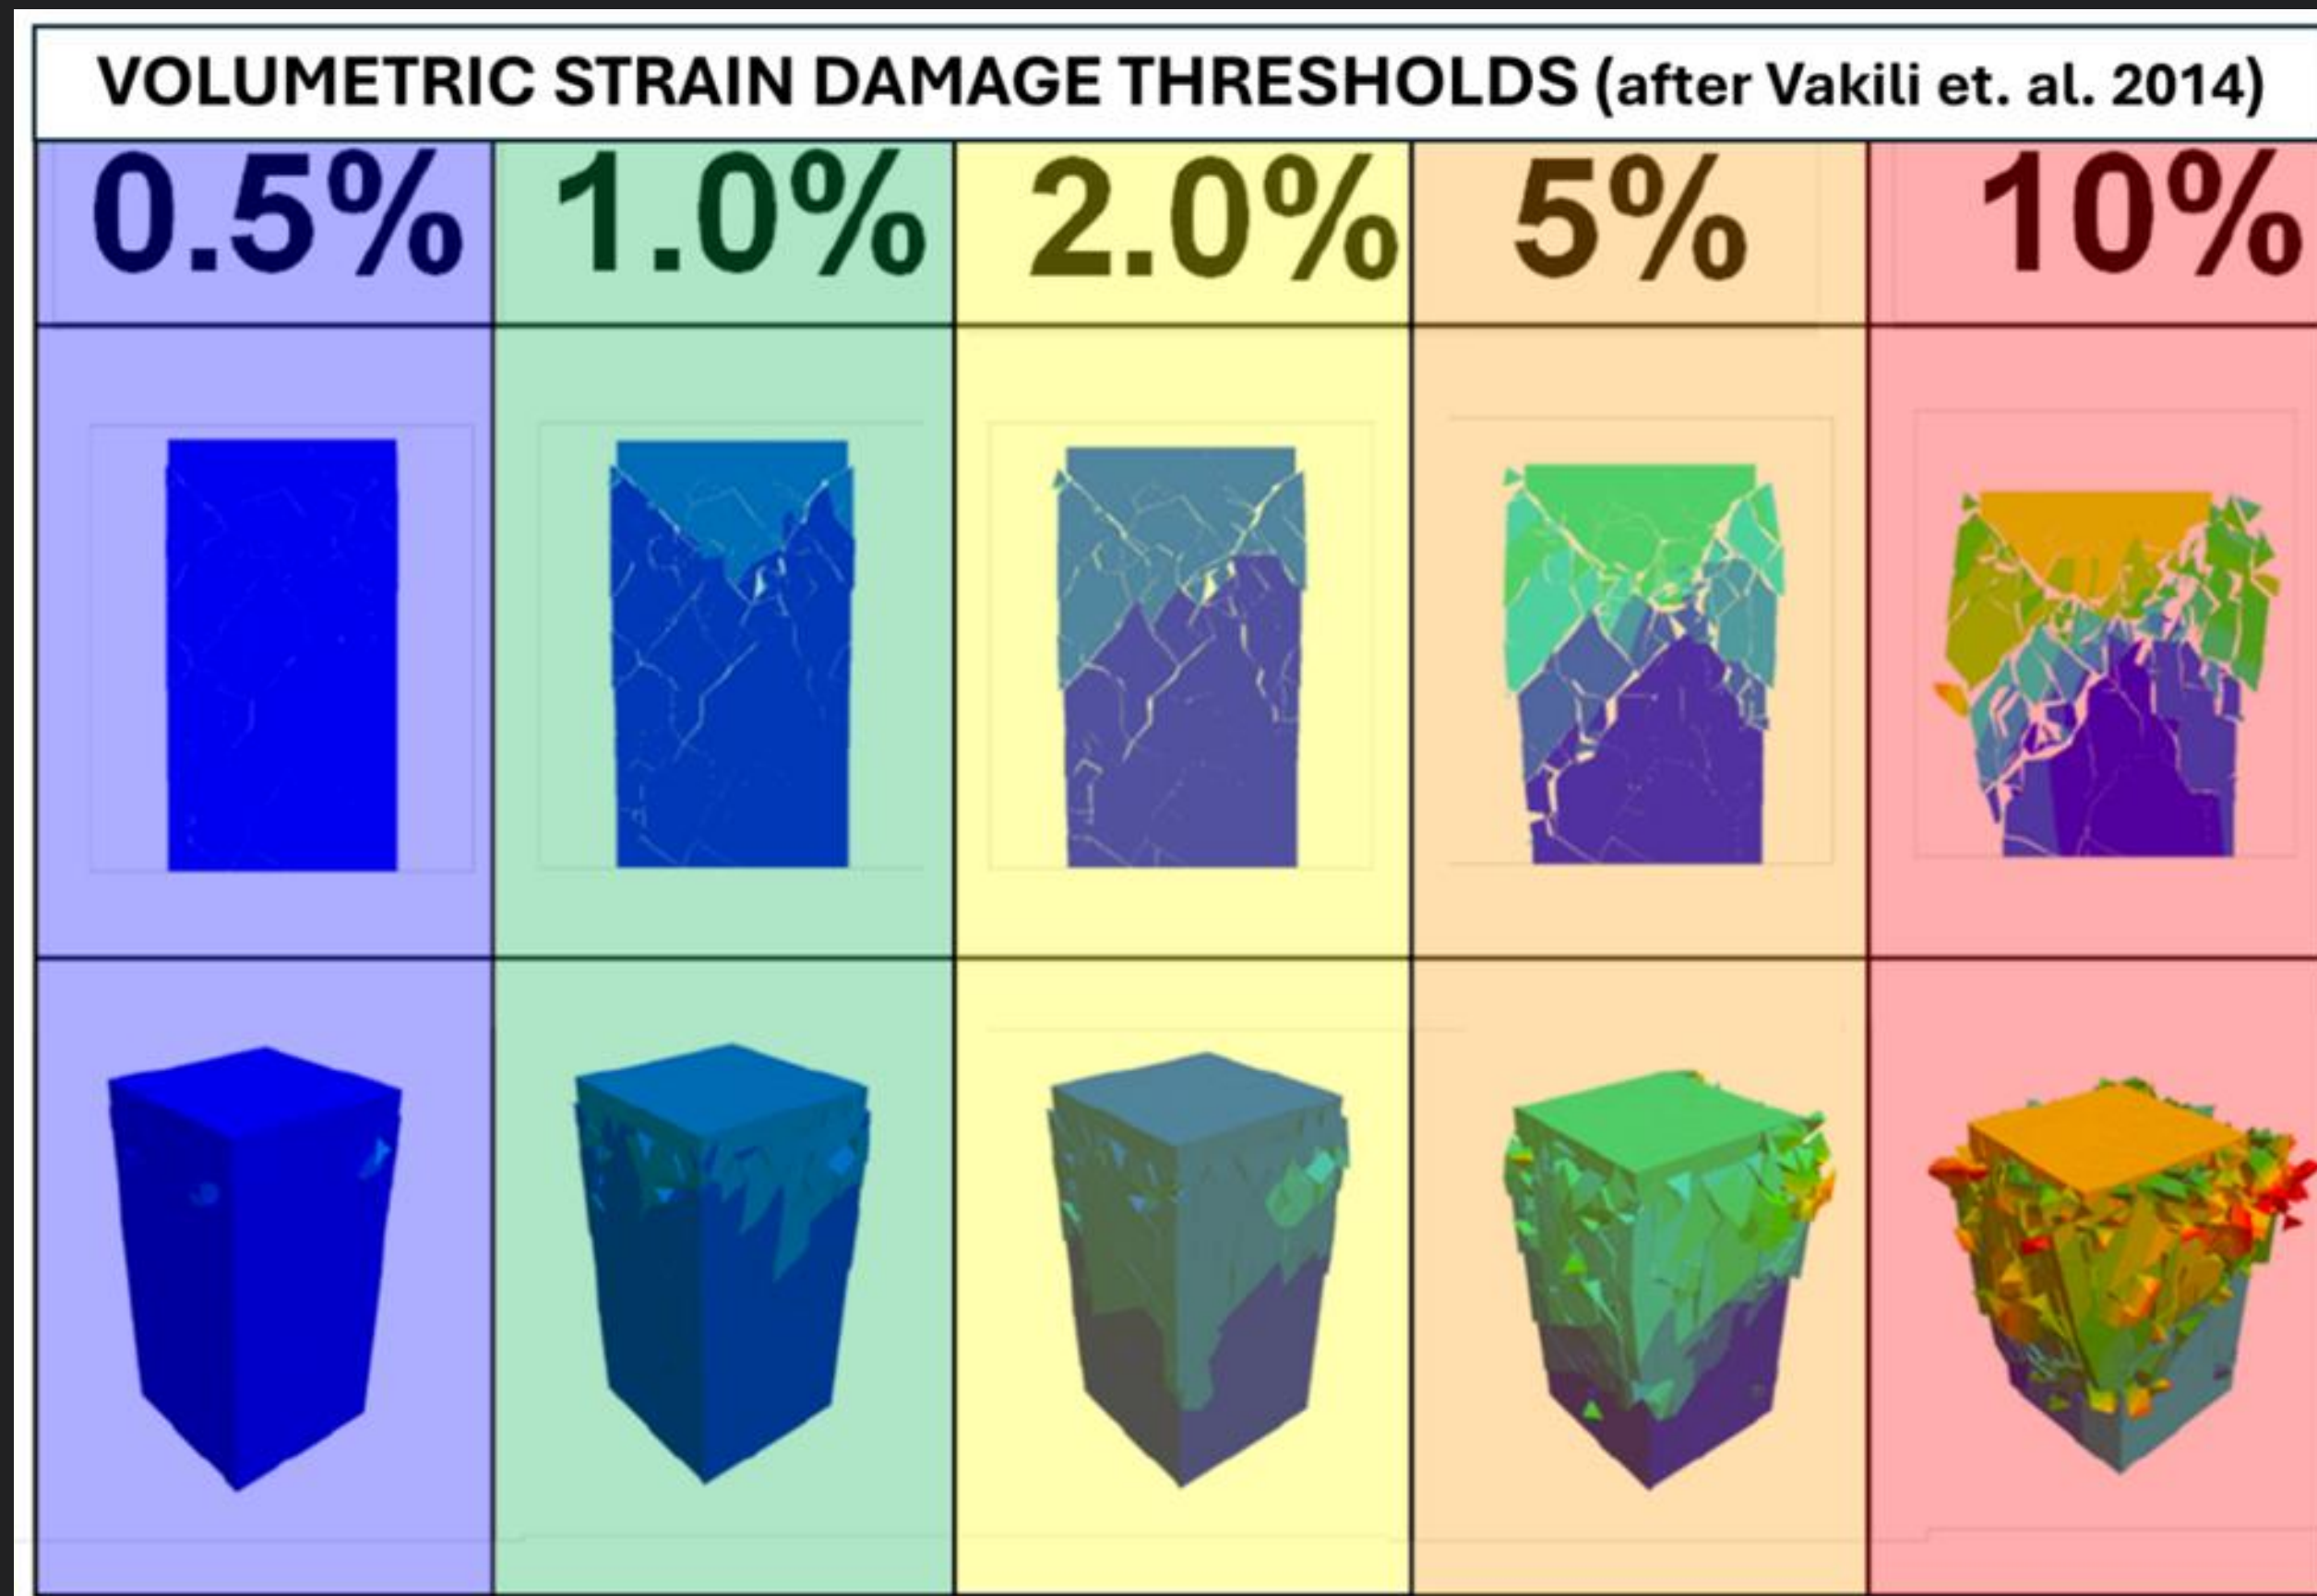
VOLUMETRIC STRAIN

- Volumetric strain – a measure of rock mass damage due to inelastic deformation
- Liner yield
- Rockbolt and cable yield
- Rockbolt and cable load

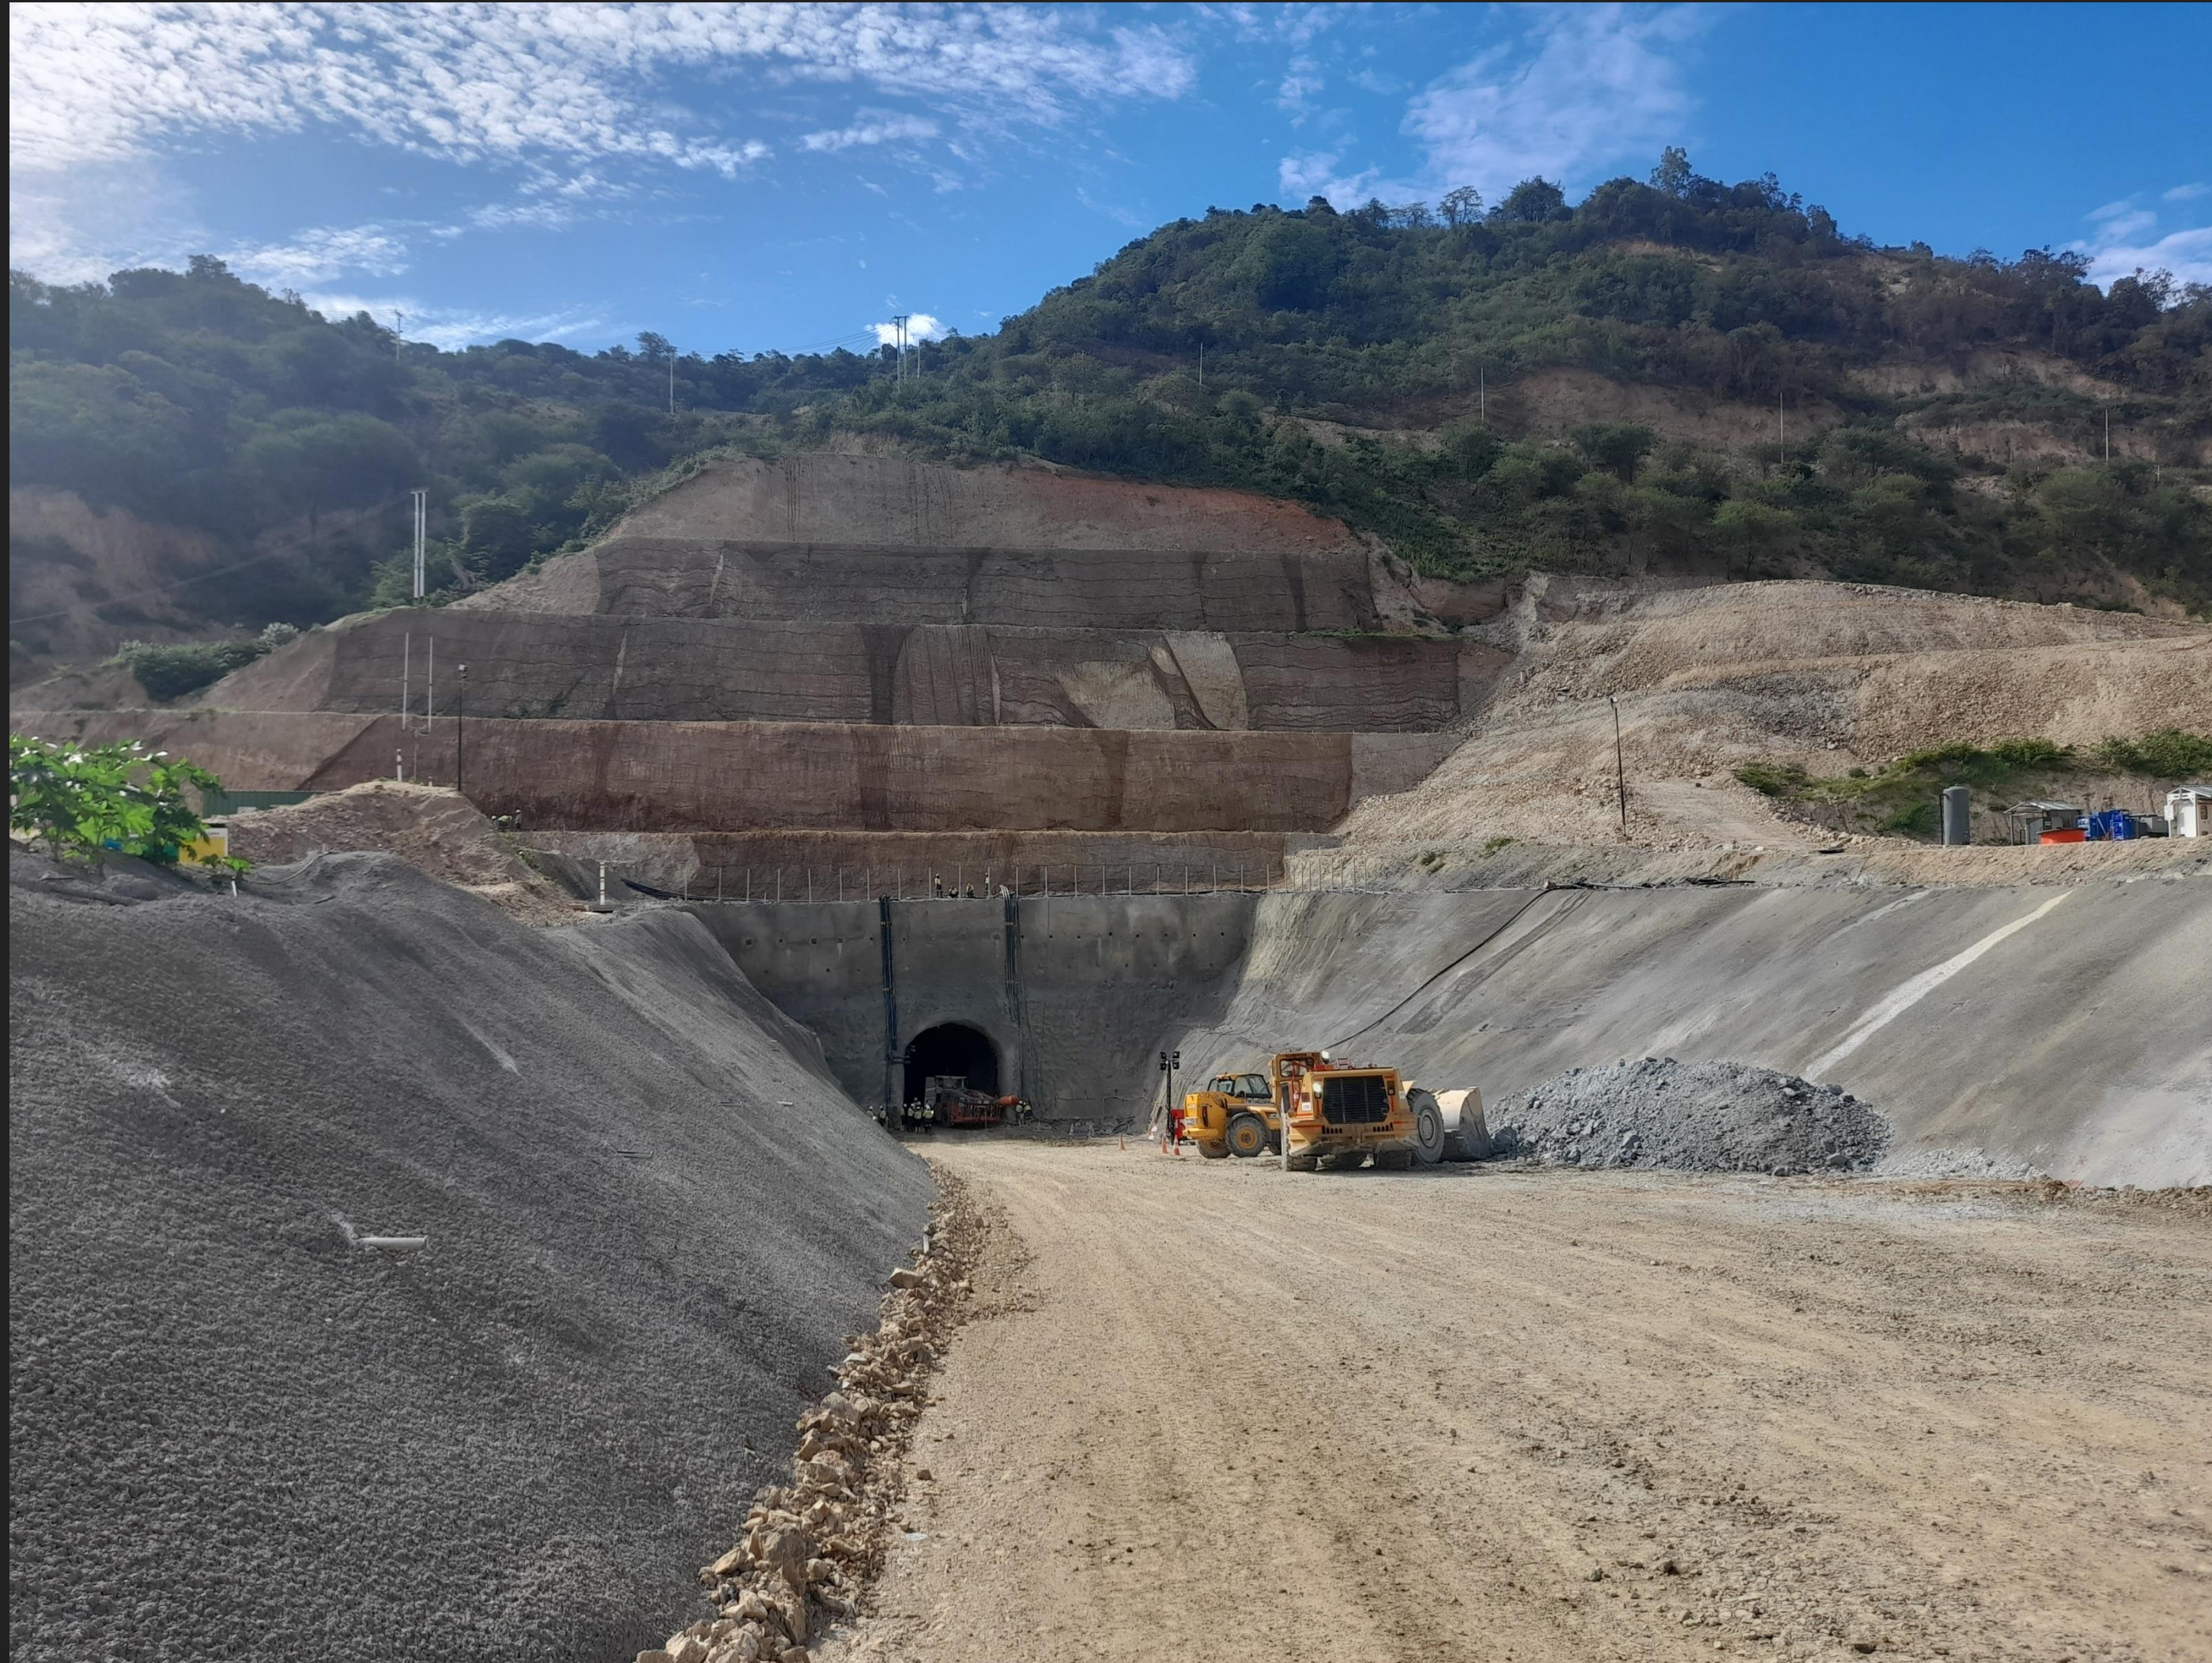
SITE VISIT (MARCH 2025)

- Boxcut & portal Face
- Mesh & fibrecrete on alluvium slopes

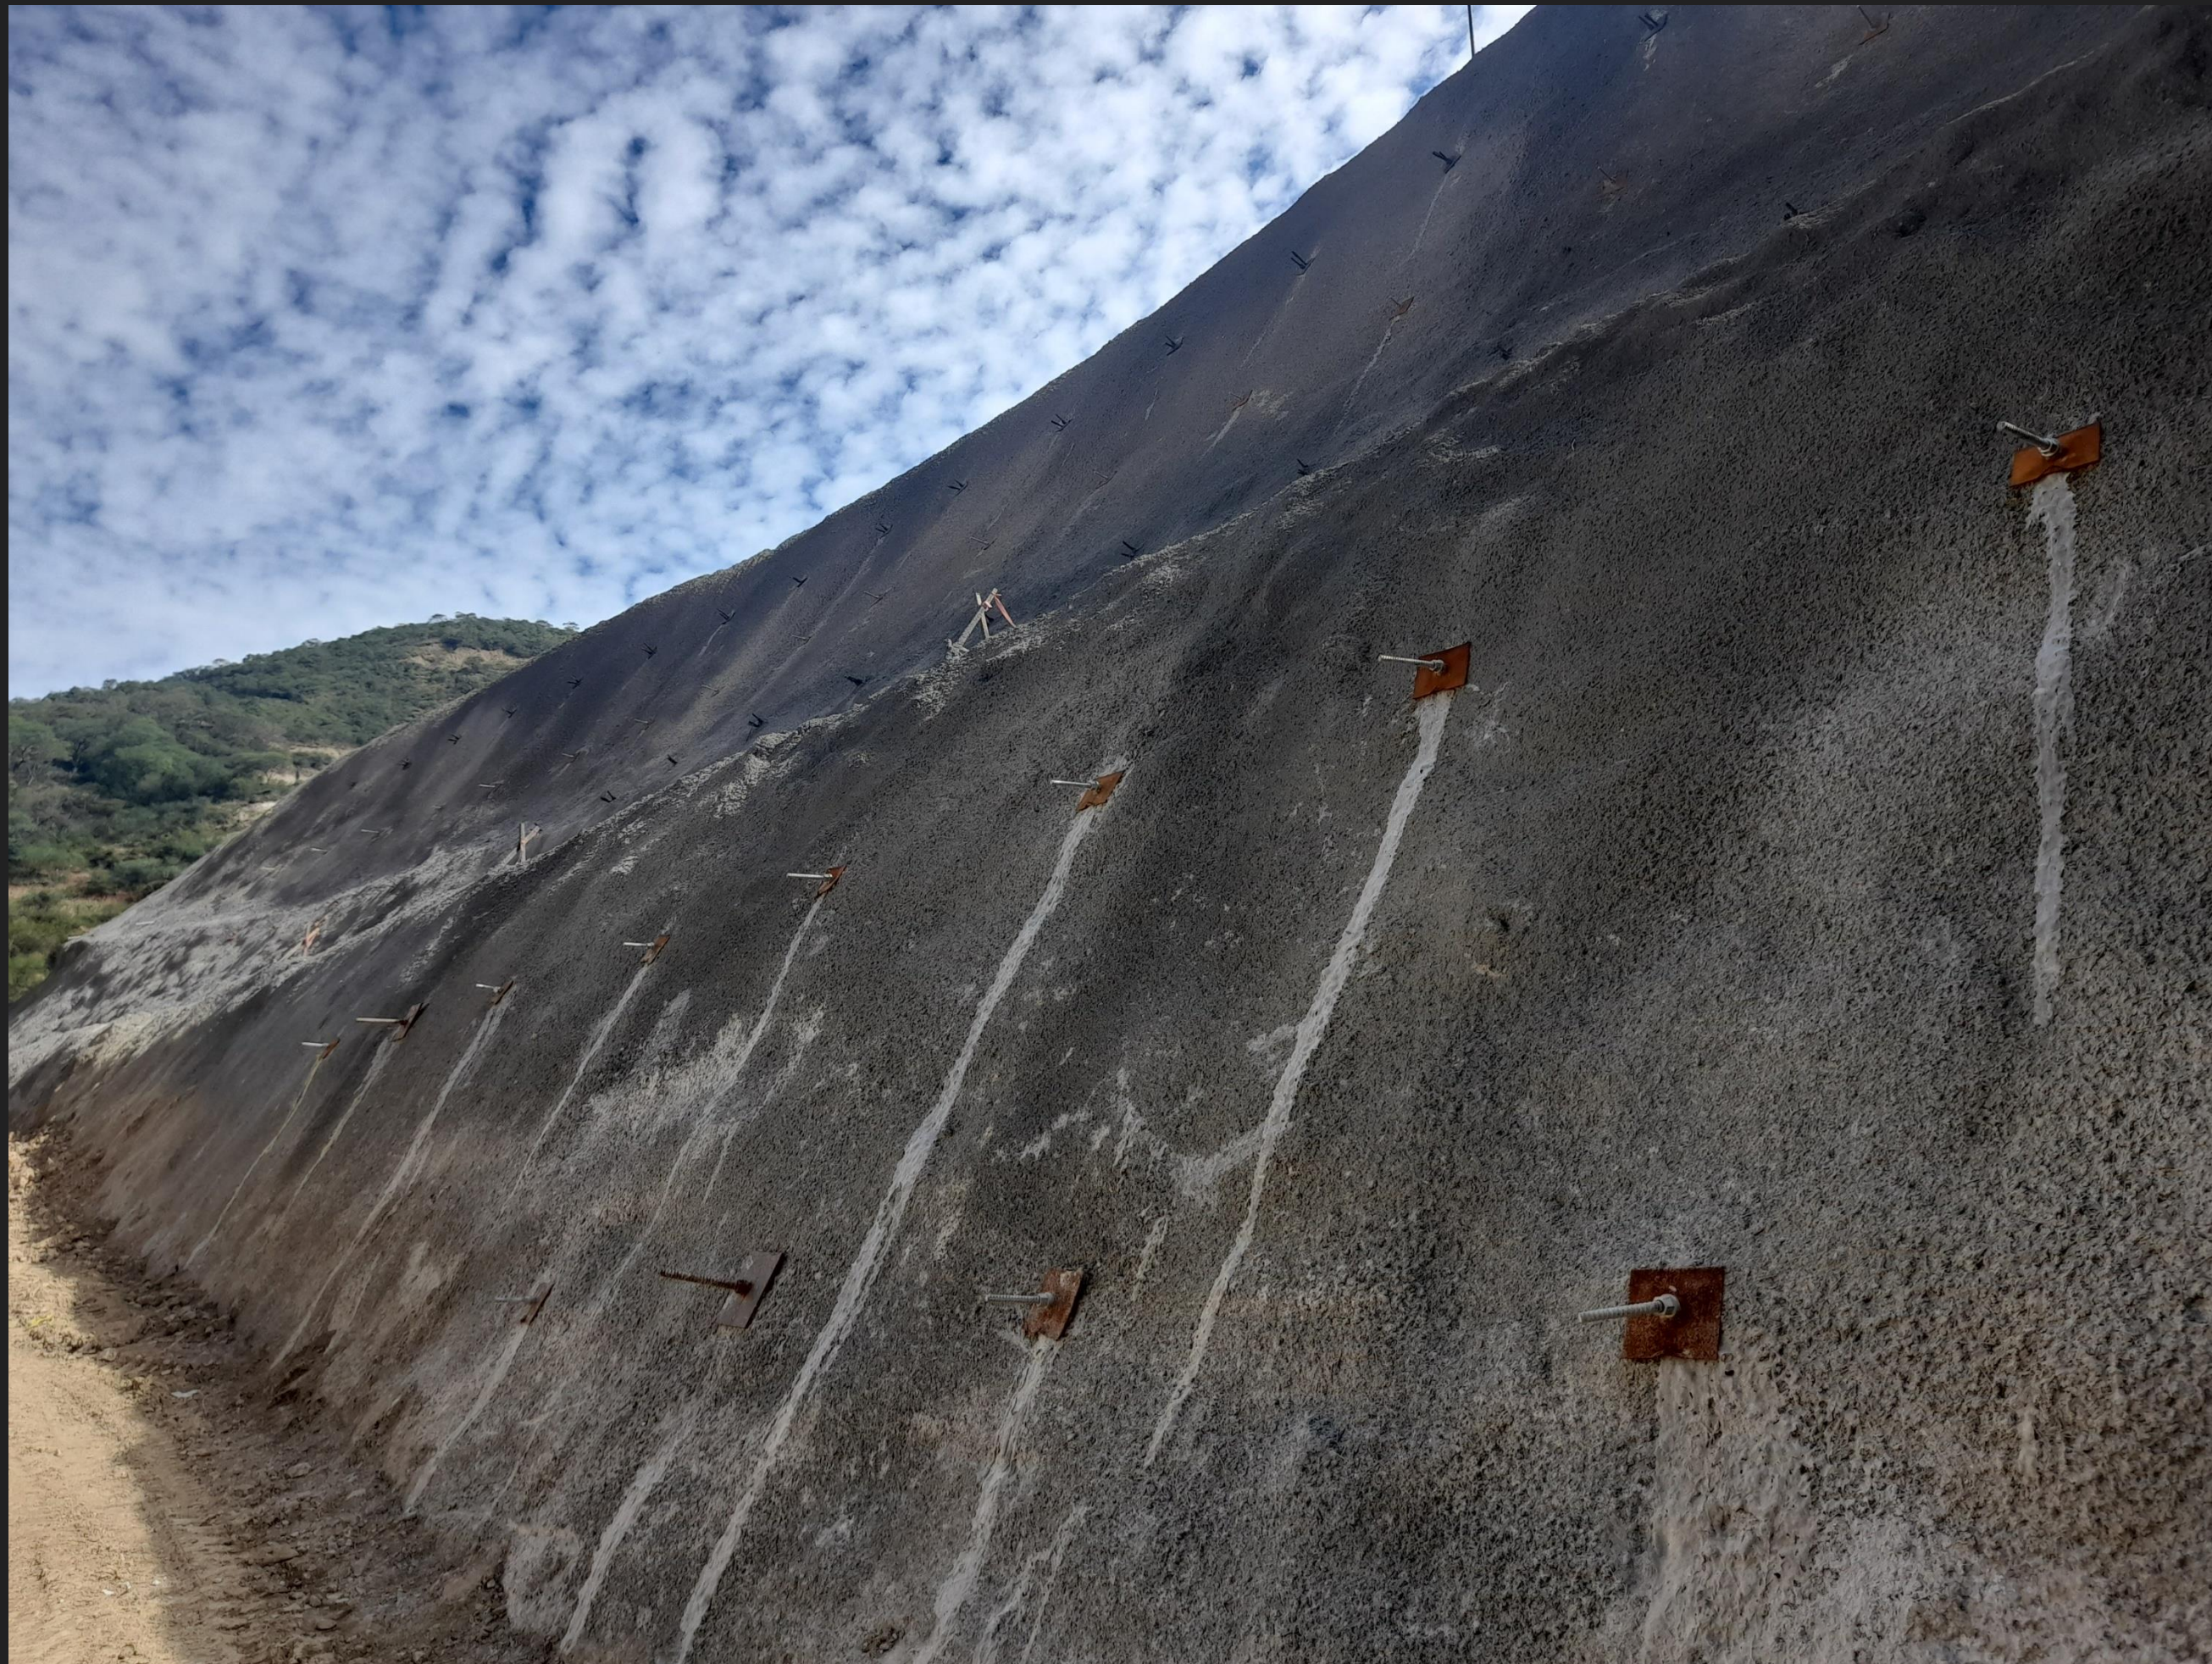
SITE VISIT (MARCH 2025)

- Boxcut wall
- Fibrecrete & bolts installed on Transitional Monzonite
