VERIFICATION OF INITIAL DEVELOPMENT DESIGN AND NUMERICAL MODEL, POBOYA RIVER REEF, INDONESIA

MINING APPROACH

BOXCUT DESIGN

SITE VISIT AND VERIFICATION

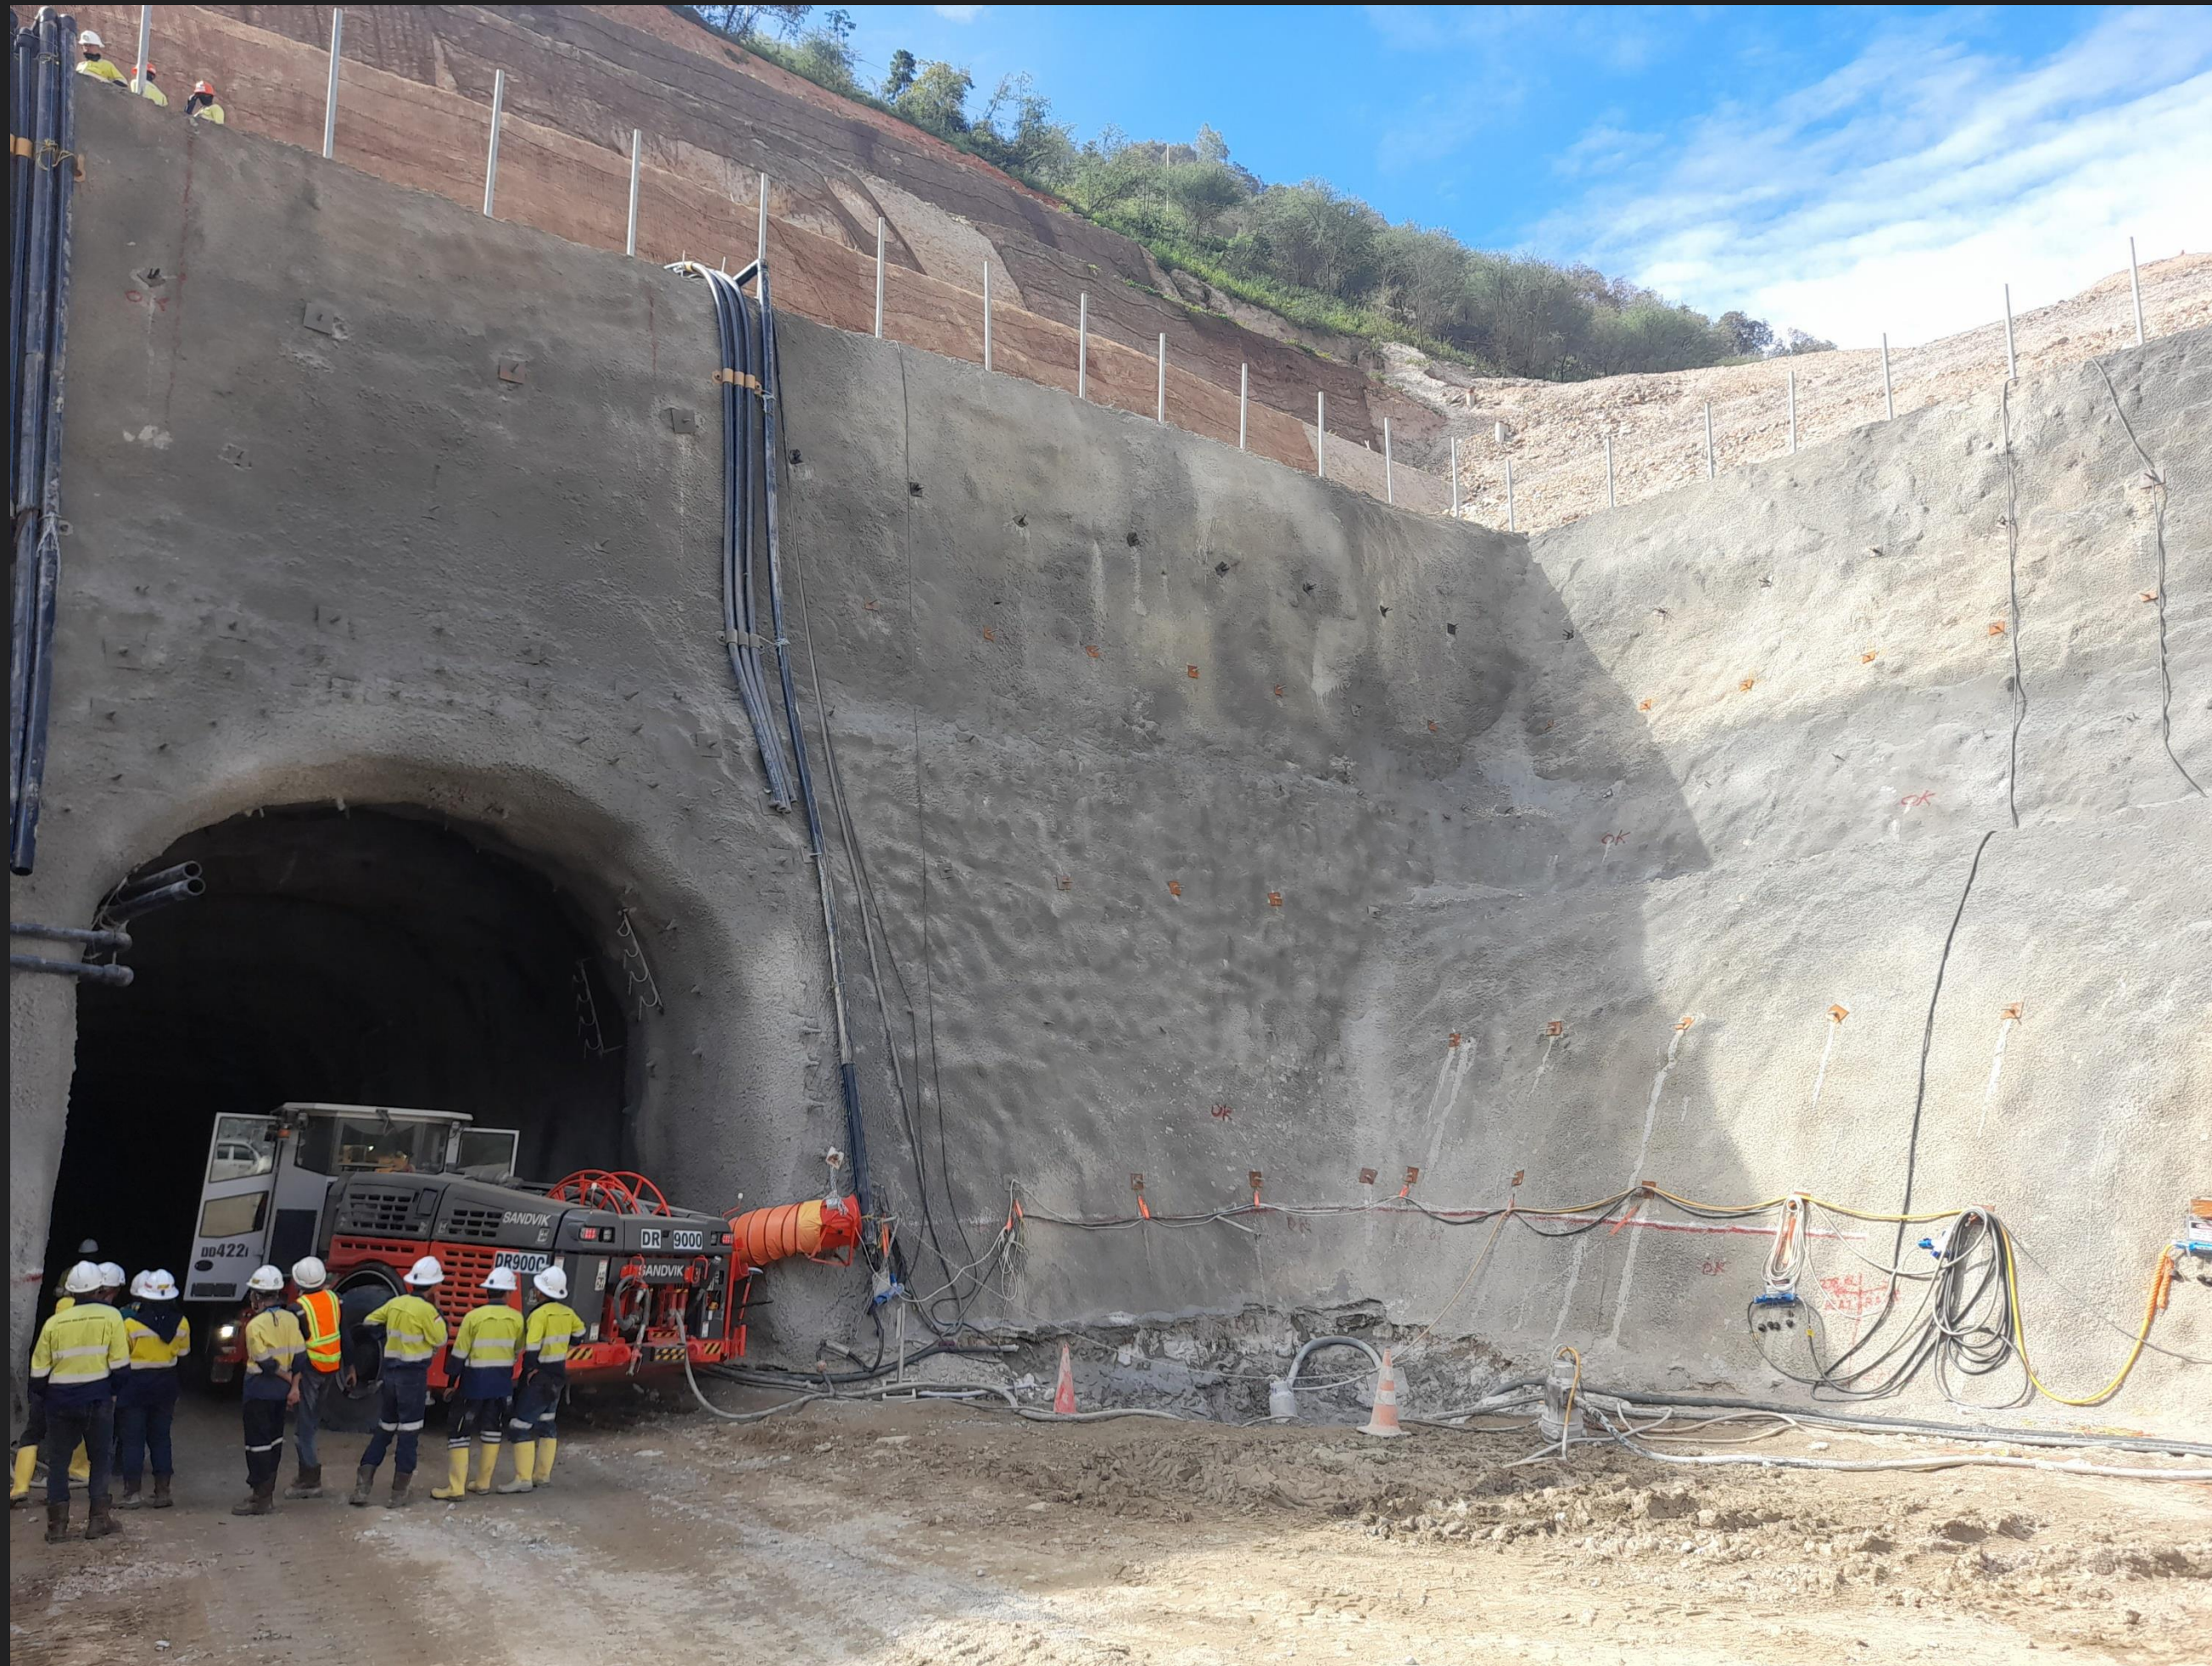
SITE VISIT (MARCH 2025)

- Boxcut wall & Portal Face
- Fibrecrete, cable bolts & solid bar installed on Transitional Monzonite

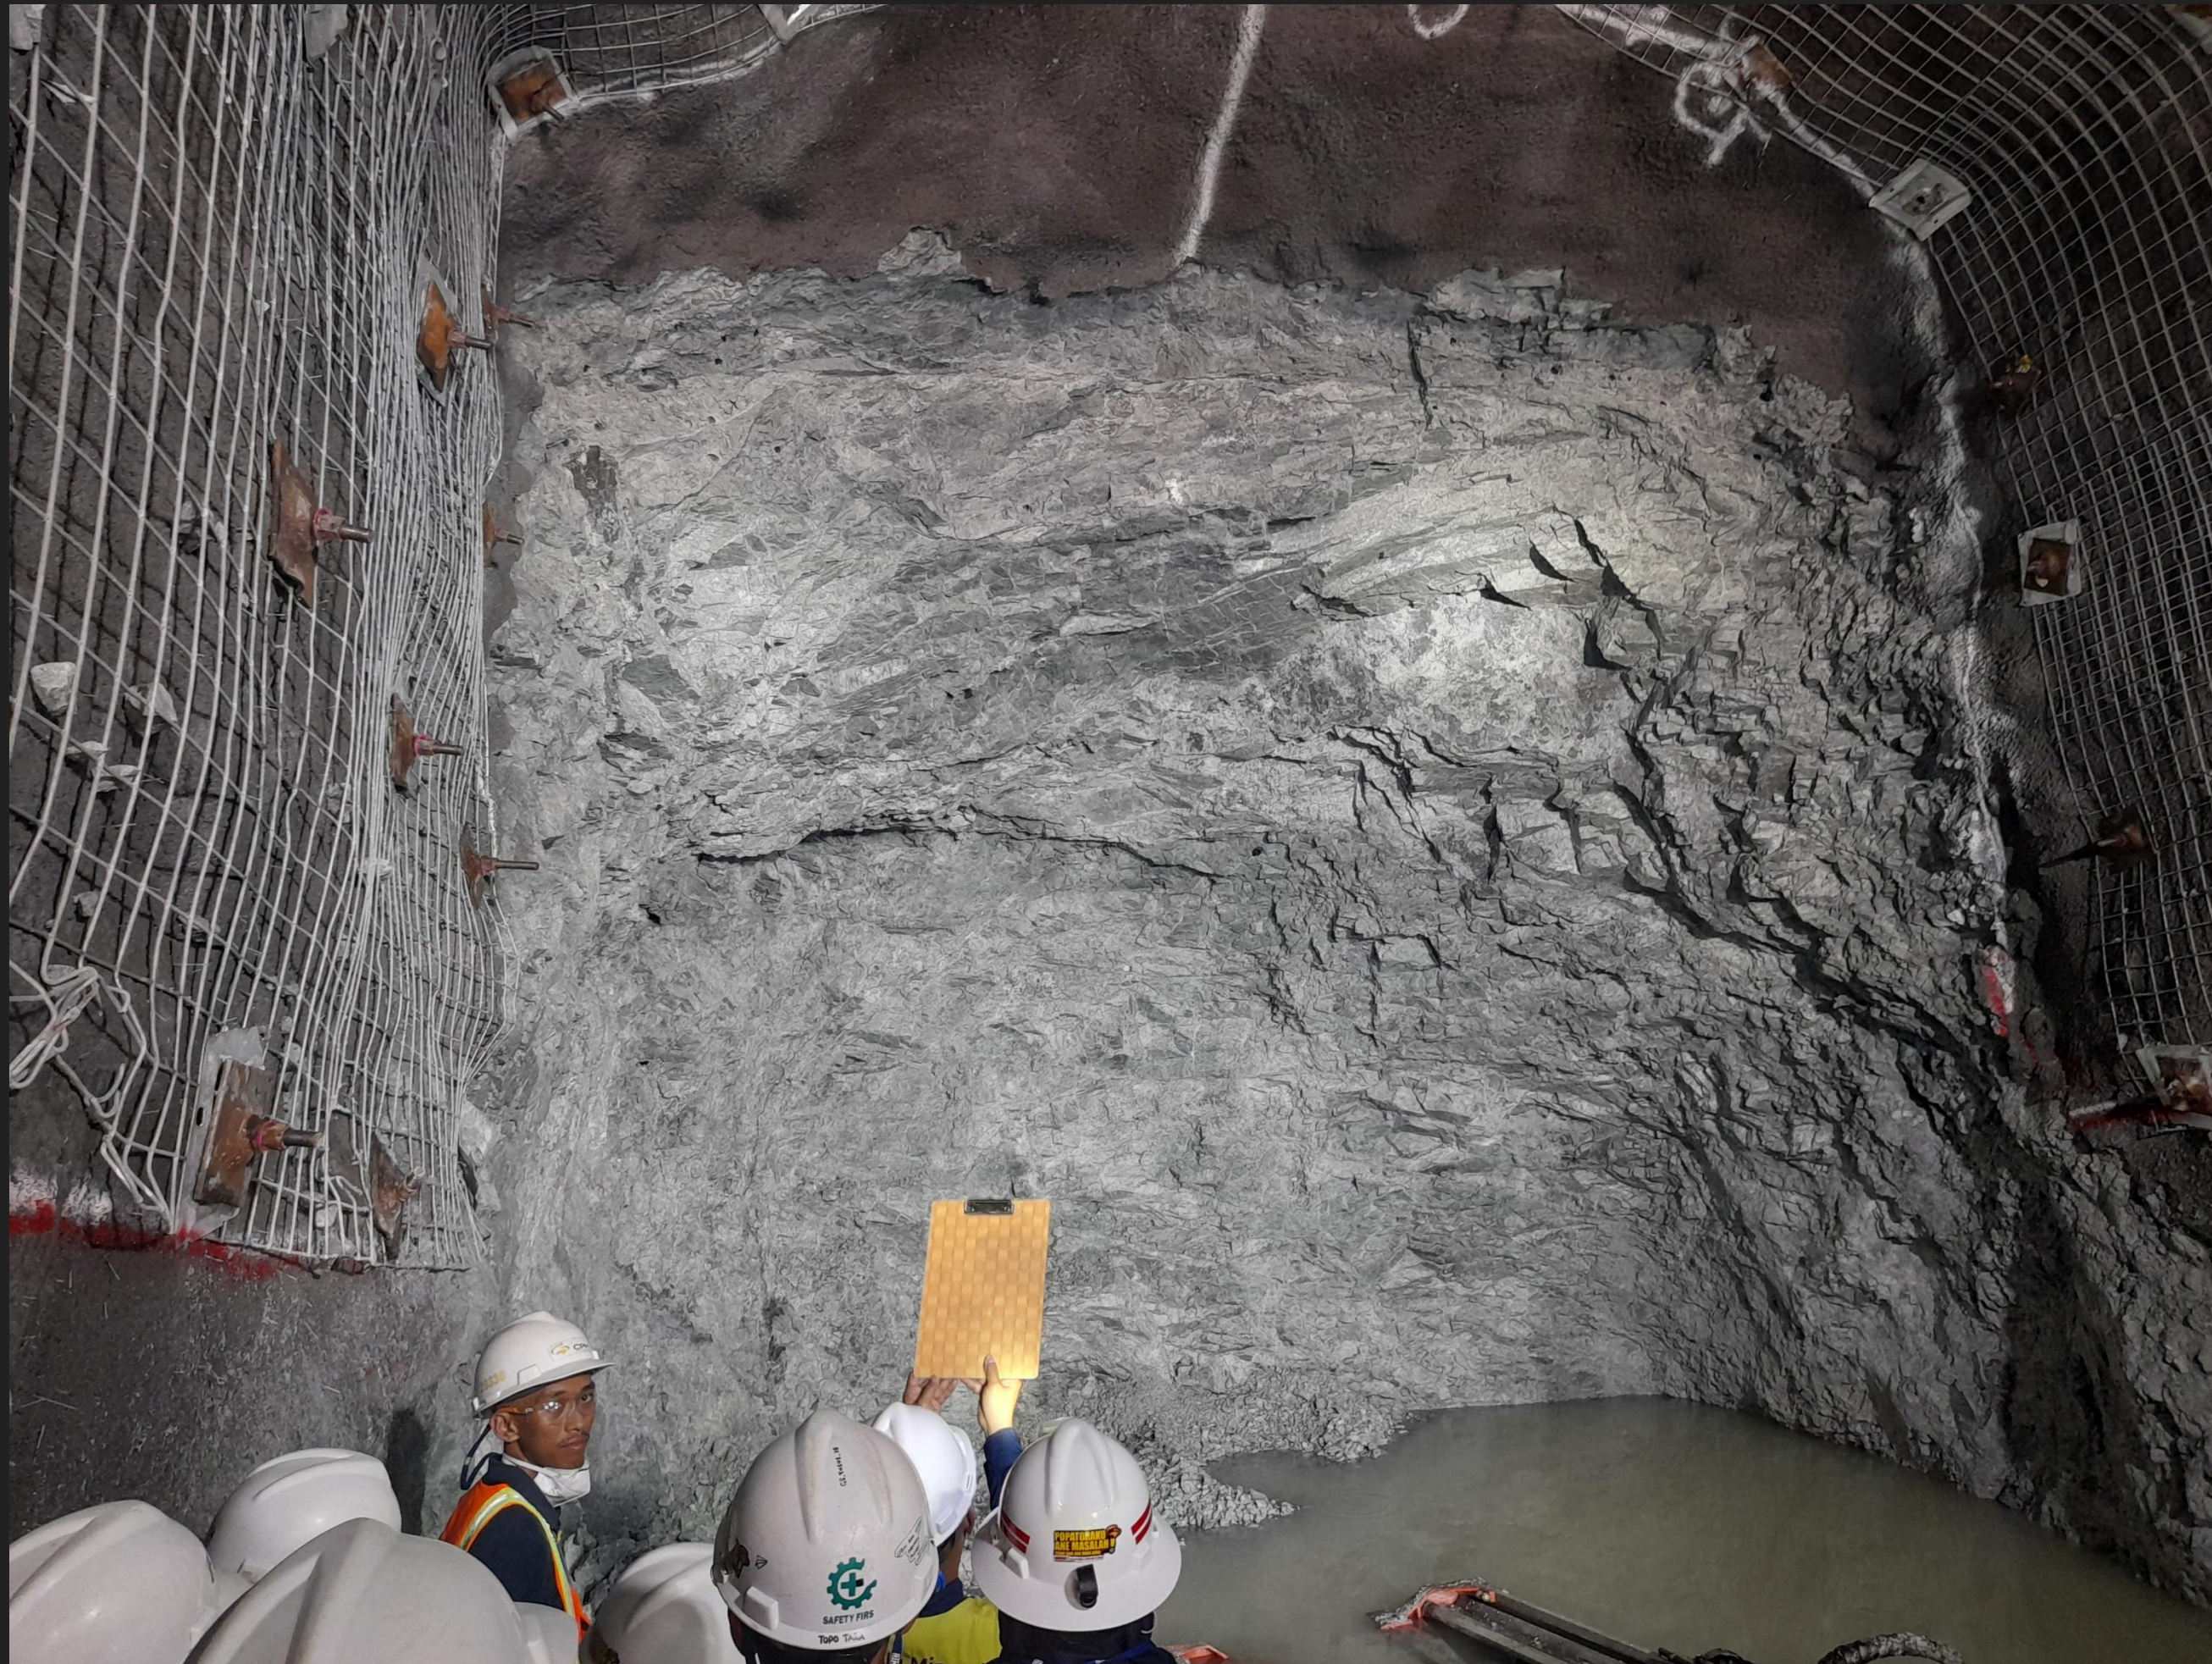
SITE VISIT (MARCH 2025)

- Decline face (approx. 20m)
- Good profile
- Mapped Q of 3.13 (Average 3.13 for last 4 cuts)
- Mapped RQD of 50 (Average 46 for last 4 cuts)
- Improving ground approaching “fresh”
- Remains very weak, foliated rockmass
