Never give up, Maramarua K1 Pit Geotech performance – a mine operators perspective

Maramarua Coal Mine

Dean Coplestone, Mine Planner

August 2023

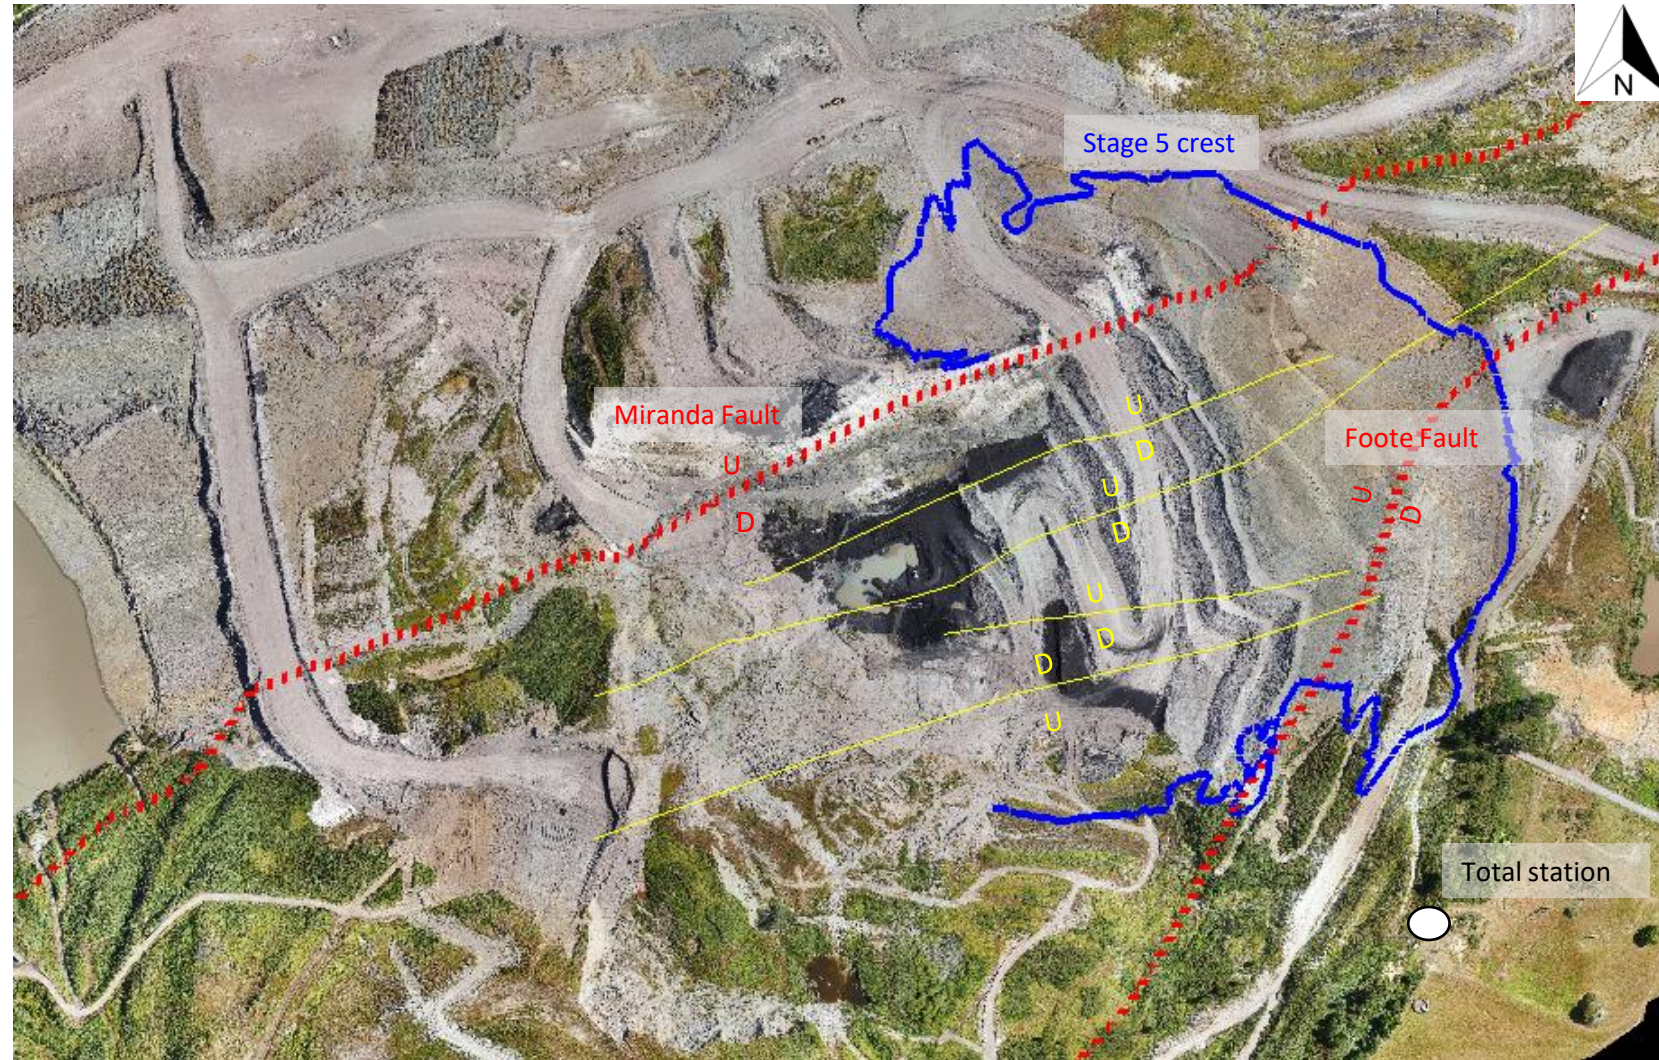
Geotechnical setting

- The K1 pit is hosted in a complex wedge structure bound by two major fault structures:

Miranda Fault:

- Normal sense of displacement
- ~10 m Deformation zone.
- Coal downthrown ~60m

Foote Fault:

- Normal sense of displacement
- ~100 m Deformation zone.
- Coal downthrown ~150m

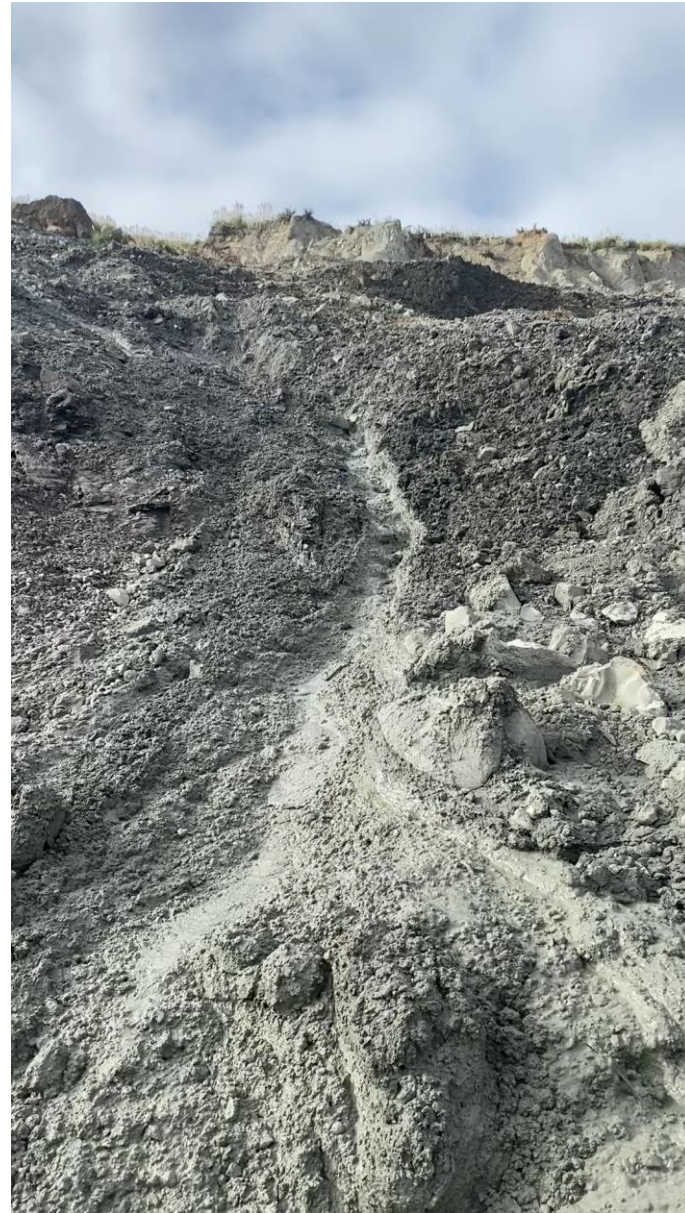
Obstacles

- Unfavorably dipping geology
- Soft conditions
- Ground/surface water control
- Low weathering resistance in the marine units
