BATHURST
RESOURCES LIMITED

Stress strain regime changes around the Mt William fault and its implications for highwall stability

Benjamin Godfrey Hyde MSc

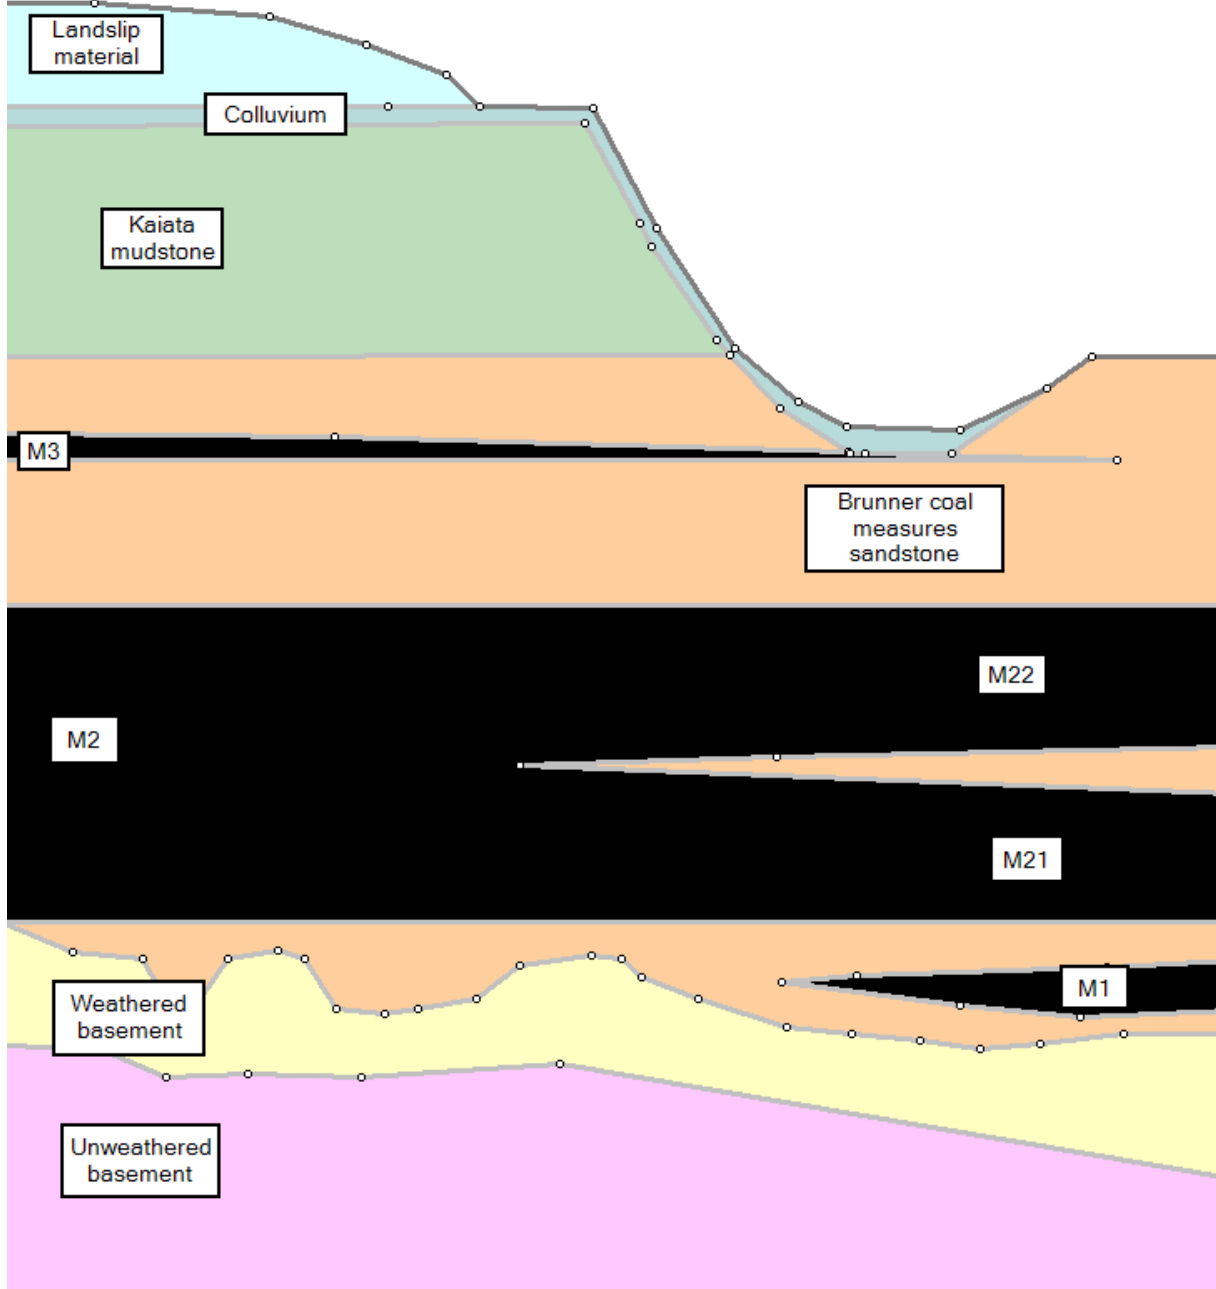
Structural system

Reactivated normal faults have uplifted the plateau. The faults moved from an extensional system of NNE-SSW trending faults 90-40Ma to a compressional phase starting around 15Ma

This history has allowed for old and new shearing to form along with the faults. Shearing in basement likely formed due to differential movement between the faults and shears in the Brunner and Kaiata formations are due to the steeply dipping normal faults not being well suited to accommodate the current compressional movement.

This has lead to stress in and around the major reactivated faults to be expressed in unusual ways. Due to the partial WNW-ESE component of the compression faulting in this orientation has taken advantage of the existing shearing in basement.

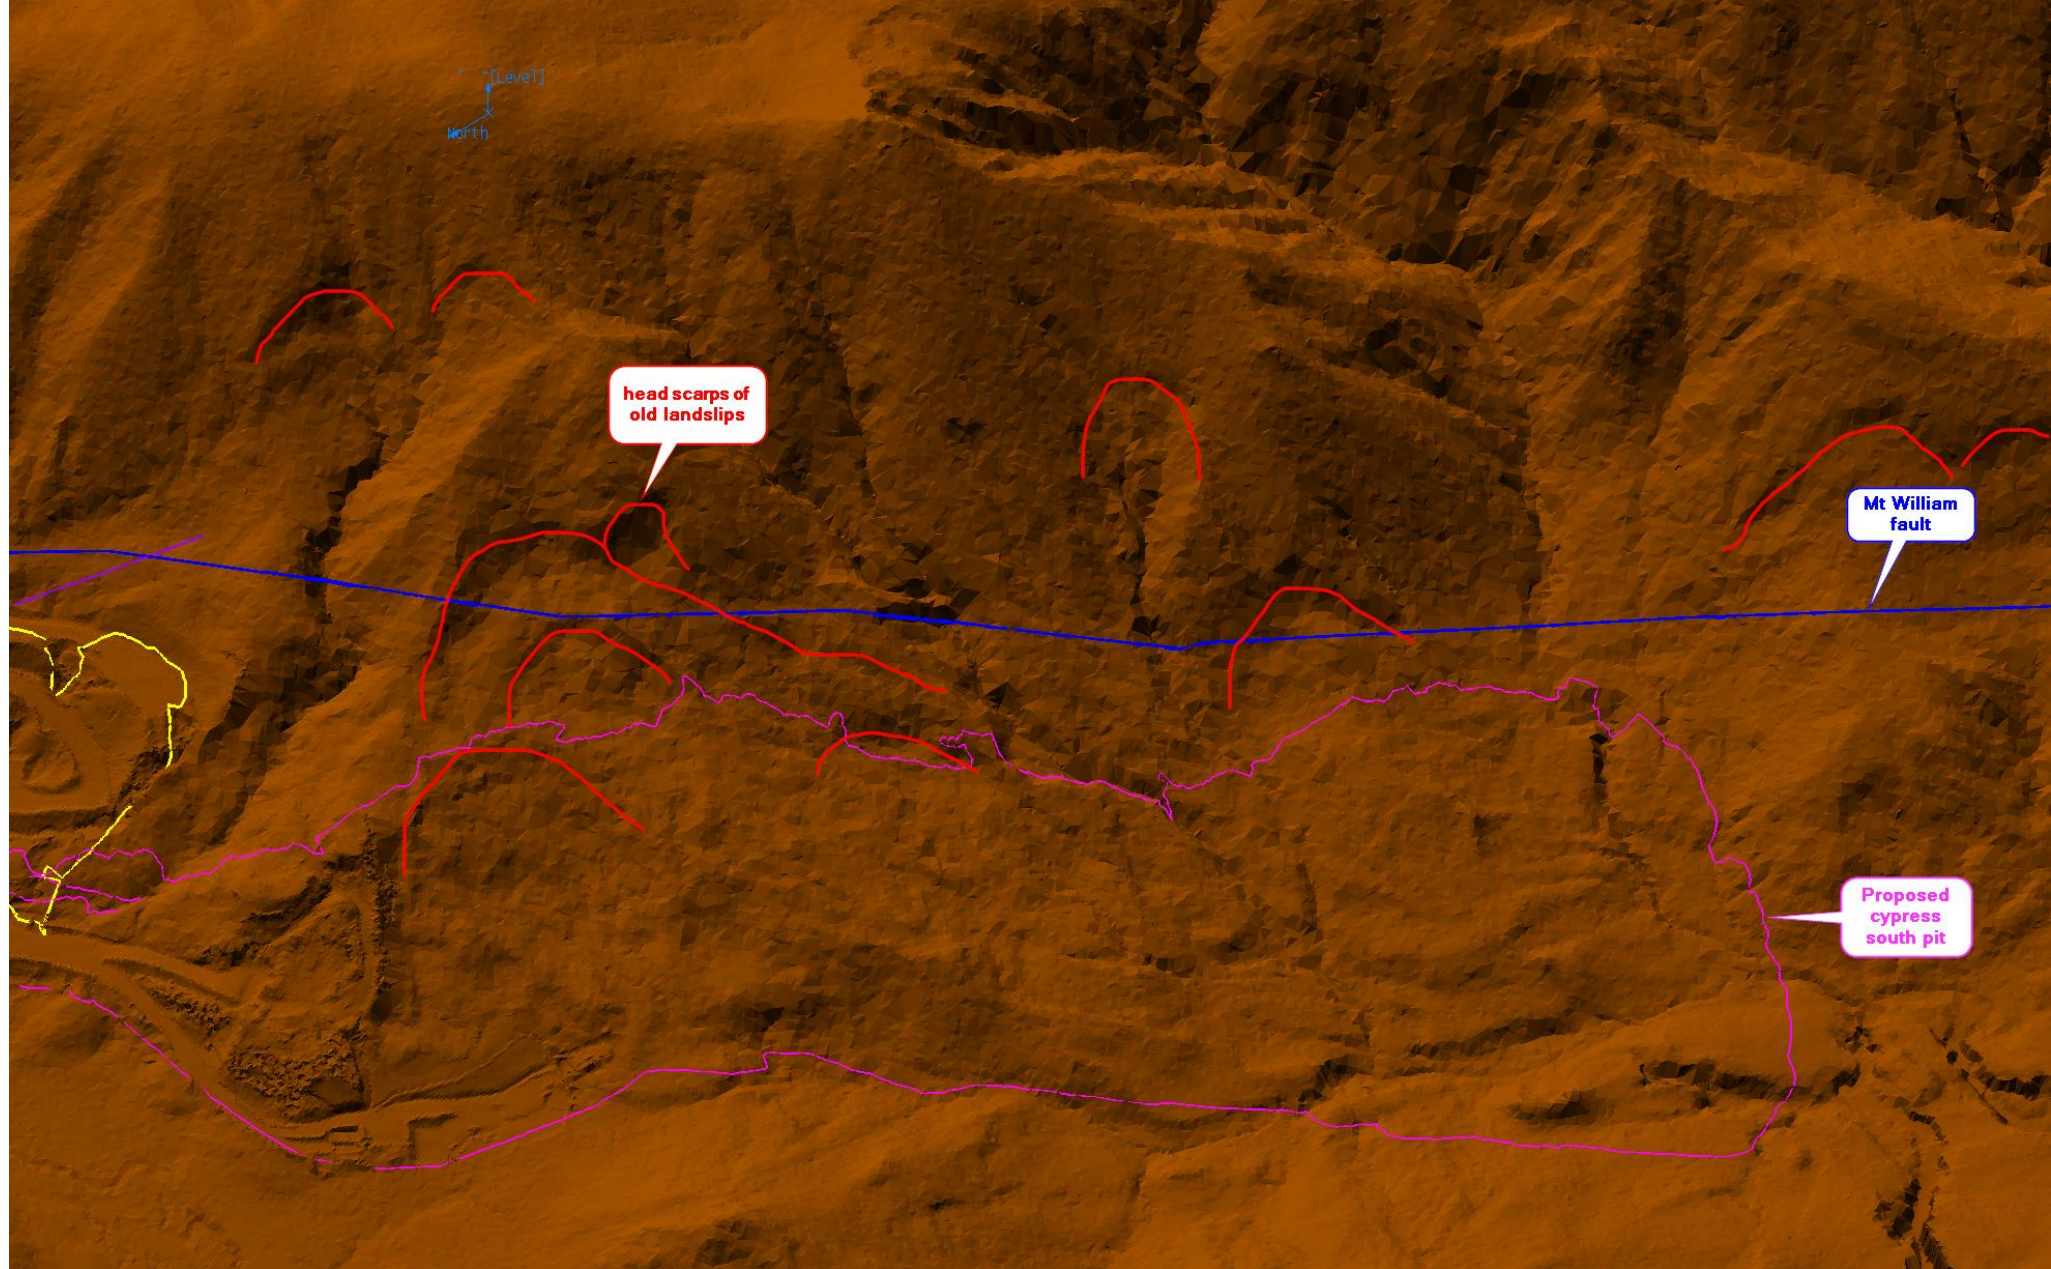
- The historic landslips are far more numerous and pronounced in the south than in the north.
- These slips are likely caused by the highly weakened basement towards the top of the ridgeline allowing larger failures to propagate.
